# Paul Stoutenburgh Preserve Restoration Studies Stakeholder Update

May 26, 2023

# Project Progress Summary

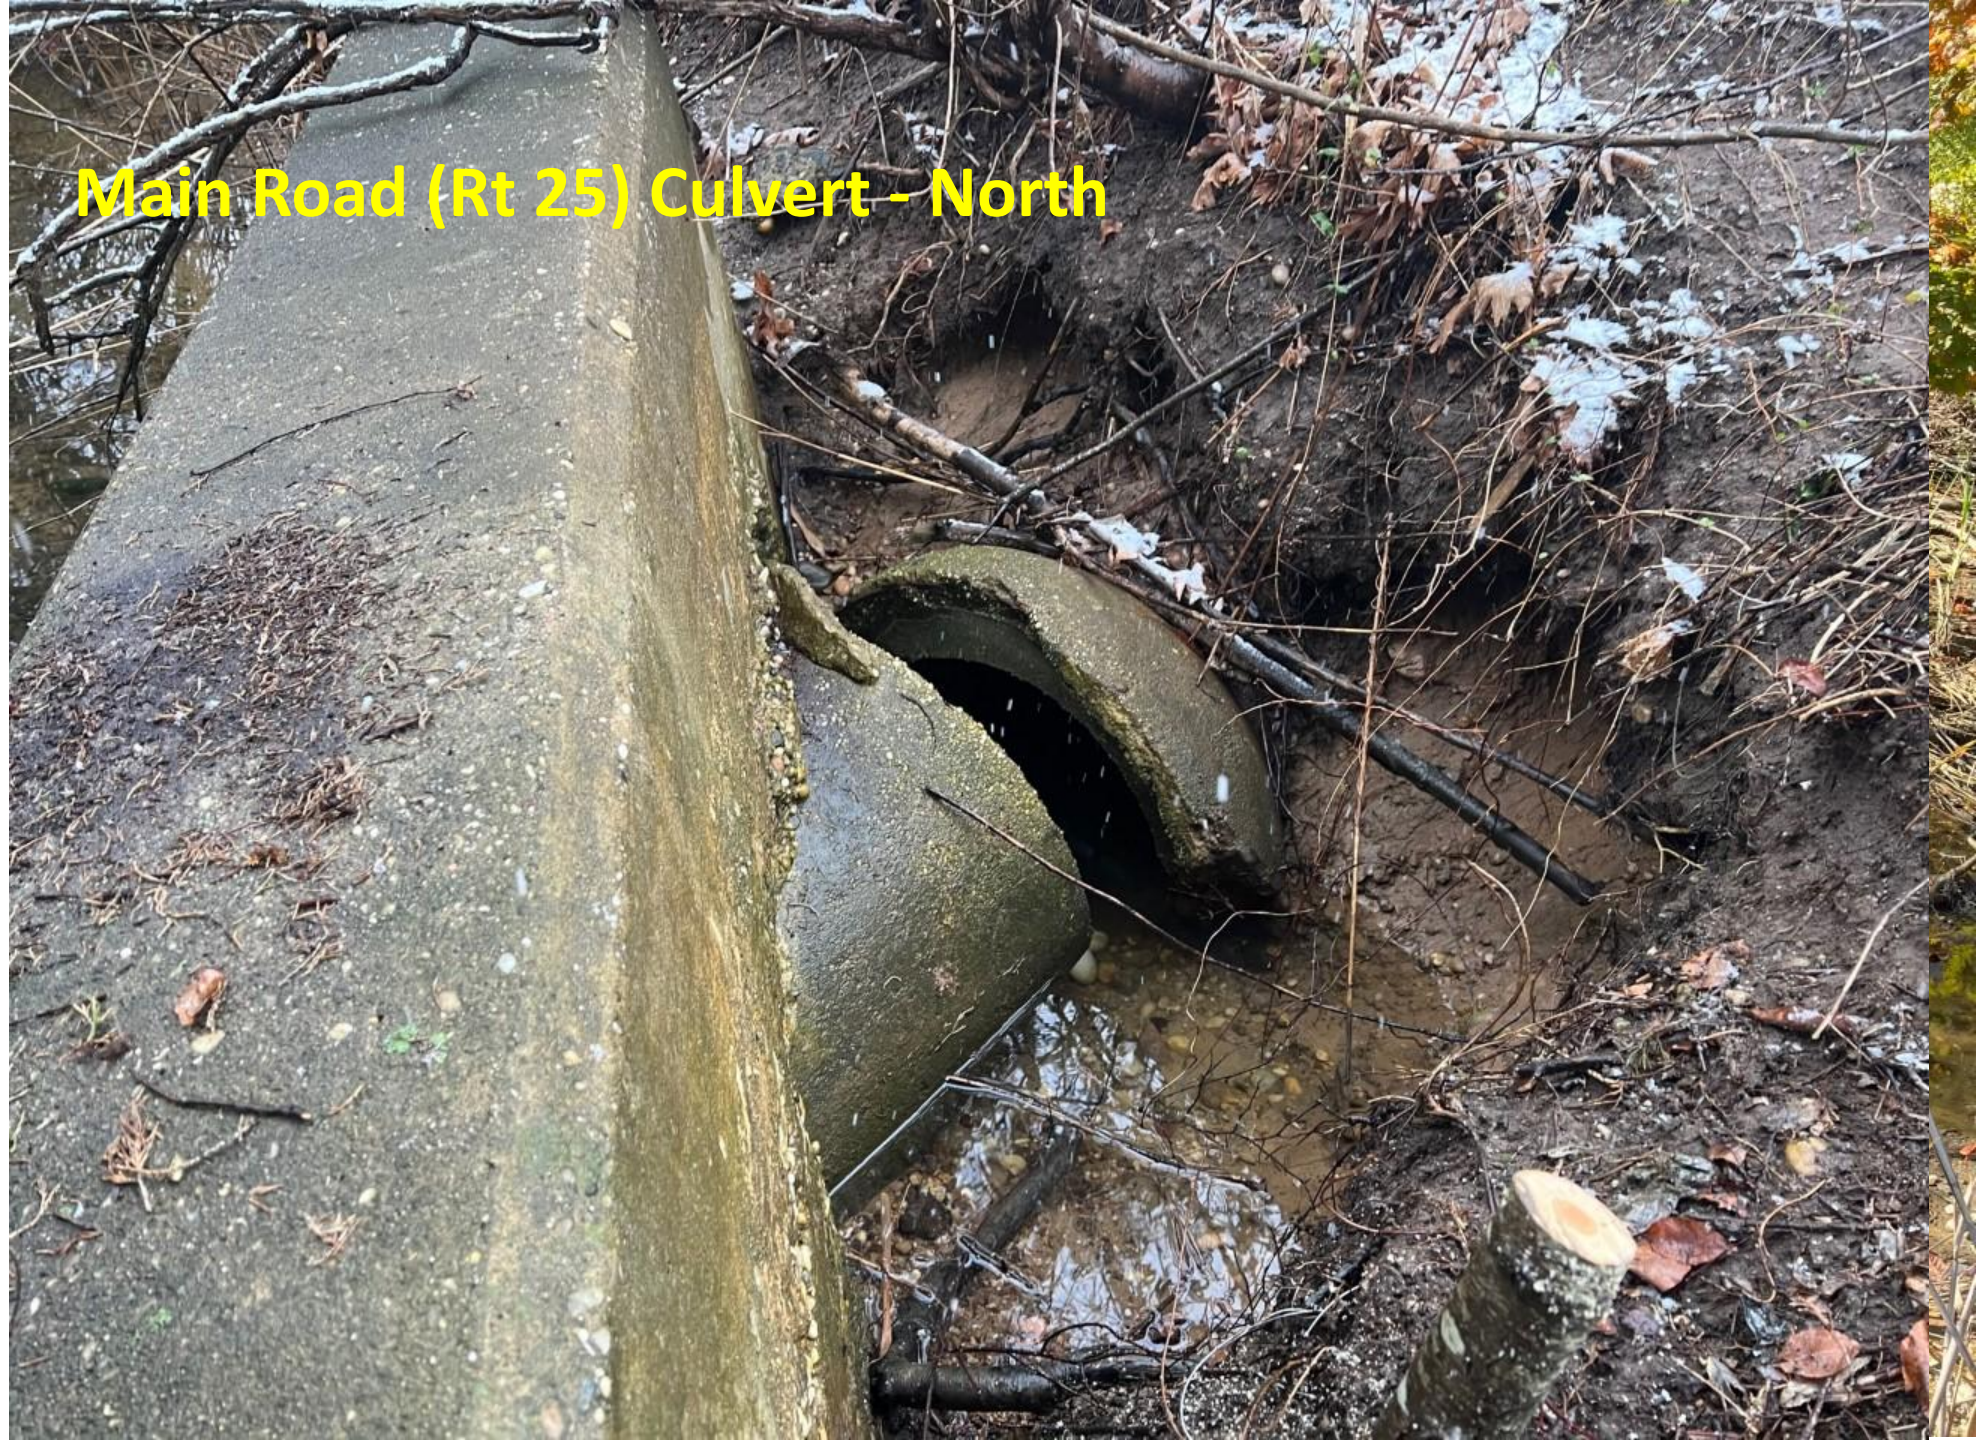
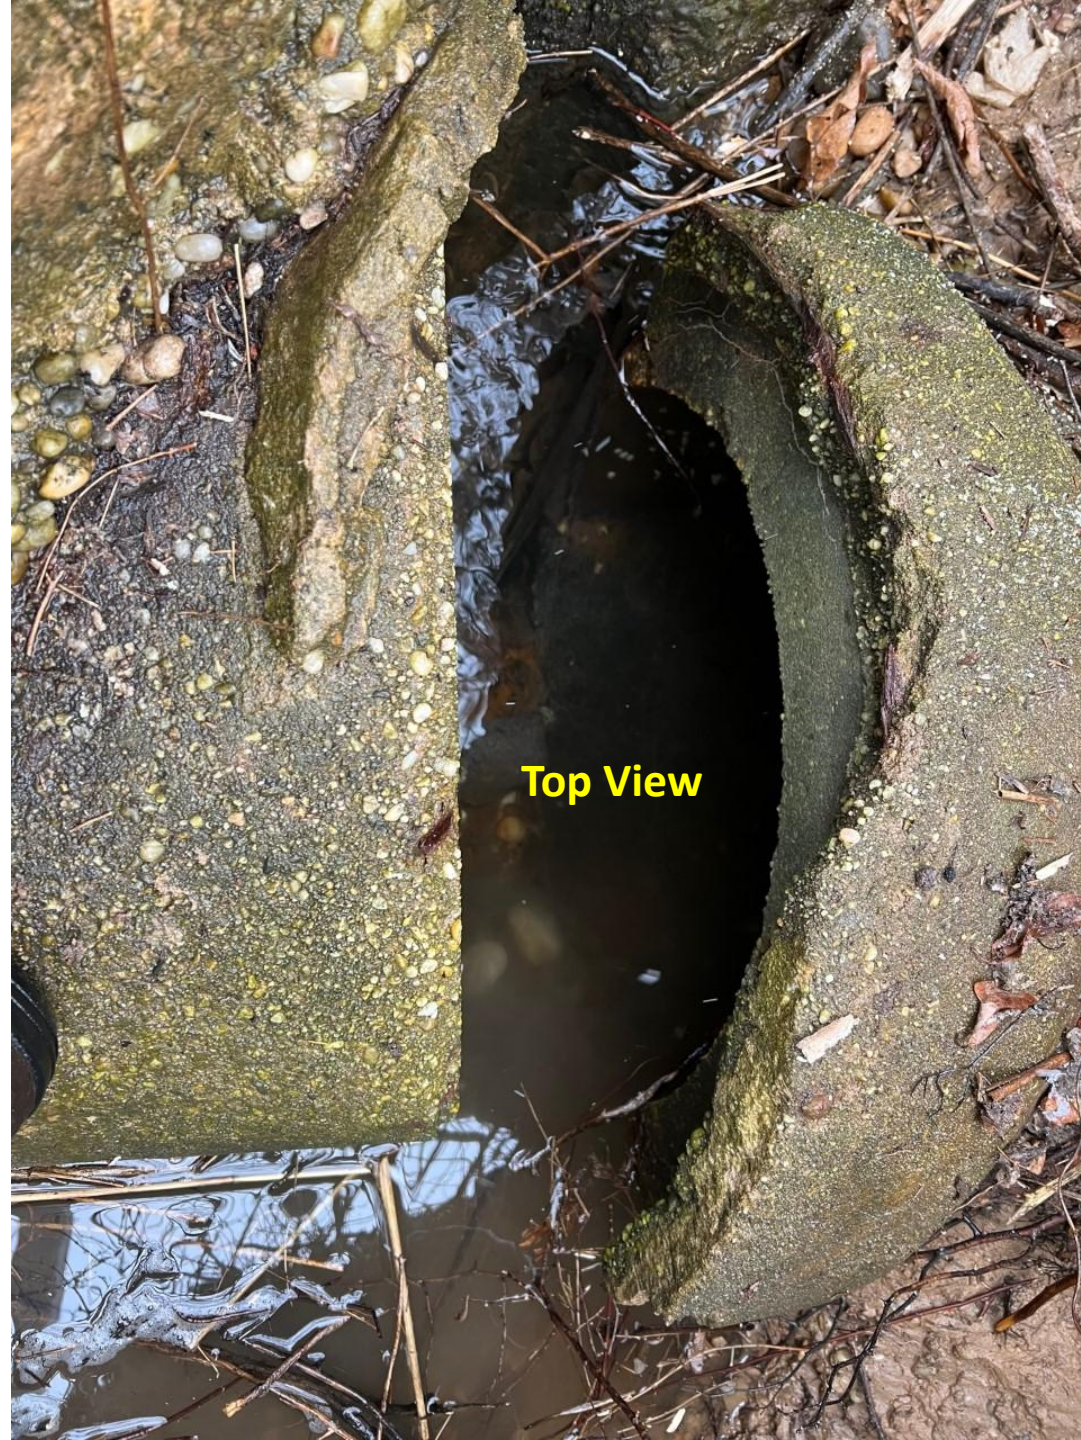
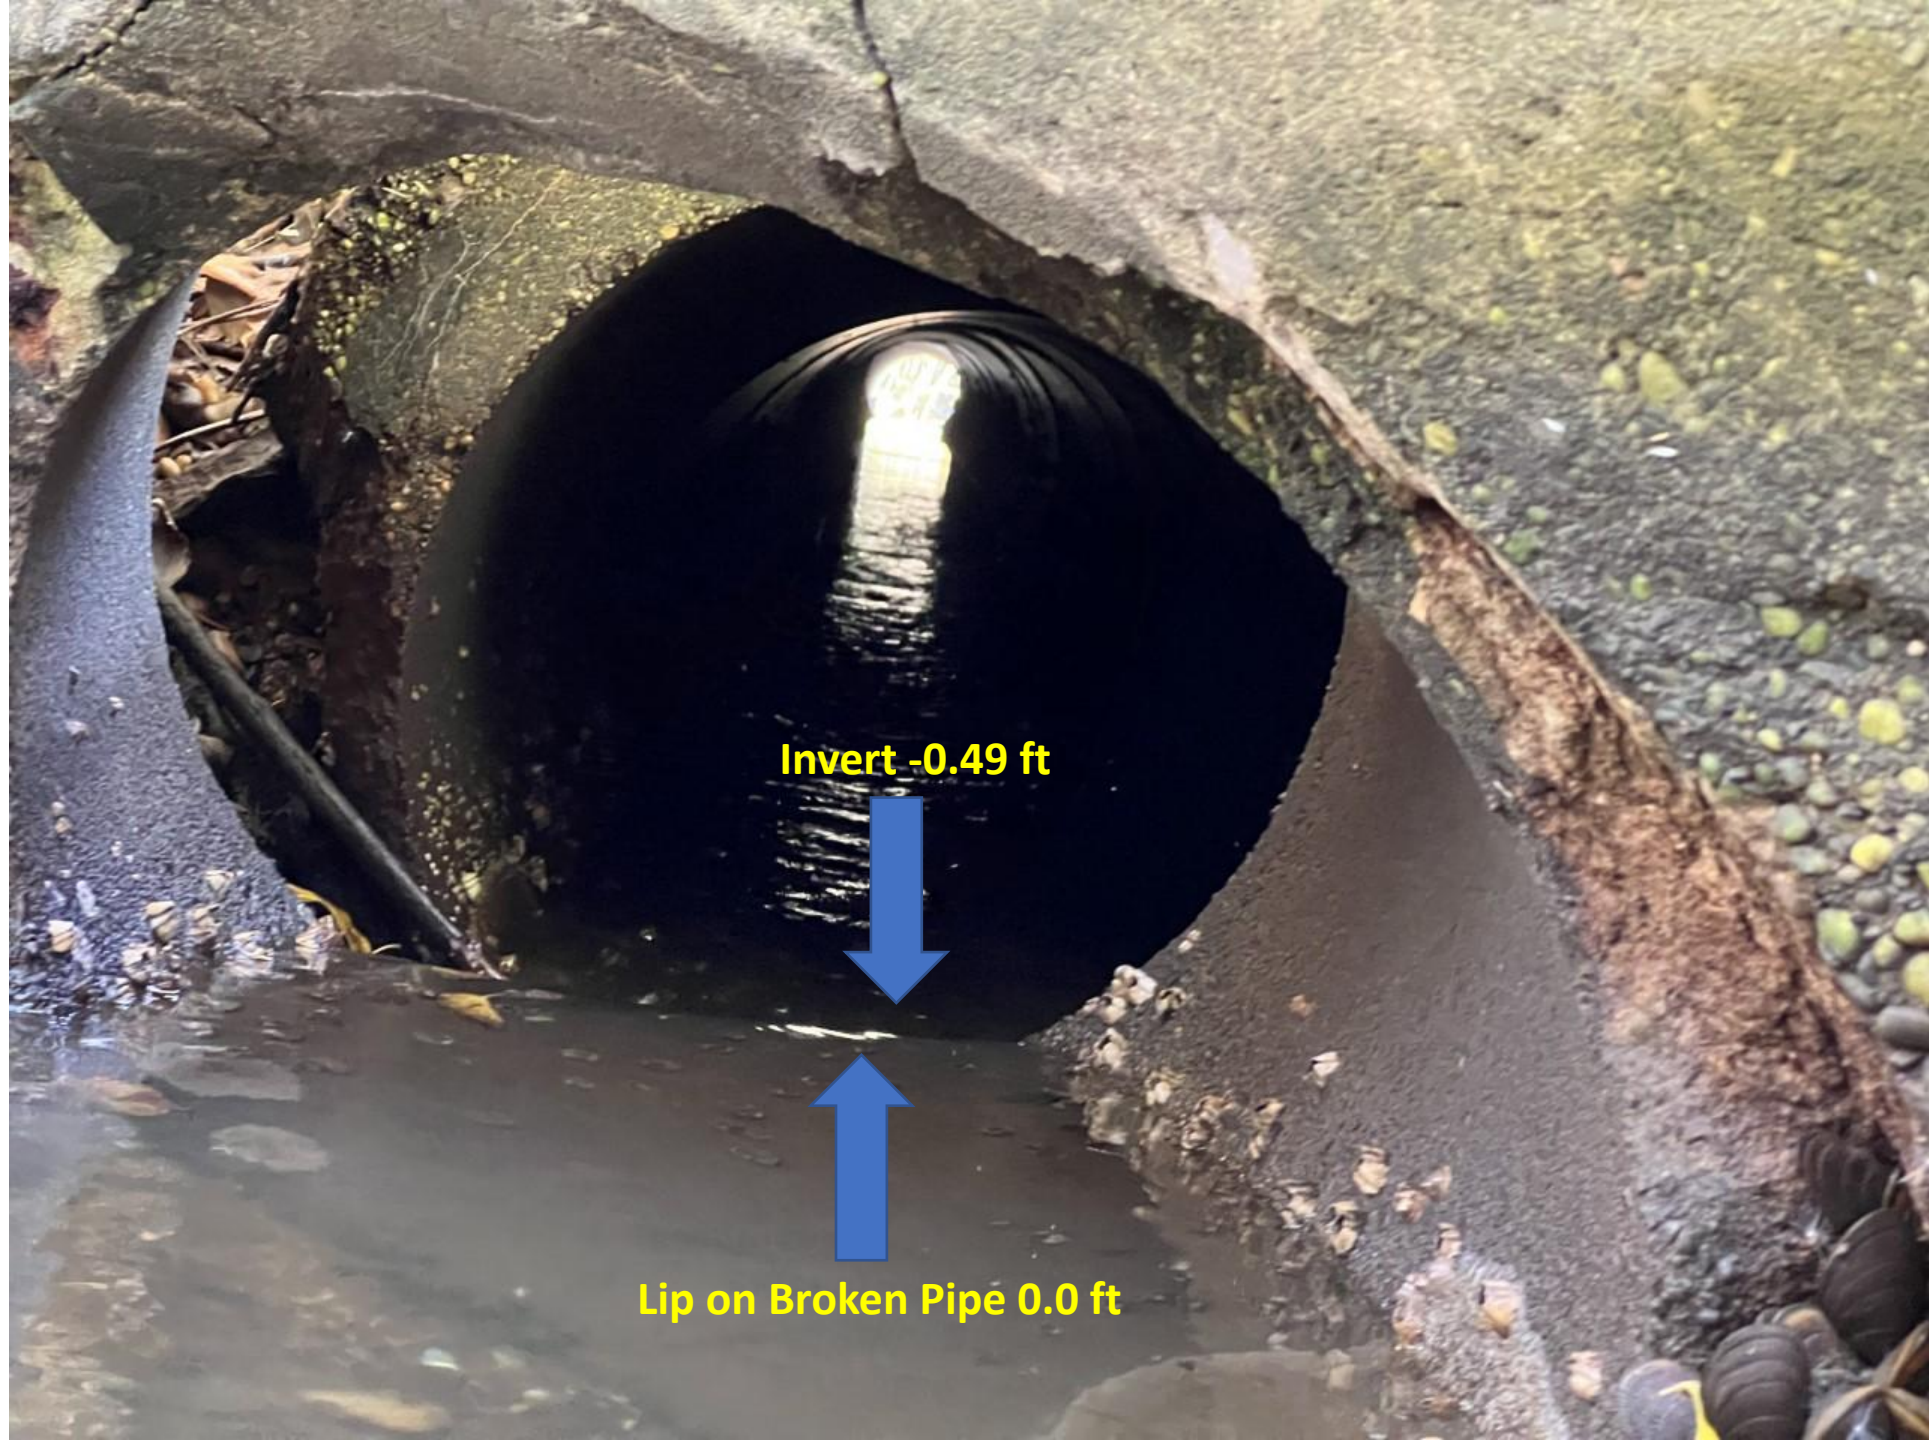
## Main Road (Rt 25) Culvert - North

Invert -0.49 ft

Lip on Broken Pipe 0.0 ft

- Culverts between Mill Creek and tidal wetland in SW area of PSP of various ages and conditions
- North side of Rt 25 culvert in state of failure and may be restricting inflows/outflows
- Tidal prism is reaching PSP tidal wetland, resulting in high water levels equivalent to Mill Creek on higher high tides/storm tides
- Water elevations on high tides on north side of railroad grade are slightly higher than on the south side
- Outflow from PSP wetland limited by downgradient channel elevations and failed Rt 25 culvert headwall.
- Tidal wetland within PSP des not fully drain on low tides; has limiting effect on wetland plant growth.
- Salinity within channels leading to PSP wetland reflect adjacent Mill Creek/Shelter Island Sound
- Salinity within PSP tidal wetland highly variable due to significant freshwater inflow from adjacent watershed and evaporation from ponded areas.

- Immediate repair of north side of Rt 25 culvert recommended.
- LIRR culvert maintenance important to provide full flow capacity between PSP wetlands and tidal channel to south
