Meetinghouse Creek Watershed Management Plan

July, 2006

Prepared by: Horsley Witten Group, Inc. Sandwich, Massachusetts

Prepared for:
Peconic Estuary Program
Suffolk County Department of Public Health Services
Office of Ecology
Riverhead, New York

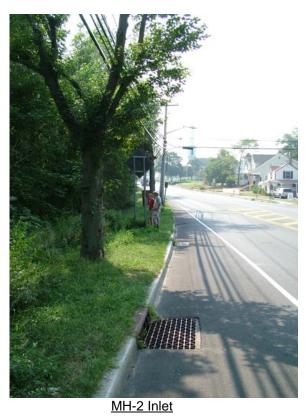
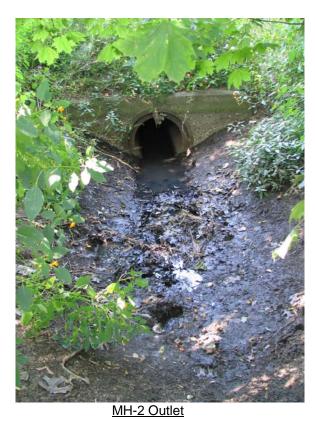
Description (preliminary assessment of	Meetinghouse Creek Park - Parcel 41
Wate from		
4.	Hubbard Avenue has clogged leaching	of most likely retrofit-quality, quantity, or both): - large amounts of sediment from stormwater runof - catch basins and built up on the parking lot.
	Unique elements of retrofit (e.g., met	hod of conveyance or stormwater diversion):
Road	way grass channel along Hubbard Ave	to a bioretention system.
