## Farmers in the Marsh: Lessons from History and Case Studies for the Future

### ABSTRACT

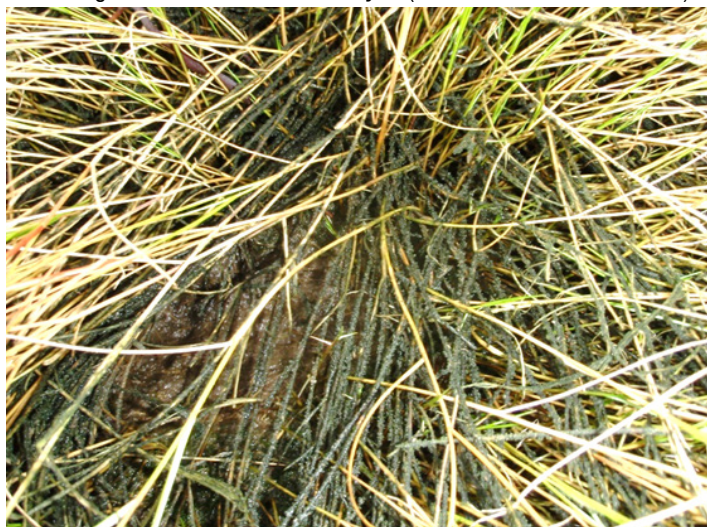
**FIGURE 4.** *Spartina patens* thatch with algae: 2010, Wells, Maine, USA. Notice bare ground visible below thatch layer. (Photo credit: S.C. Adamowicz.)

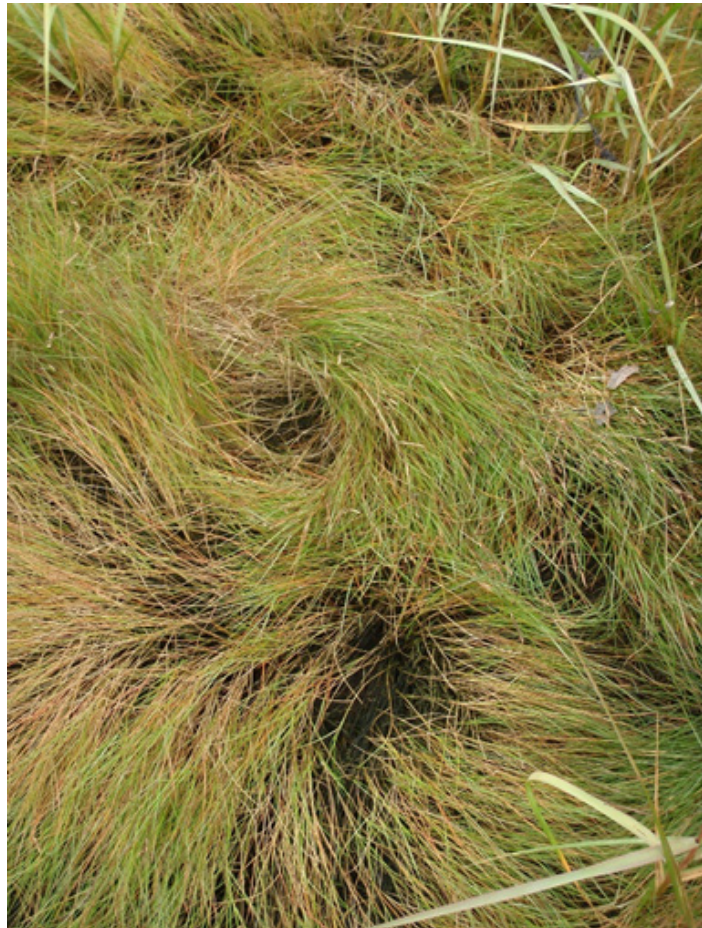
**FIGURE 5.** Encroachment of *S. alterniflora* into “high marsh” showing algae on thatch; 2010, Wells, ME, USA. (Photo credit: S.C. Adamowicz.)

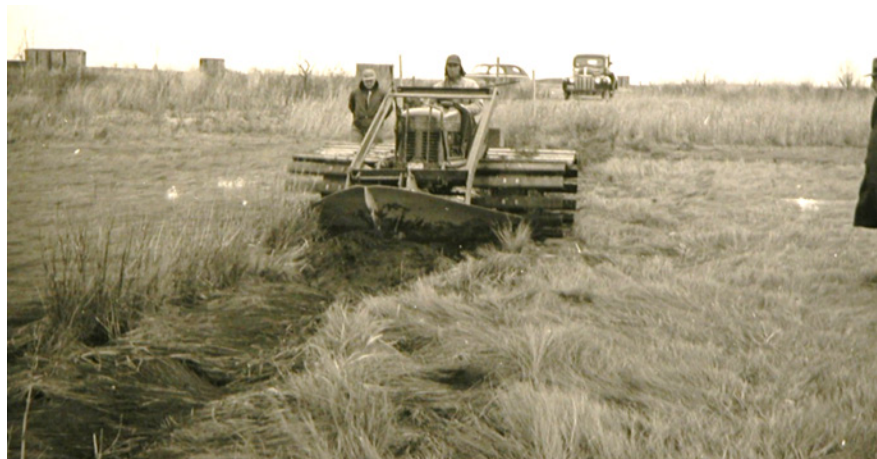
**FIGURE 9.** Scavel plow clearing debris from a mosquito control ditch circa 1940-1950s. Mechanized ditching patterns are ubiquitous from Massachusetts southward, often overlay previous agricultural ditching patterns, may not adhere to tideshed boundaries or original marsh slope, and develop highly compacted embankments on both sides of ditches. (Photo credit CT DEEP.)

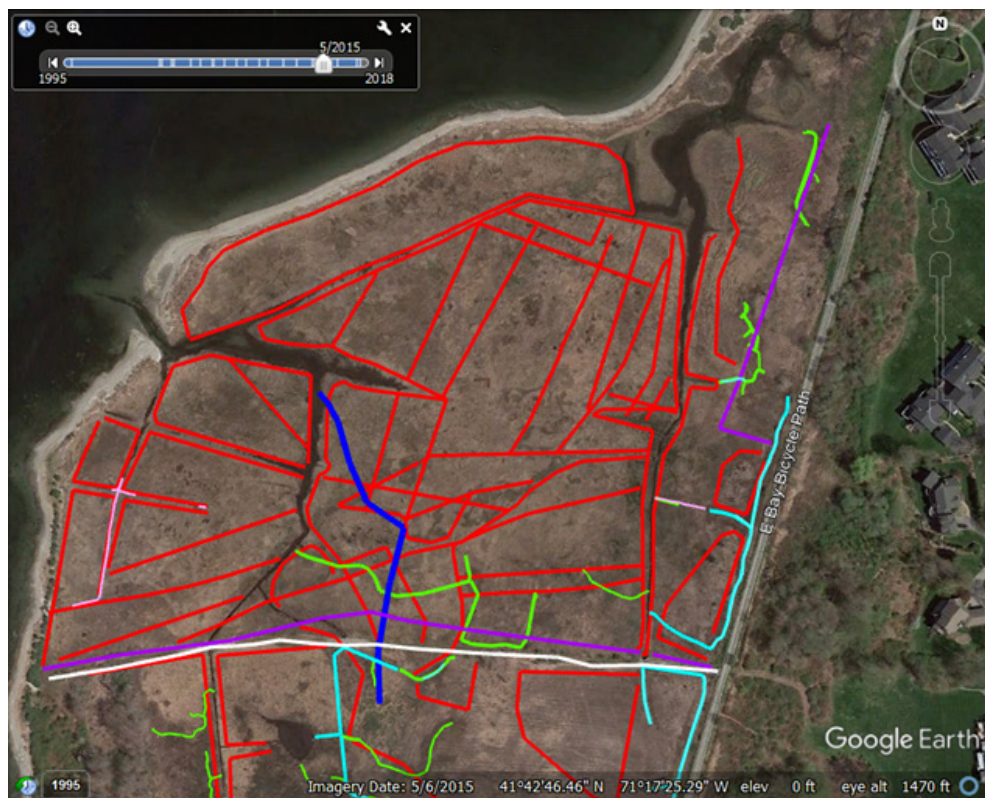
**FIGURE 11.** Jacob’s Point, Warren, RI, with runnels (light green), larger cleared channels (light blue), ditches (pink), embankments (red), stonewall embankments (purple), road/footpath (white), possible historic channel (dark blue) (Google Earth accessed May 19, 2020). All delineations were based on aerial signatures and need to be field verified.

Jacobs Point is managed by the Warren Land Conservation Trust and lies west of the East Bay Bicycle Path (a former railroad line) and just north of the Rhode Island Audubon Claire D. McIntosh Wildlife Refuge (Figure 11). This site is crossed by a 1915 road that is currently used as a footpath. An extensive patch of invasive *Phragmites australis* was controlled partially in 2010 through the replacement of three collapsed culverts under the footpath by partners including Save The Bay, U.S.D.A. Natural Resources Conservation Service, and the Town of Warren. Patches of *Phragmites* south of the footpath
