Award: SUNY RF of Stony Brook University Peconic Estuary Partnership– GE1523

2024 Alewife Monitoring on the Peconic River System: Grangebél Park and Woodhull Dam

Kellie McCartin Ph.D.
Assistant Professor of Marine Biology
Department of Mathematics and Science
Eastern Campus, Shinnecock 219
Suffolk County Community College
121 Speonk-Riverhead Rd
Riverhead, NY 11901

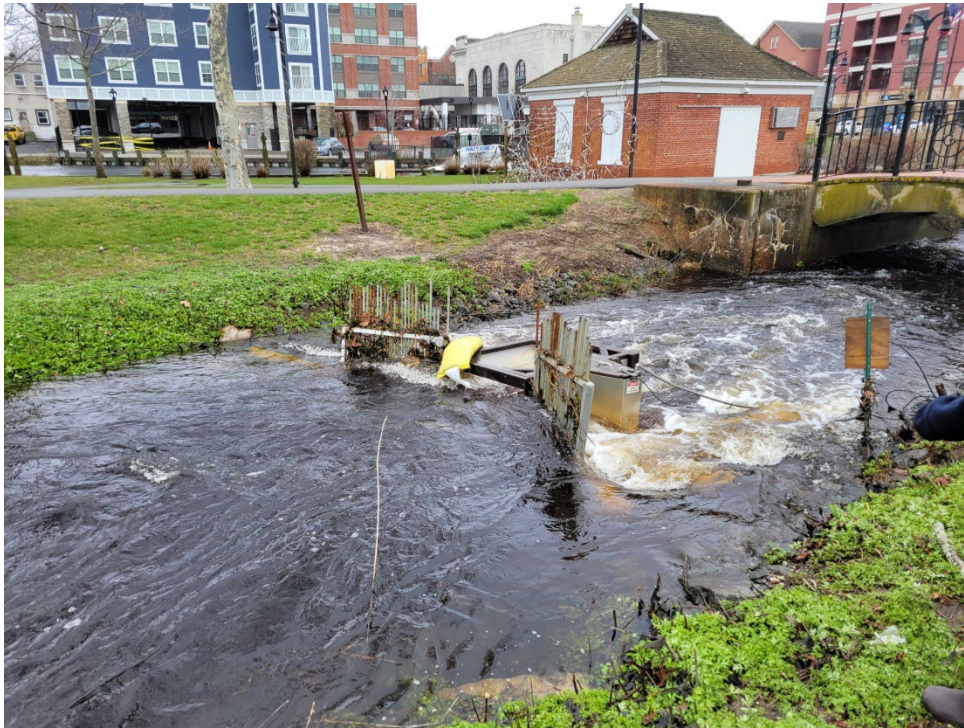
Figure 1. Image of Camera box during high water level, showing passage ability around weirs. Note the eroding banks on either side of the weir.

2) Shortly after installation in late March and early April, there was a massive flooding event that spanned several weeks during the peak of the run which created large channels on either side of the camera for Alewife to bypass. During this flooding event, the Exit RFID antenna was fully submerged and the downstream antenna was damaged and inoperable (Figure 1,2).

Camera Relocation Suggestion: Severe flooding occurred for the second third year in a row. The camera box needs be deployed upstream next year, away from eroding banks and as close to the exit as possible to avoid complete submersion at low tide (Figure 1, 2).

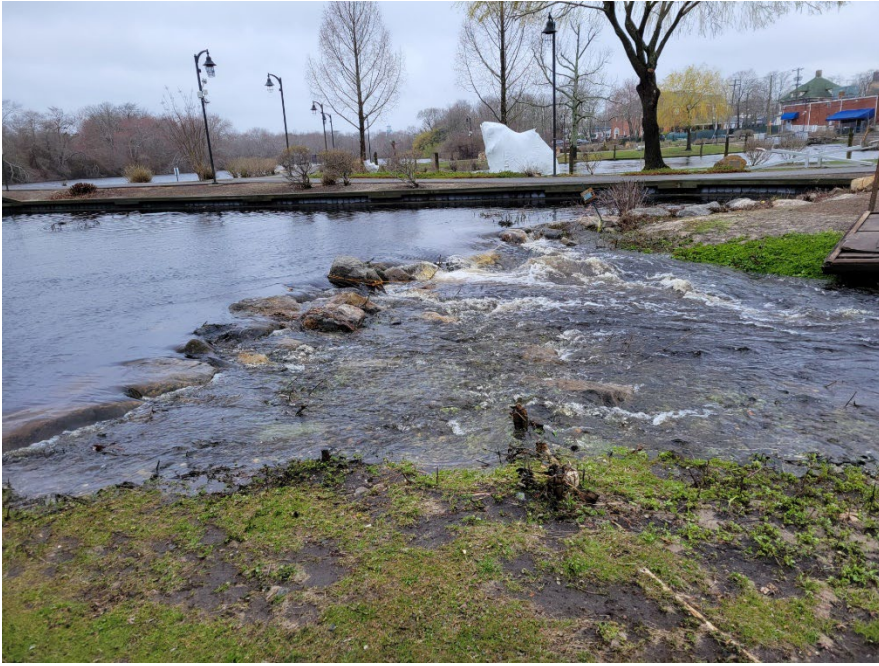
Figure 2. Upstream Exit in Grangebel Fishway during flooding event; RFID antenna completely submerged.

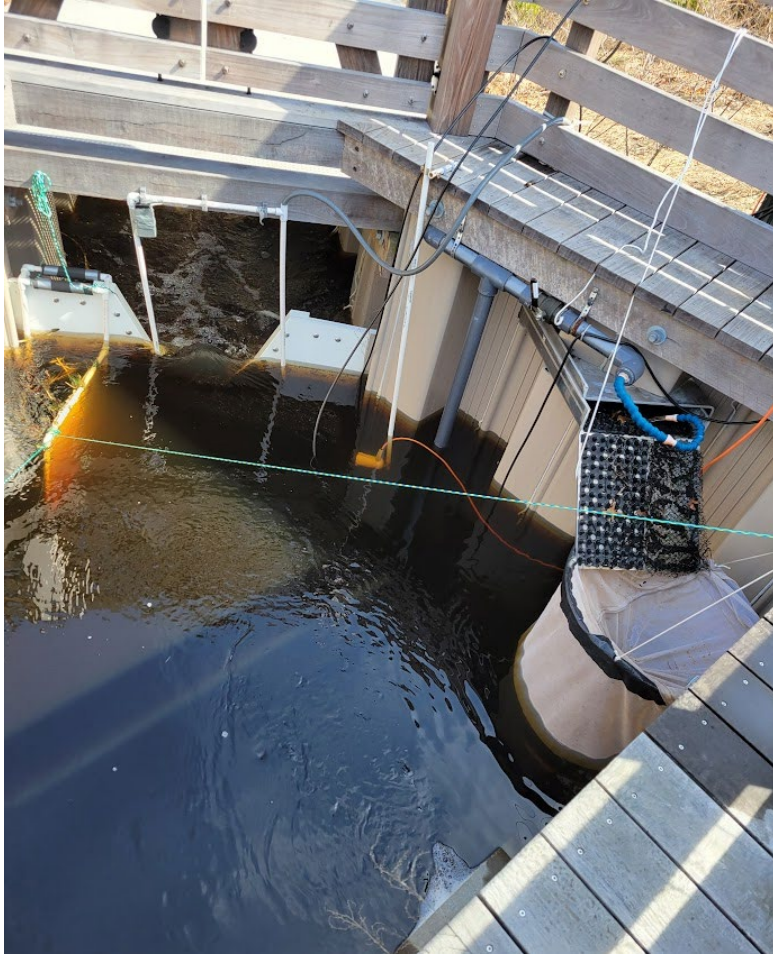
Figure 3. Viewing pool at Woodhull. Camera placed at fishway exit with reflective board on opposite side. Fyke Net collecting eels below eelpass.

Equipment Maintenance and installation: The new camera was installed Feb 27th 2024 before Alewife were seen arriving in the Peconic River. Videos were analyzed through May 6th. The new placement of the camera is successful at capturing all Alewife successfully passing the fishway (Figure 3).

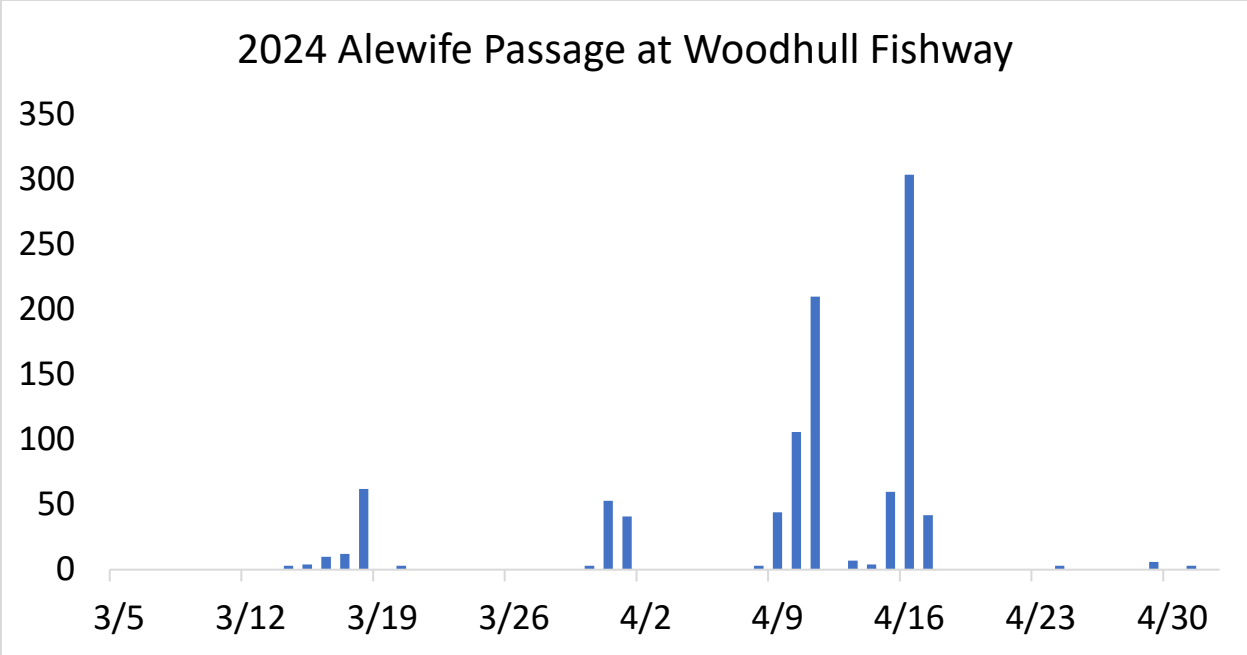
Figure 4. Daily Alewife Counts at Woodhull Fishway

Alewife Woodhull Passage: Visual estimates of Alewife in the Woodhull pool varied between 10,000 and 40,000 in early March. A total of 983 Alewife were detected going through the fishway and passing through the camera between 3/14/24 and 5/1/24 (Figure 4). The fishway can successfully pass Alewife. Since the 2023 passage total could not be obtained, this 2024 value is the first quantification of passage efficiency and upstream usage by Alewife.

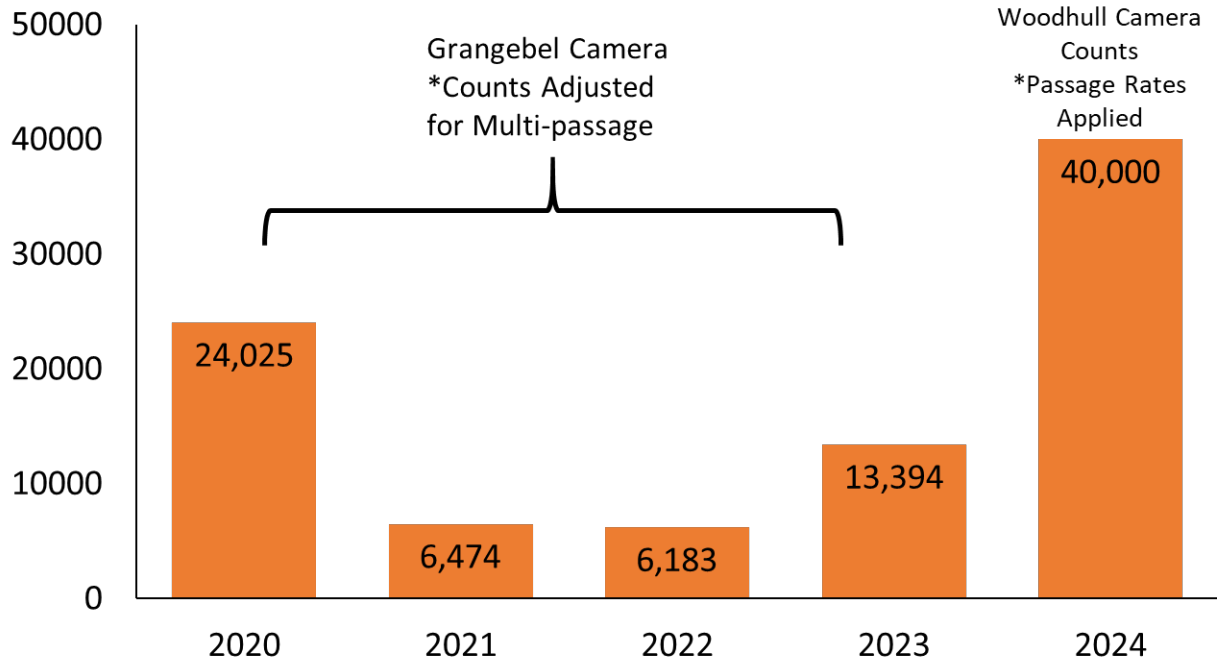
Figure 5. Alewife Population Estimates for Peconic River, 2020-2023 were obtained from visual counts at Grangebel Park. Multipassage rate applied to all years was 67%, decreasing all visual counts by 67%. 2024 was obtained from Woodhull only.

Several hundred Alewife were PIT tagged and released below Woodhull Dam in 2023 and 2024. Passage rates can be obtained next year when tagged fish return to the system, contingent on the PIT tag antenna array being deployed and maintained by Dr. Peter Daniel (Hofstra University). The PIT tag passage efficiency (# tagged fish detected at upstream antenna / # tagged fish detected at downstream antenna) was 2.5%. Applying this proportion to the total camera count results in approximately 40,000 Alewife in the Peconic River (Figure 5.). A Lincoln Peterson model (equation below)
