Award: SUNY RF of Stony Brook University Peconic Estuary Partnership– GE1525

2025 Alewife Monitoring on the Peconic River System: Grangebél Park and Woodhull Dam

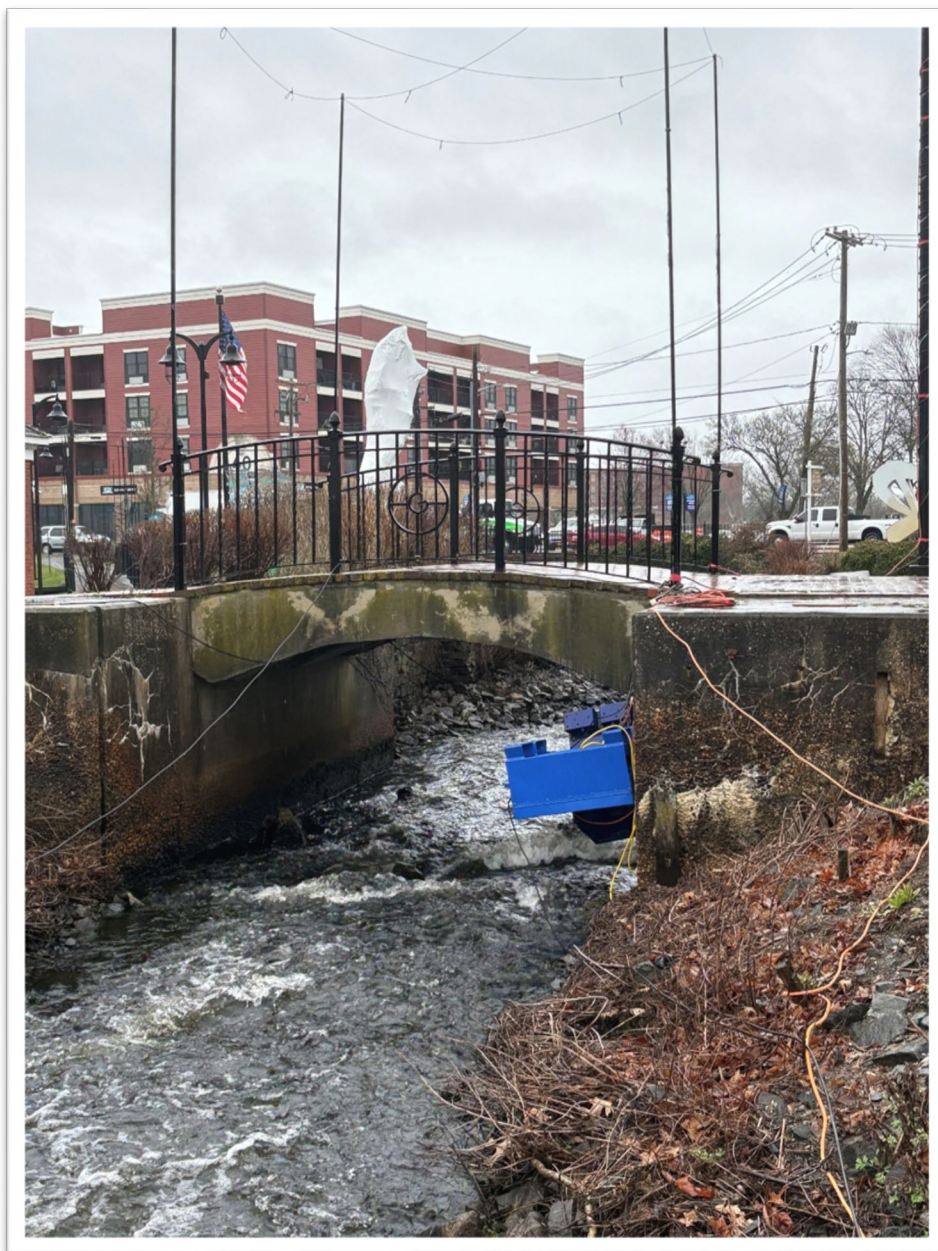
To calculate total passage at Grangebel, full season video capture is needed. Vandalism was found on April 3<sup>rd</sup> 2025, which included the job boxes containing the laptop controlling the camera and the RFID controls being pushed off the walking bridge platform (Figure 1). Therefore, only a small portion of run (several weeks or <20%) was captured and the camera, laptop and hard drive was damaged. Without full camera coverage and RFID detections, an accurate population estimate at this site is cannot be calculated. Video analysis efforts were focused solely on Woodhull for the 2025 season.

*Figure 1. Camera box vandalized at Grangebél, all equipment was pushed over the walkway during heavy rain and some parts were submerged.*

*Job Box Security:* Currently there is only one attachment point (the walkway bridge railing) for two job boxes (Camera and RFID). An additional eye hook or plate U hook secured into the concrete base of the bridge would allow less slack in the chain for this type of vandalism to occur again.

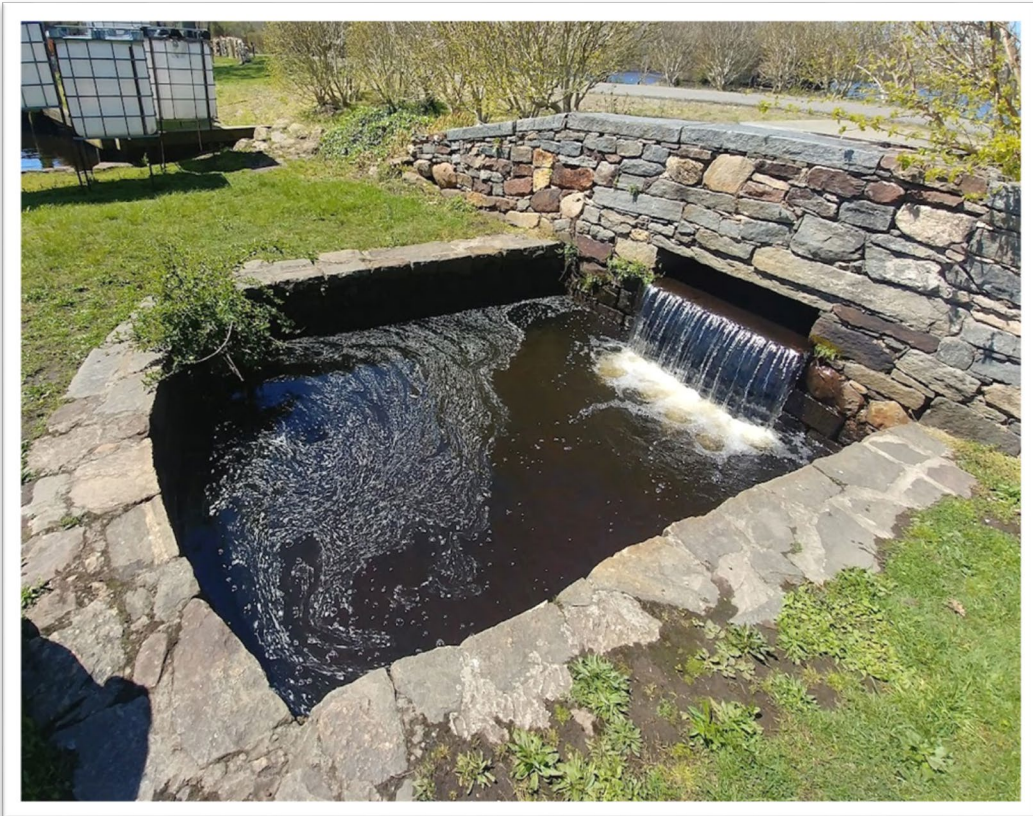
**American Eel:** The head of tide dam is located in Grangebél Park, along with a nature-like fishway and a small man-made pool with a spillway called “Bridal Veil Falls”. Glass eels appear unable to climb the barrier wall and move upstream at this site, resulting in a bottleneck and an unusually high density. A temporary eel pass, comprising of a tied-up net, was placed at the Bridal Veil Falls barrier (Figure 2) to facilitate glass eel upstream migration for the first time in 2025. The net was removed at the end of the season.

*Figure 2: Bridal Veil Falls in Grangebel Park*

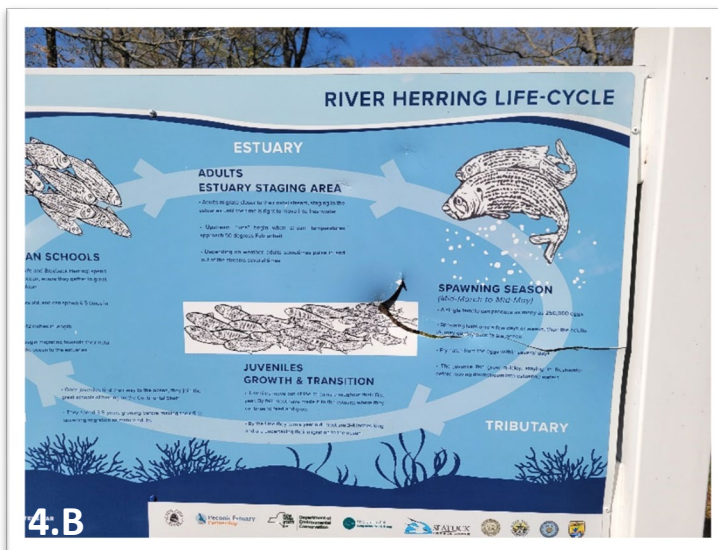
*Equipment Maintenance and Installation:* The new camera was installed February 21<sup>st</sup> 2025 before Alewife were seen arriving in the Peconic River. Videos were analyzed through May 16<sup>th</sup>. On April 28<sup>th</sup>, 2025, vandalism occurred at Woodhull. The damage included the destruction of the Byron Young Fishway Sign, deconstruction of the RFID antenna and wires were pulled out of the antenna, damage to the gate and the locks, all equipment (RFID, camera and eel pump) were unplugged, ropes holding the camera backboard were cut (Figure 4.) Nothing was permanently damaged and the camera was operational within 40 hours. There was also fishing line and hooks in the viewing pool and Alewife scales on the walkway. An Alewife was detected on camera getting snagged on a fishing hook before the power went out.

Figure 4. Woodhull vandalisim. A) Antenna and backing for camera disassembled; B) Sign damaged; C) Gate and lock shows damage; D) Hosing for eel pass disassembled

Additional cameras and signs may be helpful in deterring vandalism.
