# Suffolk County Peconic Estuary Program Conceptual Habitat Restoration Designs

Narrow River Tide Enhancement and Phragmites Management  
Orient, Town of Southold

Date: July 2019  
Revised:

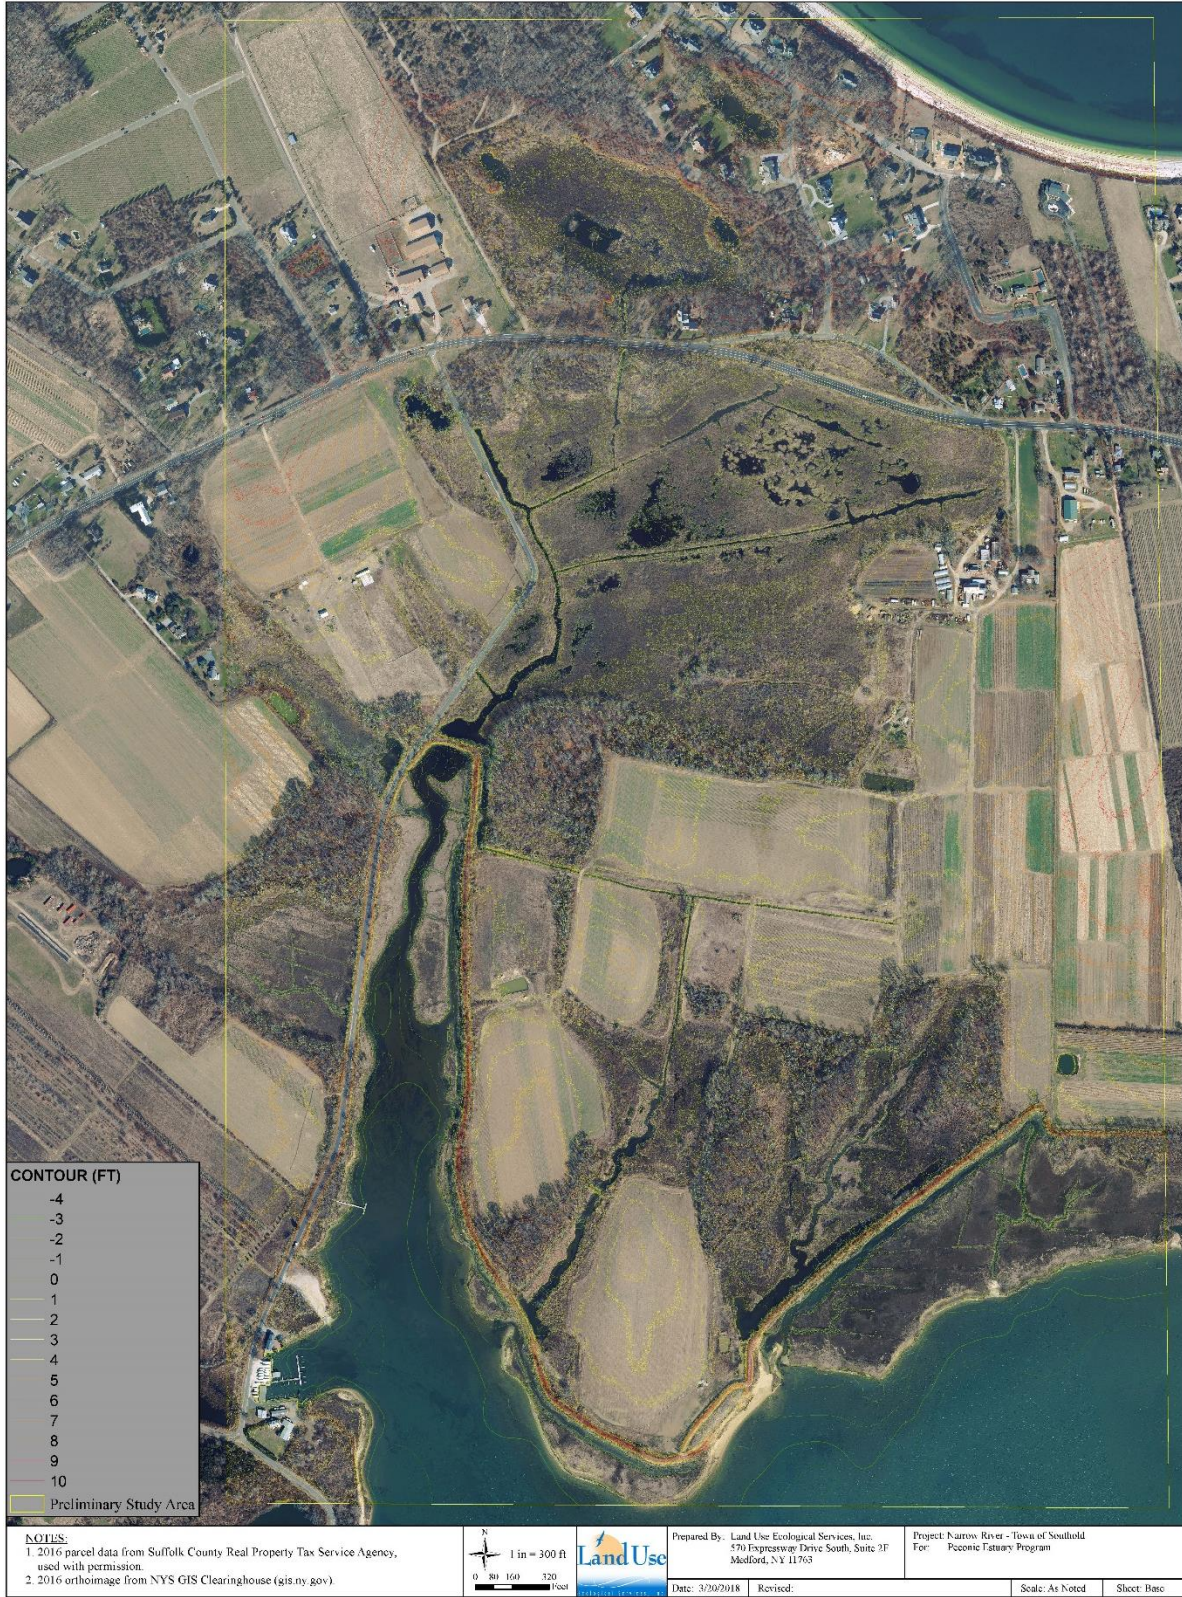
Figure 1: Narrow River topography utilizing 2016 USGS CoNED Topobathymetric Model (1887 - 2016): New England, obtained from the NOAA Data Access Viewer. Contour tool utilized in ArcMap on DEM.

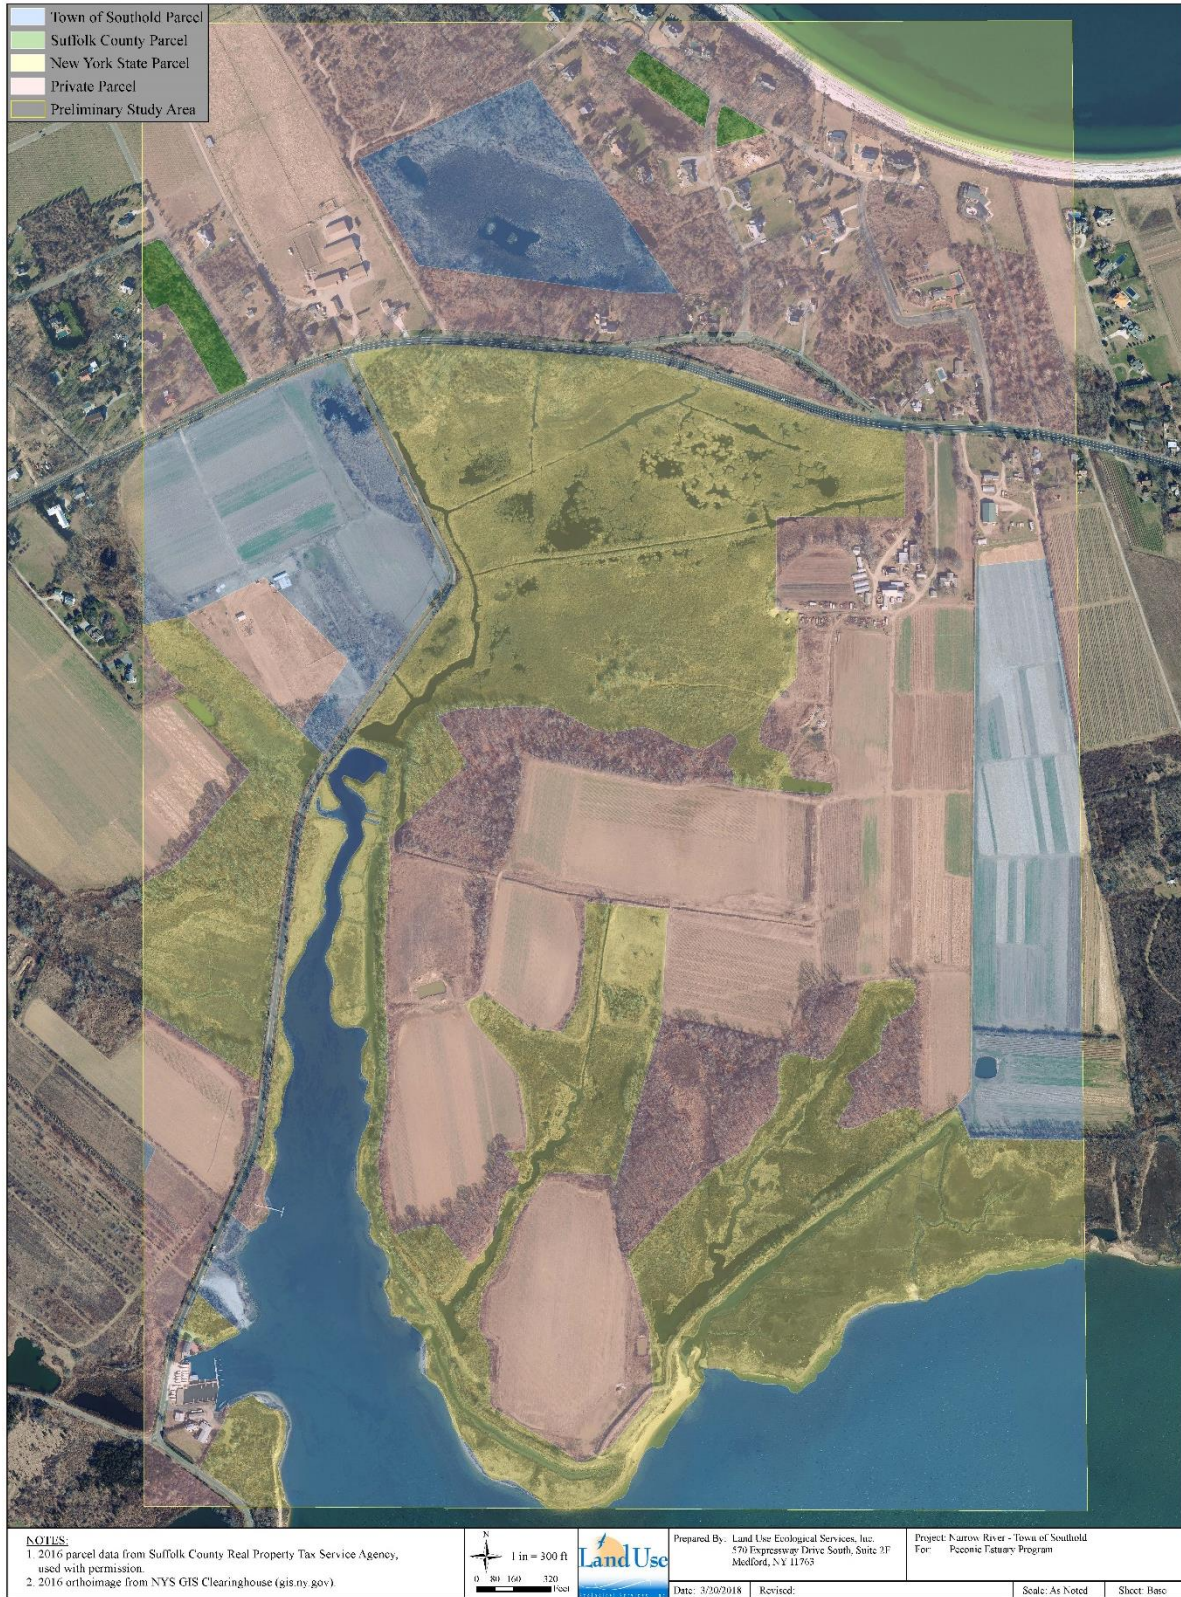
Figure 2: Parcel ownership within the project area. Parcel data obtained from Suffolk County Real Property Tax Service Agency, used with permission.

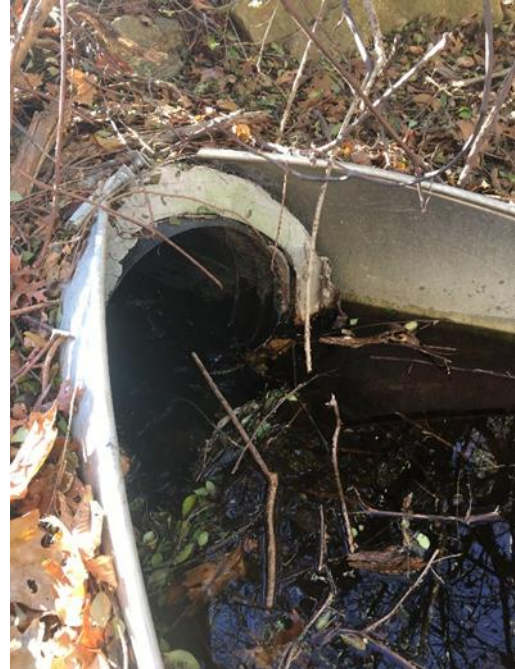
Figure 4: Culvert at Route 25 crossing.

The headwaters of Narrow River flow from the Town of Southold Whitcom Marsh Preserve to Broad Meadows Marsh through a 1.5-foot culvert under Route 25 (Figure 4). The culvert slope is currently approximately 2%, with the upstream invert at elevation 1.0 feet and the downstream invert at elevation -0.1 feet NAVD88. Ordinary high water marks were identified at approximately the invert elevation on the downstream side and the culvert is perched approximately 0.7 feet. These conditions present a barrier for fish and aquatic organisms at certain periods of low flow. The small size of this culvert restricts water flow, resulting in backwater upstream of the culvert and deposition of sediment, rather than allowing the natural flow of water and sediment to move into the downstream

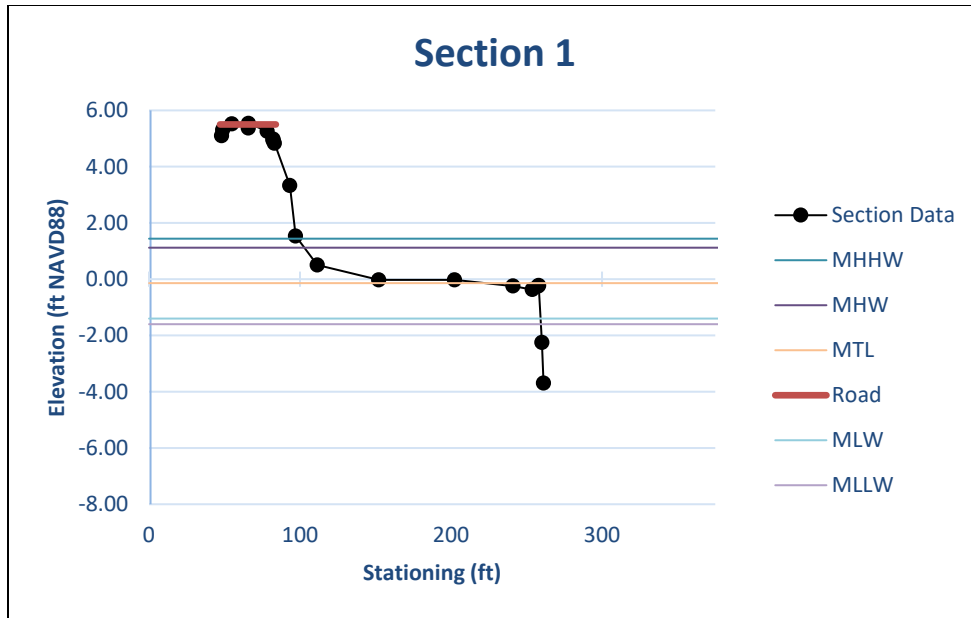
Figure 6: Route 25 is approximately 4 feet higher in elevation than the unimpeded MHHW elevation.

Route 25 is approximately 4 feet higher than the MHHW at Cross Section 3 (Figure 6), but approximately 850 feet further to the east, the road elevation is only 2.5 feet higher than MHHW. The LIDAR topographical data (Figure 1) corresponds well to the collected survey data. The road elevations range from about 4 feet to the east to 6 feet in the middle and about 7 feet near the west end of the road in the study area (Figures 7, 8).

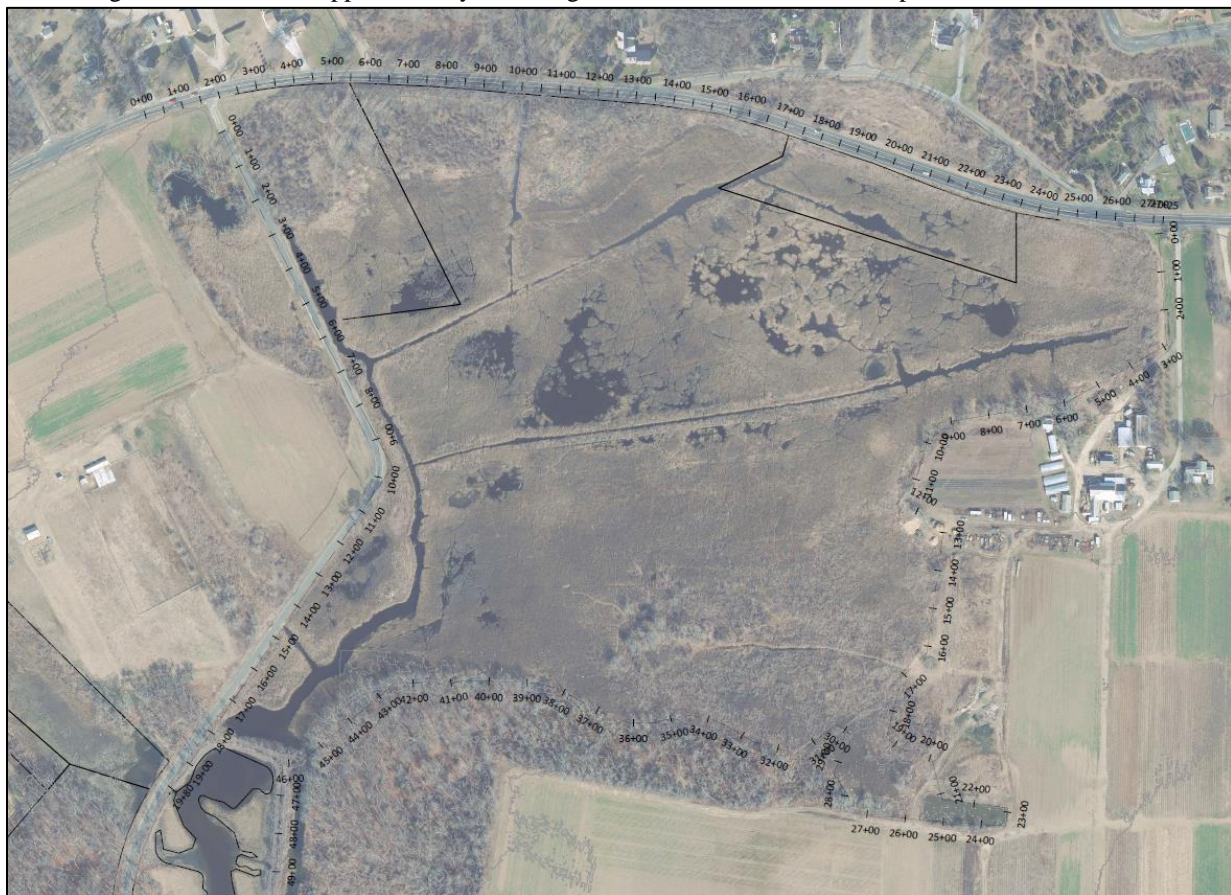
Figure 7: The LiDAR elevation data was evaluated along the edges of the study area with three profiles: 1) Route 25 from W-E; 2) Narrow River Rd from N-S; 3) the eastern and southern property boundary from N-S.

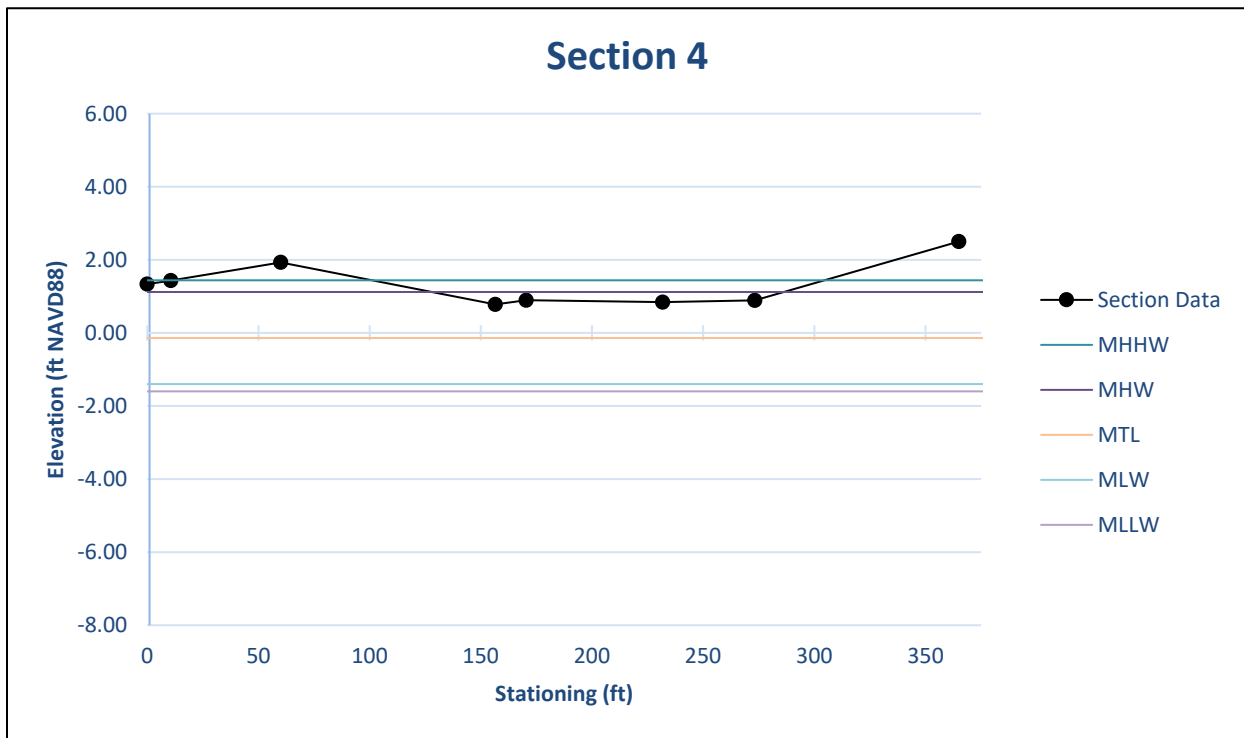
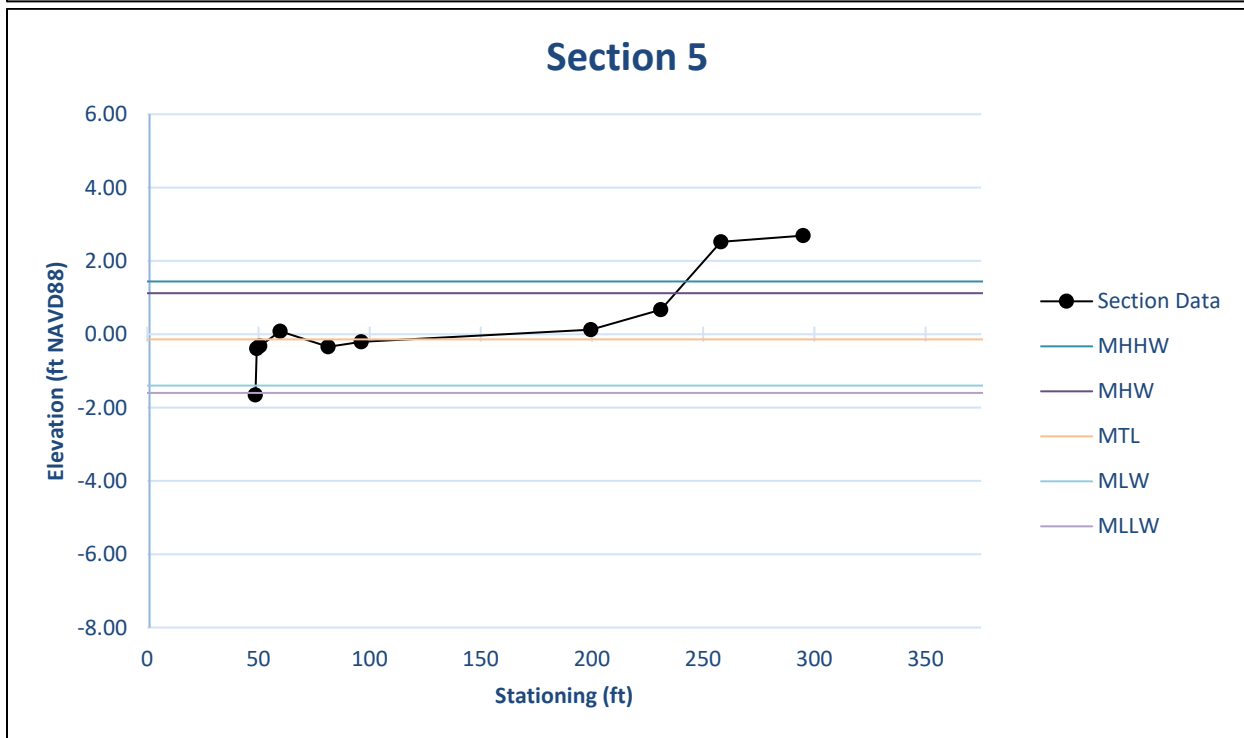
Figure 12: Section 4 and 5 surveyed reflect the elevation in the marsh and edge of farm fields along the southern and eastern edges of the marsh respectively.

On the eastern side of Broad Meadows Marsh, the fields on the Latham Farm were at approximately elevation 2.5 feet in the areas surveyed, about 1 foot higher than the unimpeded MHHW in the estuary downstream of the double culverts (Figure 12). If the tidal range in the marsh were to be restored, these fields in the area surveyed would still be higher in elevation than the typical daily tidal fluctuations. The SHW, however, is slightly higher at approximately elevation 1.6 feet. We evaluated an elevation profile, derived from available LiDAR data, along the Latham Farm property boundary (Figure 13). We found areas as low as 1.0 feet, but these may be in locations adjacent to higher elevation ground that was not sampled in the profile. So, while it is possible that some areas of the farm are vulnerable to flooding, further survey of the remaining edges of this property should be completed to confirm locations potentially vulnerable to the MHHW or this SHW.

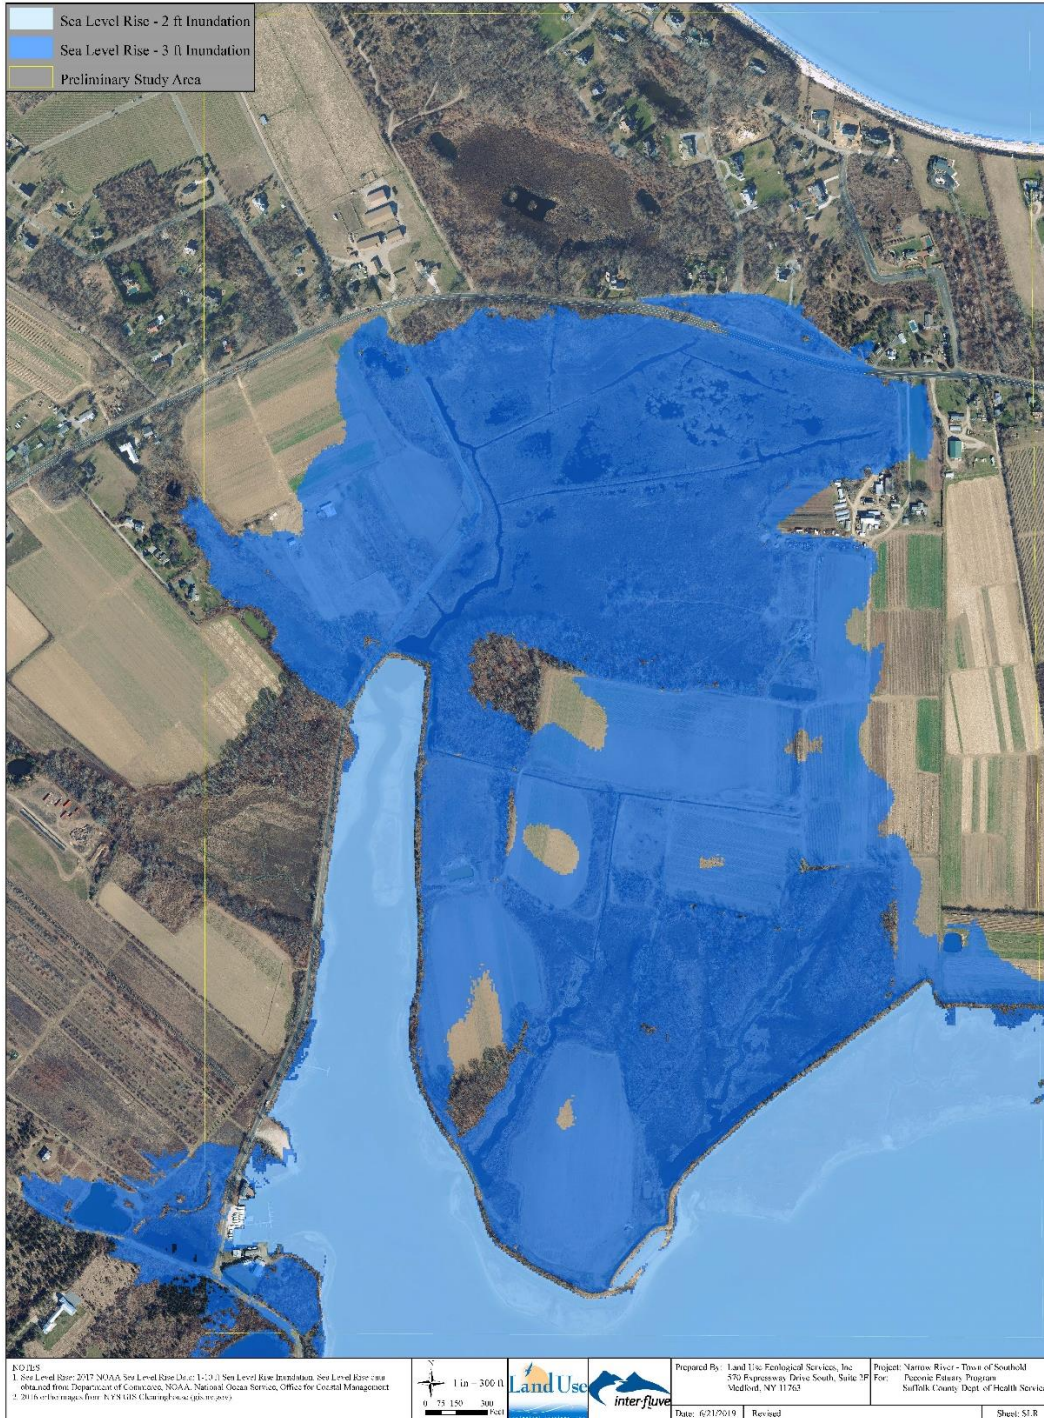
Figure 15: Predicted Sea Level Rise by 2050s from NOAA 2017 Sea Level Rise Data.

The vulnerability of Narrow River Road, Route 25, and surrounding private property from storm surges or more routine tidal flooding will increase in coming decades due to sea level rise. Regional projections anticipate sea level to rise by 7-12 inches and 12-23 inches by the 2050s and 2080s, respectively, with greater sea level rise under rapid ice melt scenarios (NYSERDA ClimAID, 2010). Local projections of sea level rise for eastern Suffolk County were reviewed. Sea level rise in the vicinity of the project area is predicted to increase by 24-36 inches under rapid ice melt scenarios by the 2050s, as shown Figure 15 presenting NOAA Sea Level Rise Data.

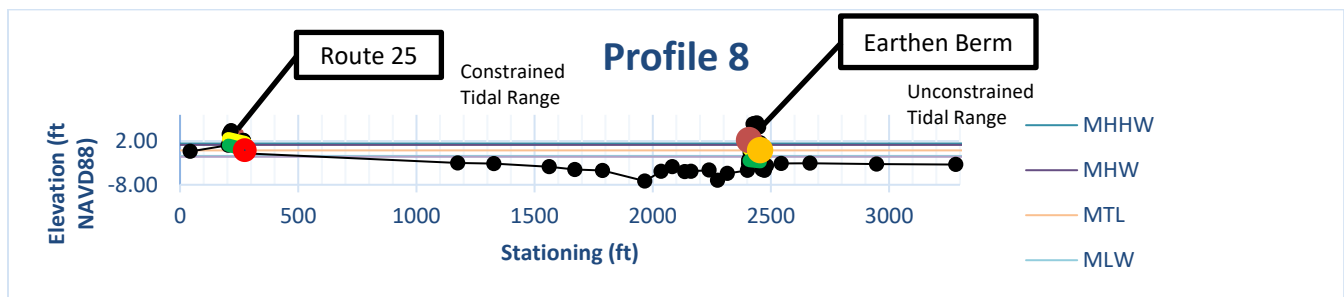
Figure 16: The longitudinal profile of the channel from upstream of Route 25 to downstream of the double culverts.

Downstream of the berm, the channel bed is more than two feet lower in elevation than the invert of the culverts, with the channel bed further downstream rising to be consistent with the culvert invert. This scour is due to the velocity of the water coming through the undersized culverts and mobilizing the channel bed substrate (Figure 17).

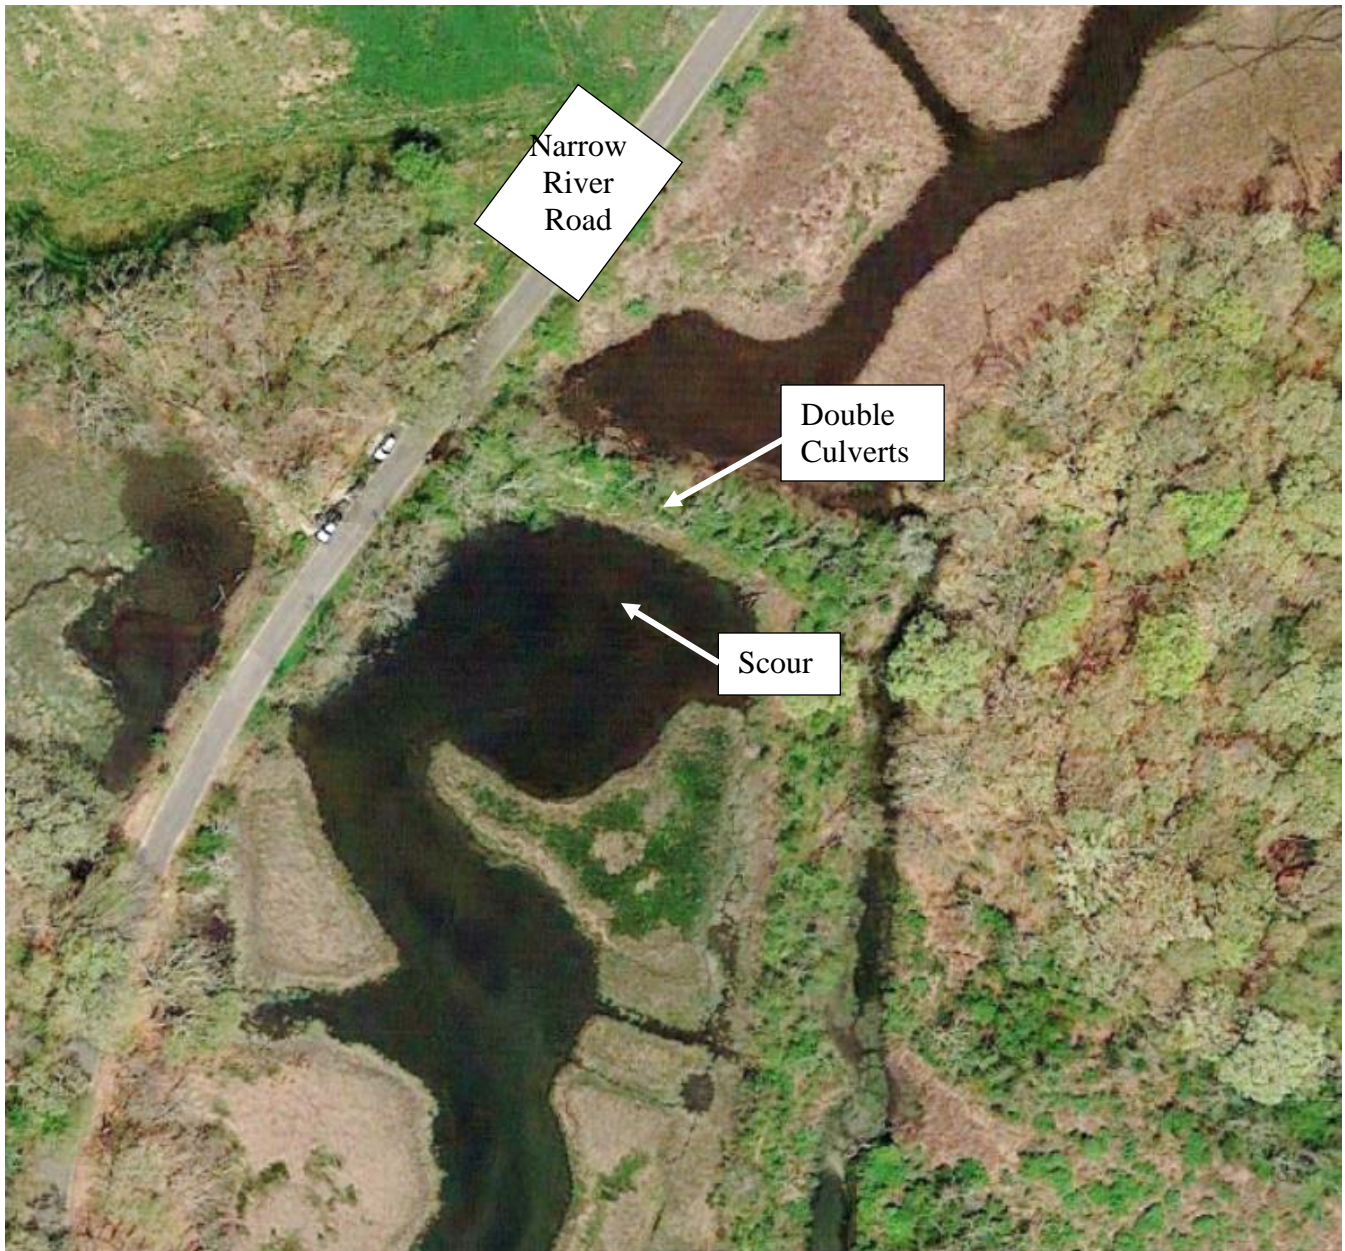
Figure 17: Scour and erosion upstream and downstream of the double culvert.

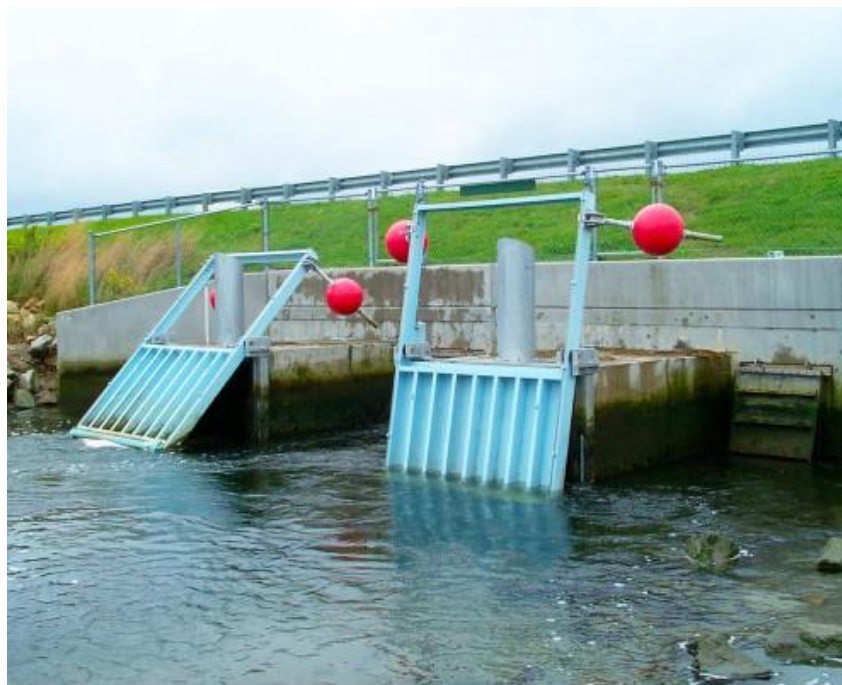
Figure 19: Representative photo of self-regulating tide gates from location (Waterman Industries).

The twin culverts in the earthen berm are undersized and restrict tidal flows to the upstream marsh. These culverts should be replaced with one or more self-regulating tide gates that would increase the typical tidal range within the marsh, but would block higher tides (above approximately 1.12 feet, MHW) and storm flows that would inundate roads and property. MHHW and SHW would also be blocked as these inundate Narrow River Road and potentially portions of Latham Farm to the east. If measures are taken to protect this infrastructure in other ways, the MHHW and SHW could be allowed into the marsh. As sea levels rise, the tide gates can be managed, but the road and adjacent property elevations would need to be addressed as well. Multiple companies manufacture these tide gates, such as Golden Harvest and Waterman Industries; representative photos, specifications, and constructions costs are based on these manufactured tide gates.

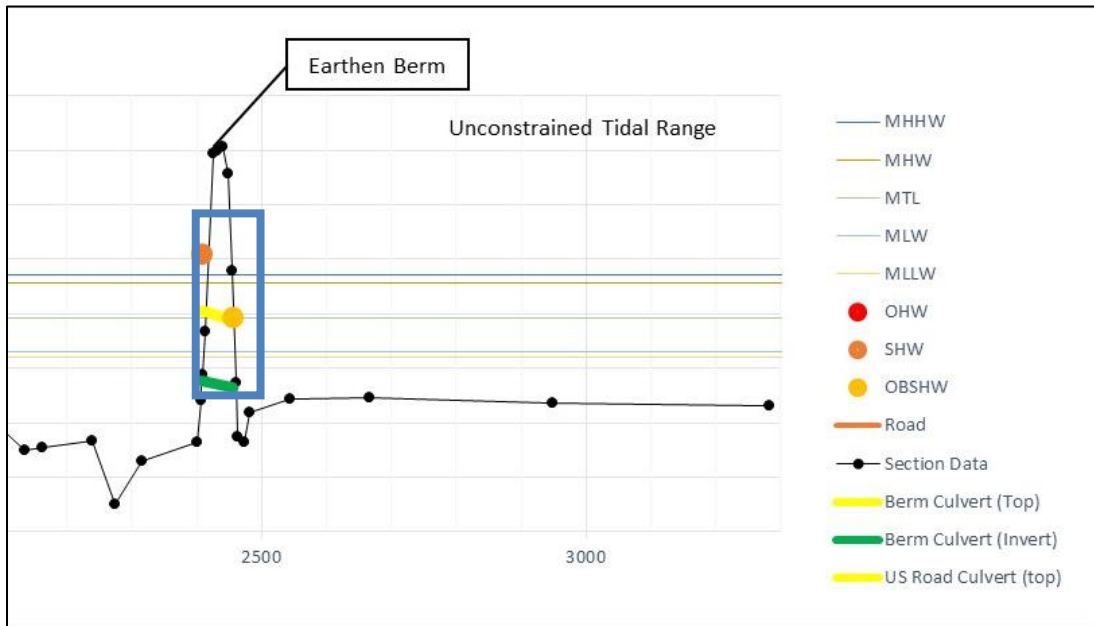
Figure 20: Approximate location of the proposed self-regulating tide gate (blue rectangle).

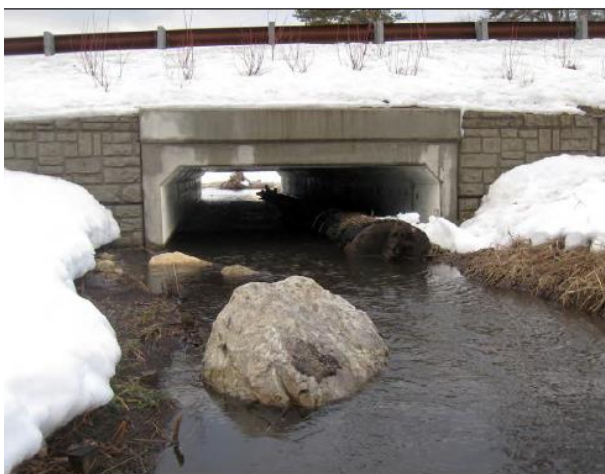
Figure 23: An example of a concrete box culvert with natural channel substrate on the bottom and a floodplain bench built for terrestrial organism passage.

Sea level rise is expected to result in conversion of many coastal freshwater wetlands to more brackish or tidal wetlands on Long Island and elsewhere over the coming decades. If tidal encroachment into Whitcom Marsh is not desired by the Town of Southold or local residents, then the proposed recommended culvert could be set at an equivalent elevation to the existing perched culvert. This alternative would provide limited increased drainage of Whitcom Marsh into Broad Meadows Marsh and minor improvements to the potential for terrestrial and aquatic organisms to pass through the culvert.

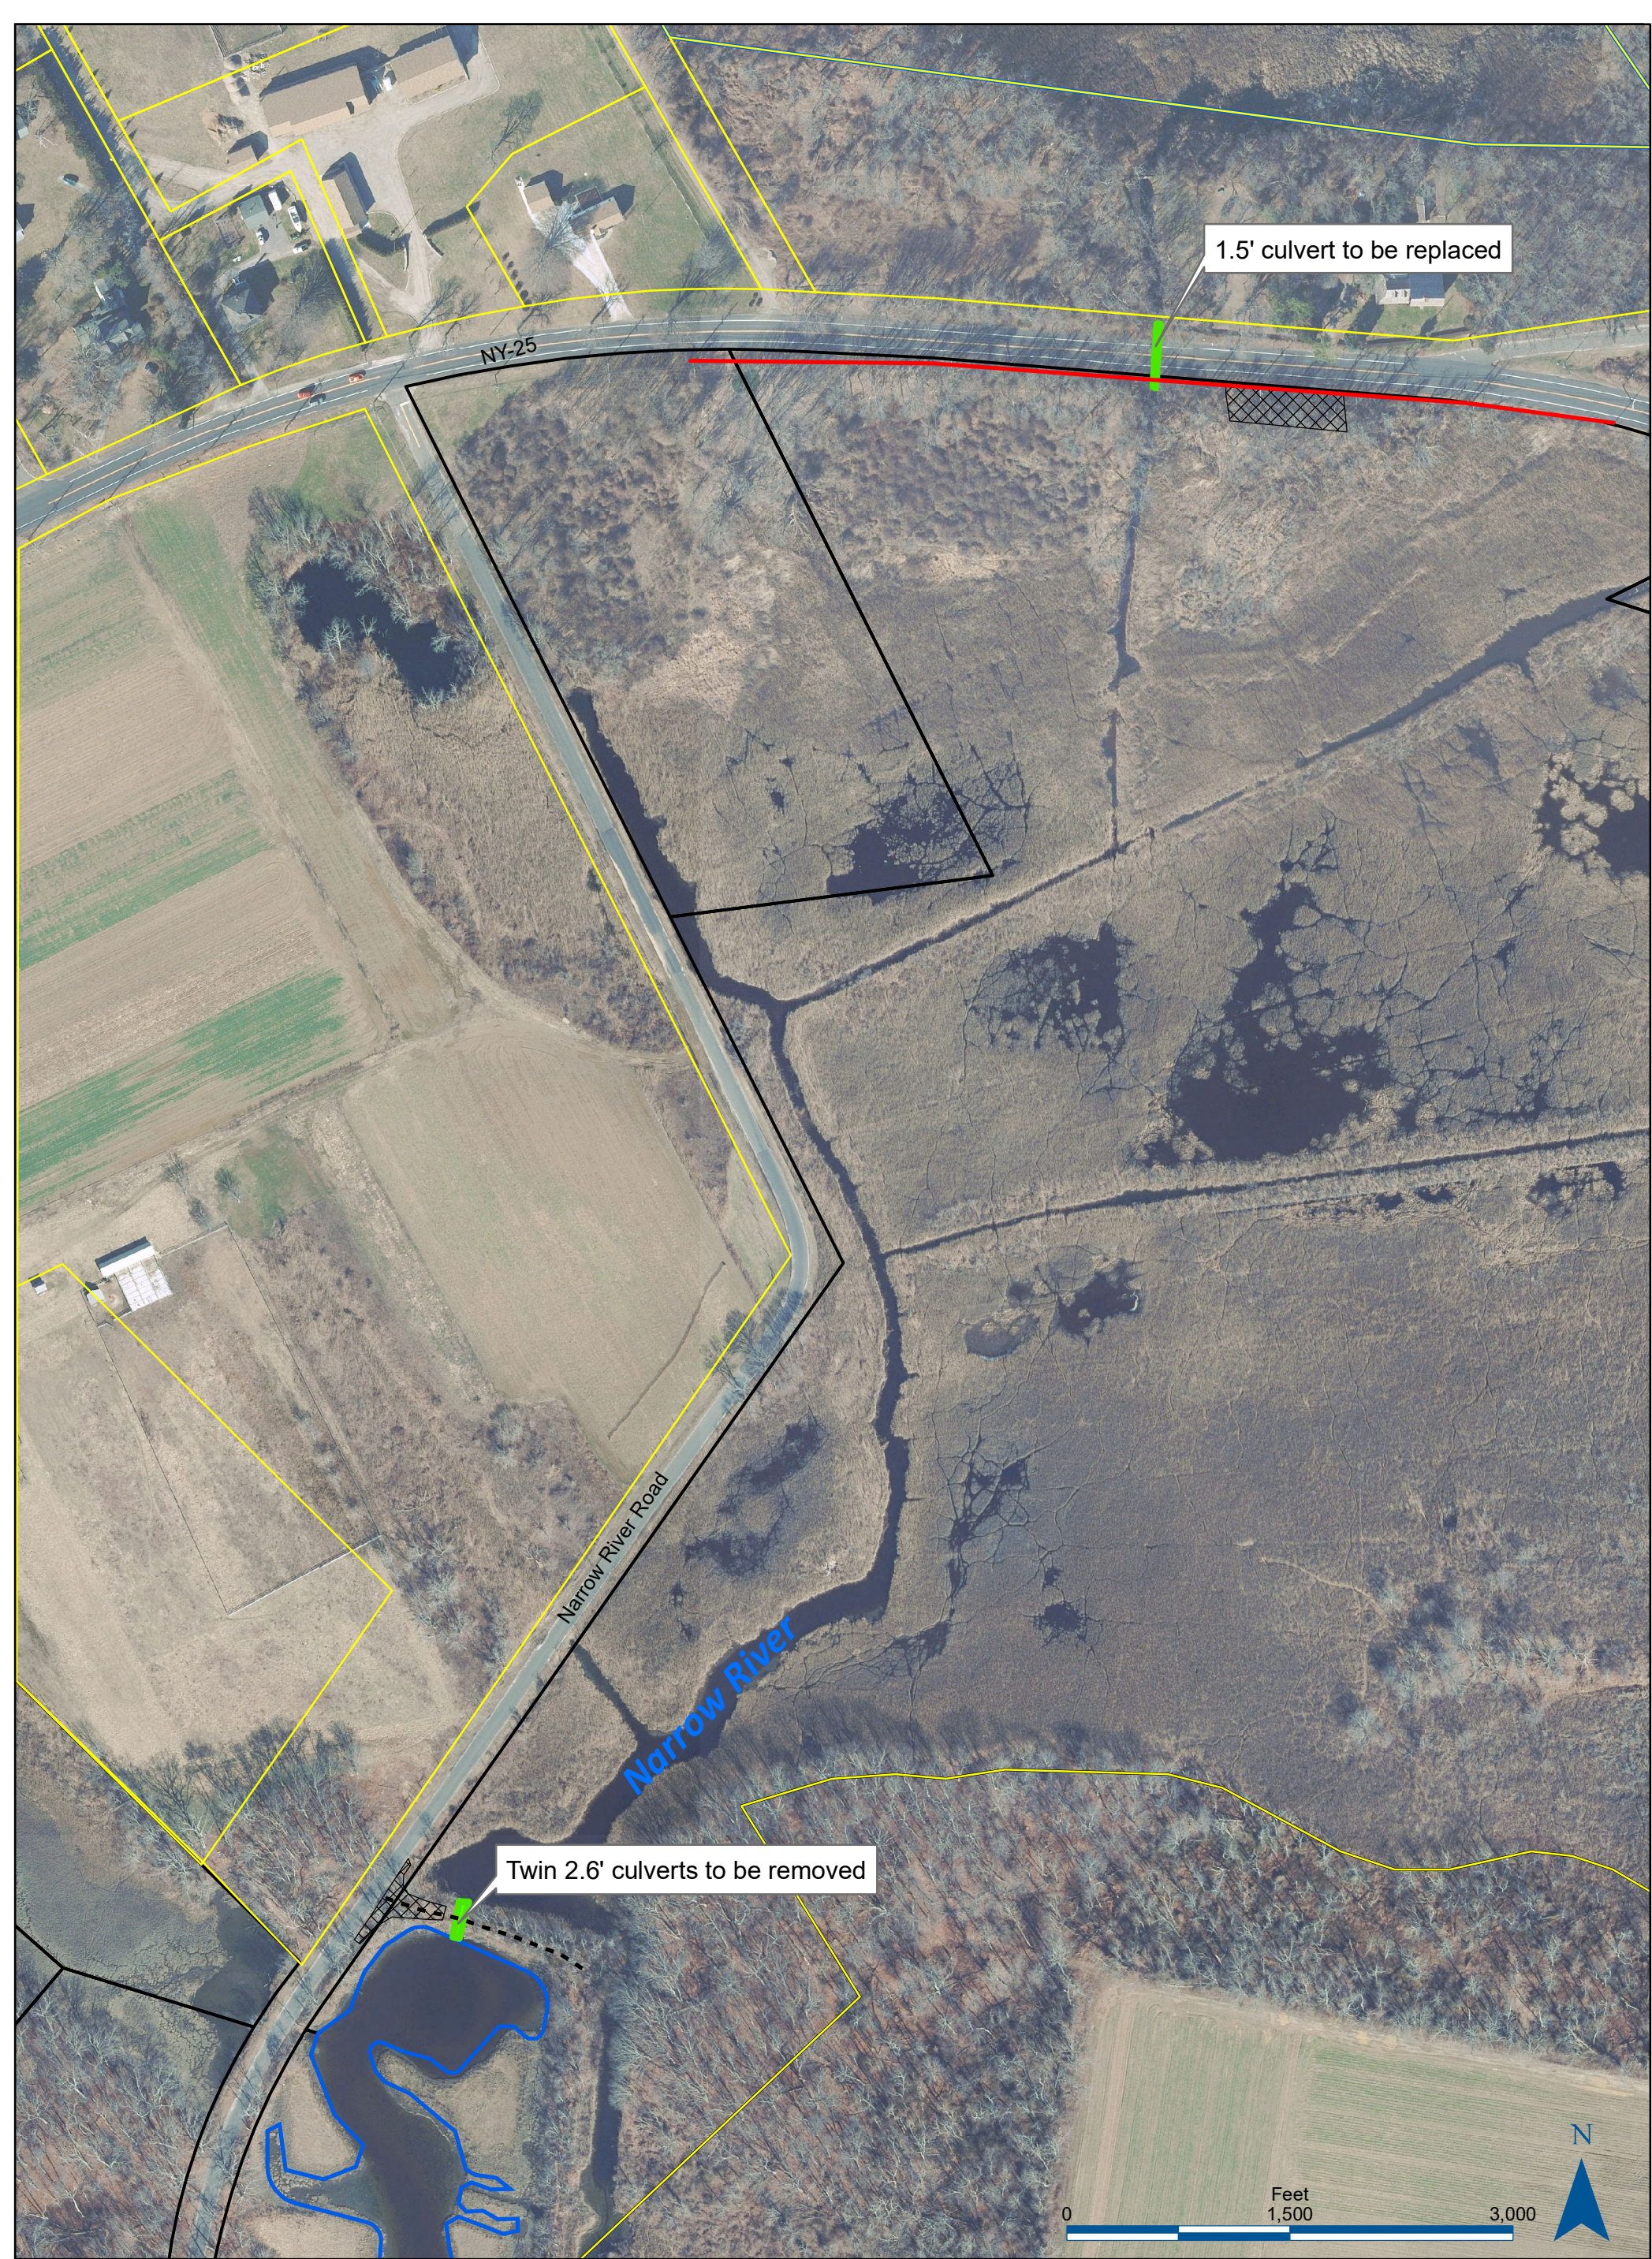
**Peconic Estuary Assessment**  
 Narrow River Culvert Replacements  
 Sheet 1 - Overall Location Map  
 Narrow River, Orient, NY, Suffolk County (NY)  
 SCTM#: 300-7-1-3

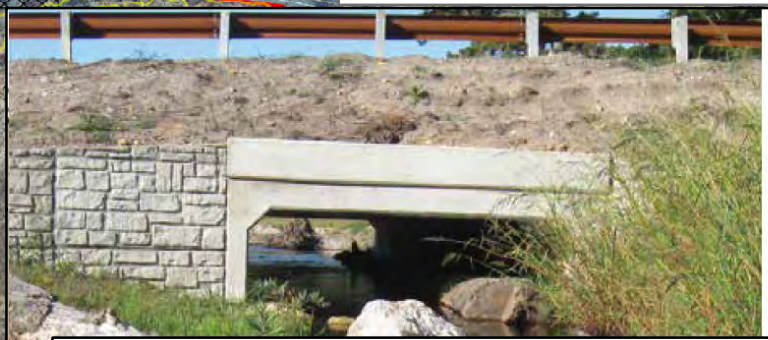
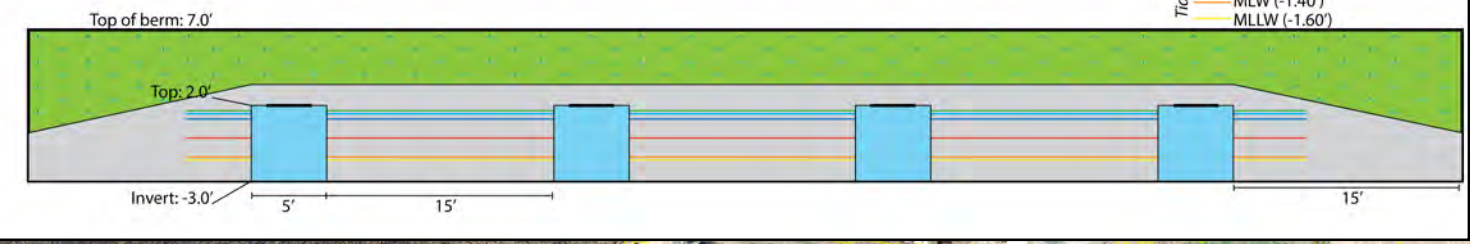
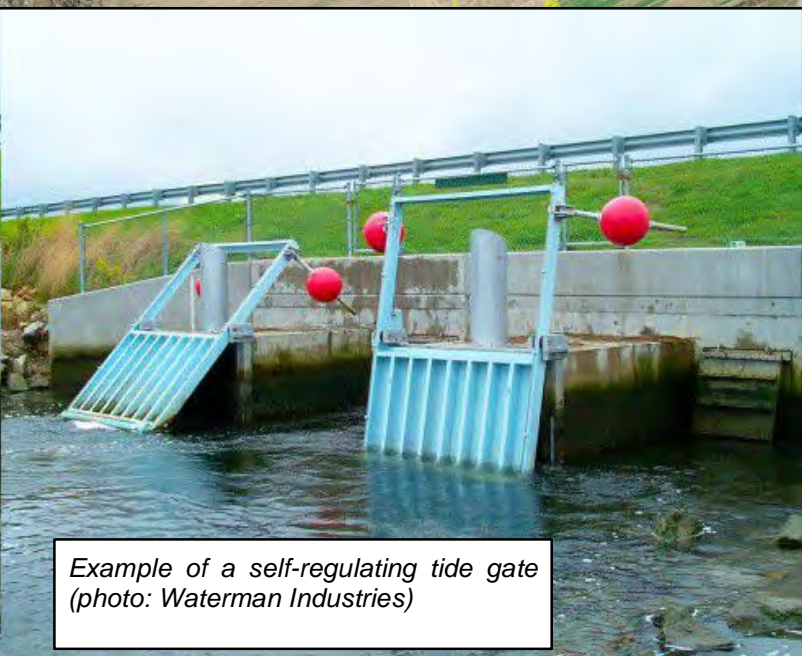
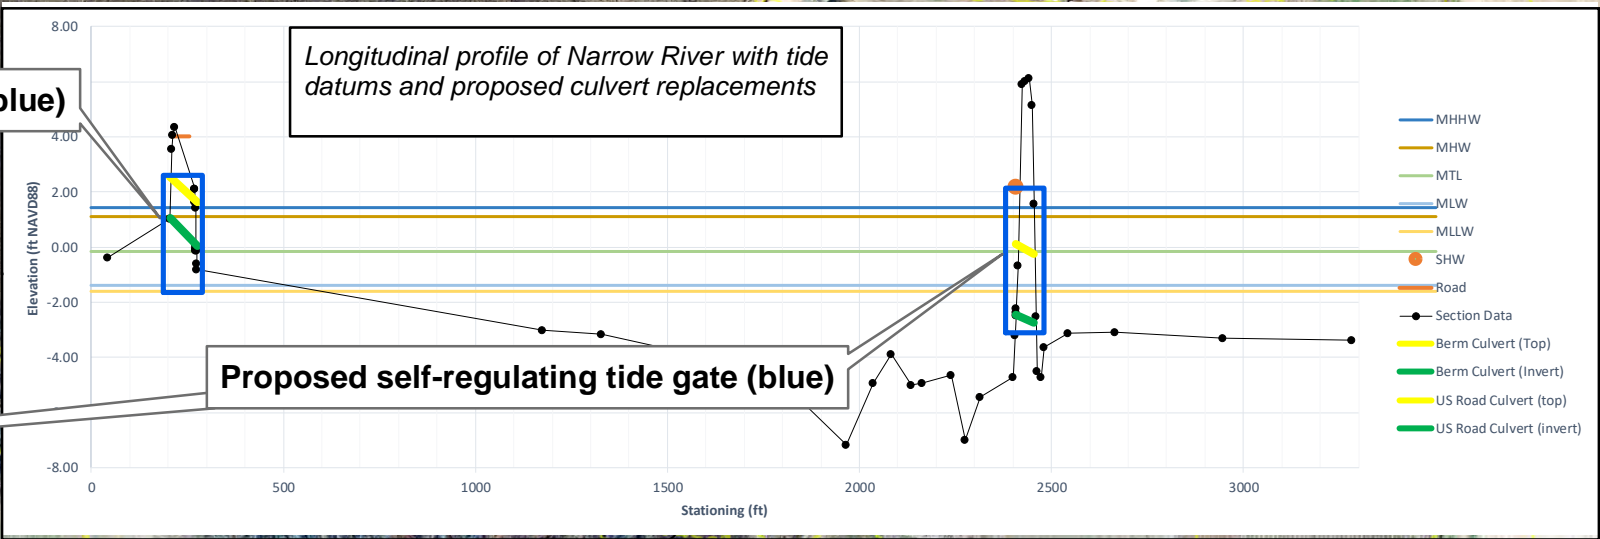
Narrow River Culvert Replacements  
 Sheet 3 - Conceptual Recommendations  
 Narrow River, Orient, NY, Suffolk County (NY)  
 SCTM#: 300-7-1-3

1.5ft culvert to be replaced with a 4ft box culvert  
 Dimensions: 4ftx4ft  
 Proposed invert elevation: -1.5ft  
 Proposed top elevation: 2.5ft  
 1ft of natural bed substrate on the bottom of the culvert

Proposed raising of low stretch of Narrow River Rd to El. 4ft

Example photo and sketch of a box culvert with natural bed substrate (courtesy of Resilient Crossings Handbook)

Sketch of four proposed self-regulating tide gates (light blue), with concrete wing wall, berm and tide datums shown.

Example of a self-regulating tide gate (photo: Waterman Industries)

Longitudinal profile of Narrow River with tide datums and proposed culvert replacements

Twin culverts replaced by proposed Self-Regulating Tide Gate  
 Invert Elevation: ~-2.0ft  
 Top Elevation: ~5.0ft  
 Total Width of Gates: ~45ft

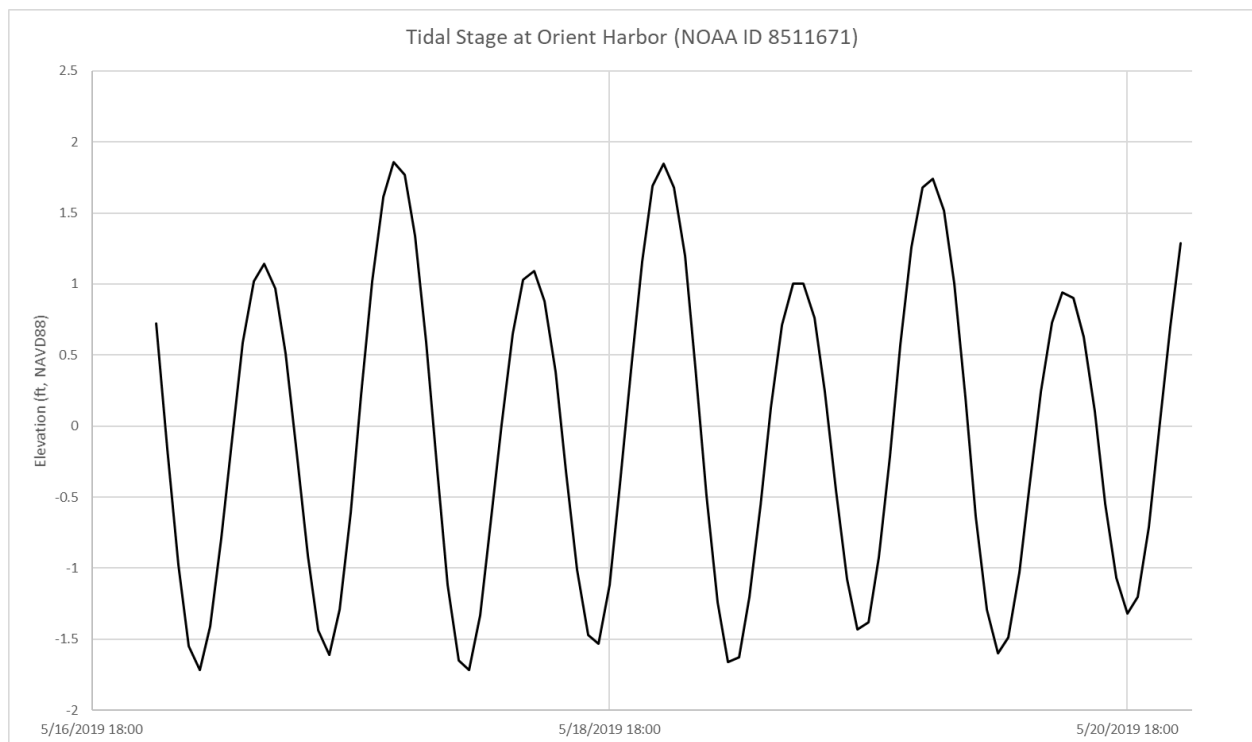
Figure 1. Input tidal hydrograph used for the culvert analysis.

The tidal stage hydrograph used as the model input was taken from the Orient Harbor gage (NOAA Station ID 8511671) and converted to NAVD88 using survey information obtained by Inter-Fluve in 2018. The gage data were assumed to directly apply to the project site, although some scaling may be warranted in future analyses. The input hydrograph is displayed in Figure 1.

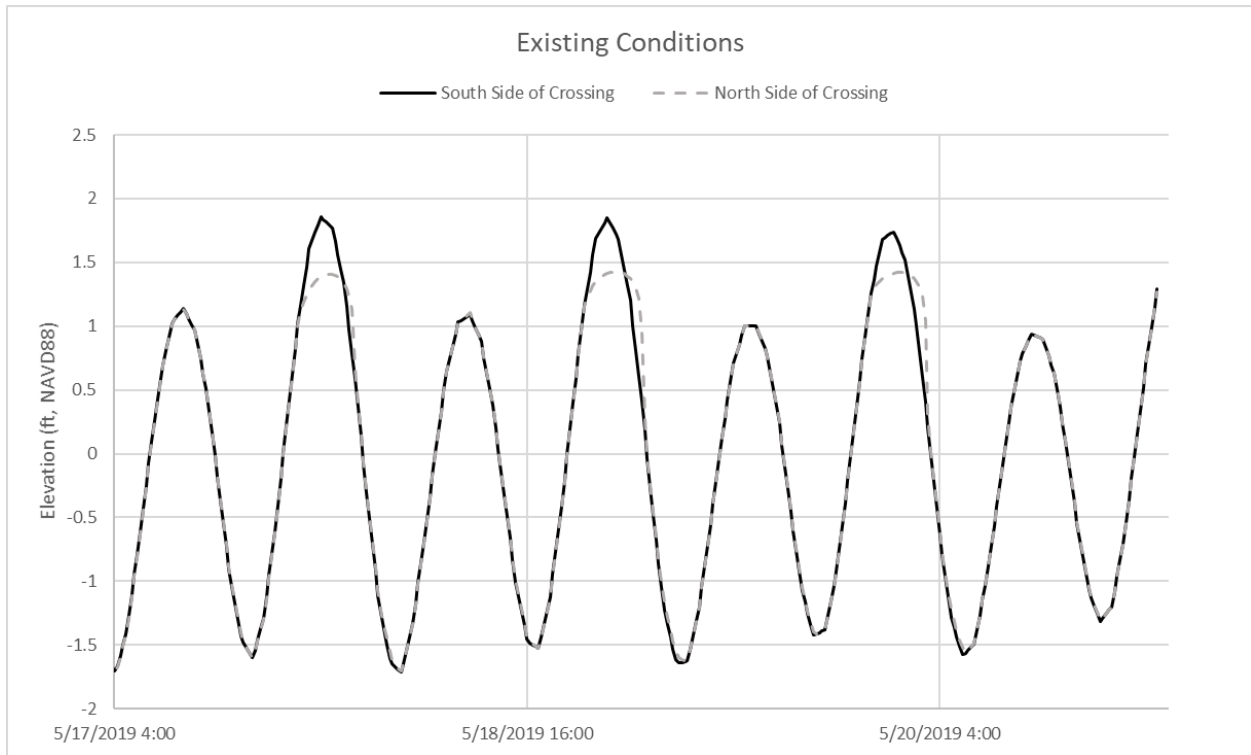
Figure 2. Analysis results for existing conditions.

Existing conditions were analyzed using the available survey information to inform the culvert configuration, and the results were checked against anecdotal observations to ensure that the model was representing site conditions reasonably well. The existing conditions results demonstrate that there is a reduction in the peak of the higher high stage of approximately 0.5 feet, with a lag on the ebb of the higher high tide (Figure 2). These results are consistent with observations; however, further verification of the model results should be conducted for different tide cycles and with the full bathymetric surface incorporated into the hydraulic model.
