# Suffolk County Peconic Estuary Program Conceptual Habitat Restoration Designs

Narrow River Tide Enhancement and Phragmites Management  
Orient, Town of Southold

Date: July 2019  
Revised:

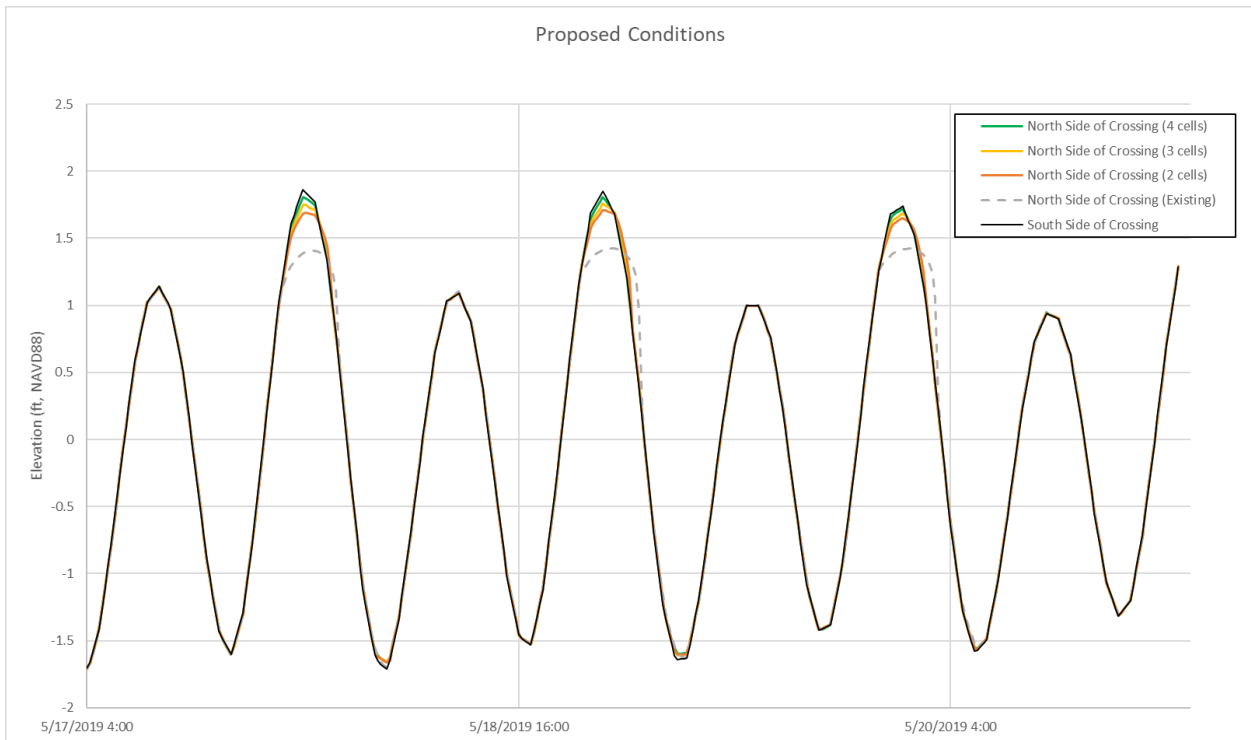
Figure 3. Summary of analysis results for proposed conditions.

The culvert-sizing analysis focused on changing the number of box culvert cells at the crossing location, until the computed hydrograph on both sides of the culvert was similar in magnitude and timing. The computed hydrographs are presented in Figure 3. The results demonstrate that four 5ftx5ft box culvert cells will allow for a nearly free-flowing condition with the assumed configuration, under the tidal conditions analyzed.

The results of the preliminary analysis suggest that a near free-flowing condition can be achieved for the tidal hydrograph analyzed using four 5 ft x 5 ft box culverts to convey tidal flows through the earthen berm. The preliminary hydraulic analysis is somewhat limited by the terrain model, hydraulic roughness delineation, and culvert parameterization. The digital terrain model primarily consists of LiDAR data, and the bathymetry of Narrow River is only incorporated in the immediate vicinity of the crossing. A single roughness coefficient was used for the entire model domain, as sensitivity analysis on the existing hydraulic model suggests that the hydraulic computations are not substantially influenced by the roughness coefficient assigned to the project area. However, incorporation of bathymetry into the terrain model for the project area and a spatially varying roughness layer could potentially improve the accuracy of the analysis with respect to peak timing and attenuation. Basic assumptions were made for the layout and configuration of the proposed crossing, and refinement of the culvert computation parameters may be warranted as the design progresses.
