# **Peconic Estuary Partnership 2019 Long-Term Eelgrass (*Zostera marina*) Monitoring Program**

## **Progress Report 20**

**Submitted By:**  
**Christopher Pickerell**  
**and**  
**Stephen Schott**

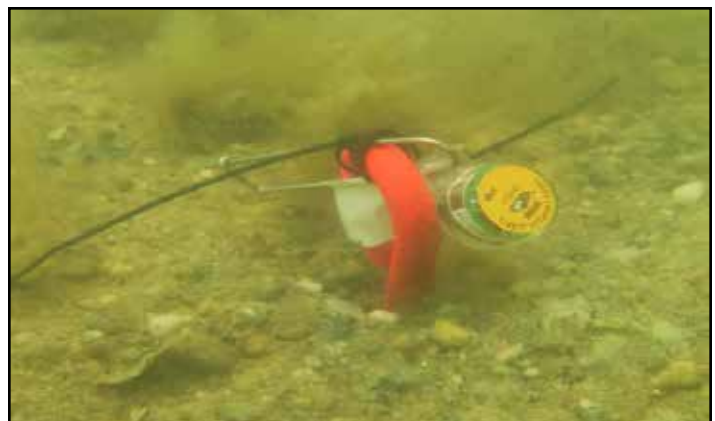
**Figure Intro-2.** A TidBit v2™ temperature logger attached to a screw anchor, deployed on-site.

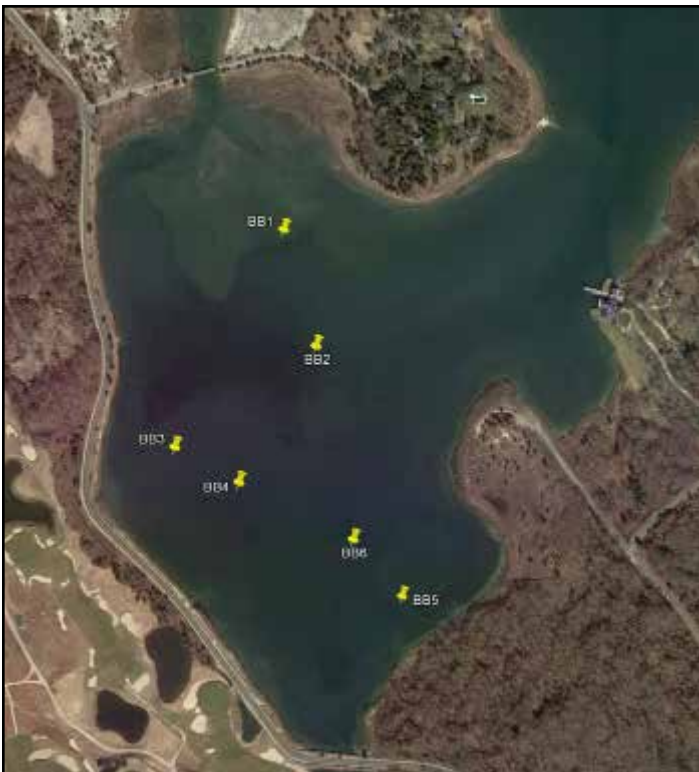
**Figure BB-1.** An aerial view of the Gardiners Bay eelgrass meadow with monitoring stations indicated by the superimposed numbers.

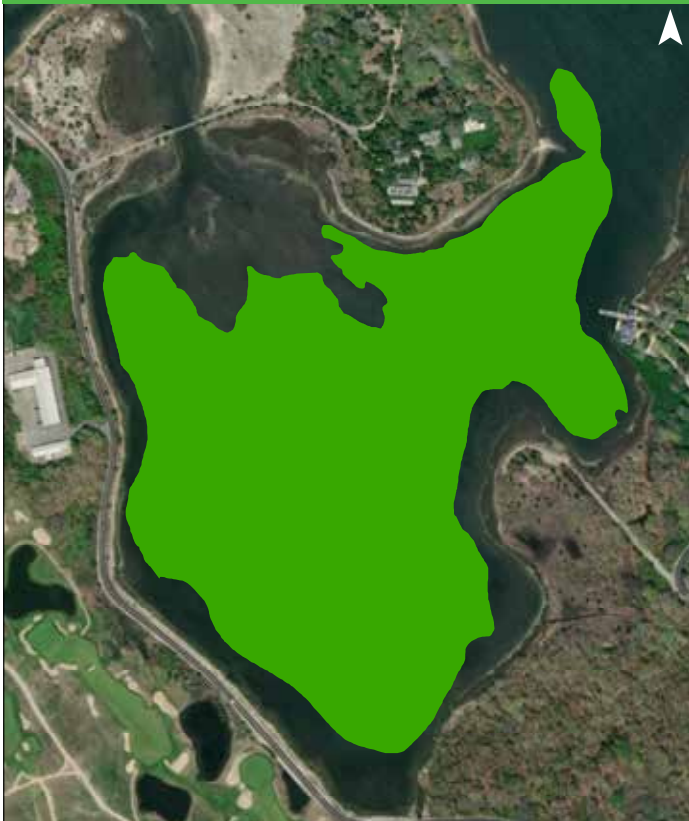
**Figure BB-3.** The 2019 delineation of the Bullhead Bay eelgrass meadow.

Delineation of the Bullhead Bay eelgrass meadow was completed using aerial imagery from Google Earth™ taken on 19 September, 2019. As is noted in Table BB-3, the Bullhead Bay eelgrass meadow has showed continued expansion since 2016. In 2019, the meadow expanded slightly from 2018 (Figures BB-3 and BB-4f). The meadow expanded from just over 56 acres in 2018 to almost 58 acres in 2019 (Table BB), and, as noted above, the density of the meadow increased over 2018.

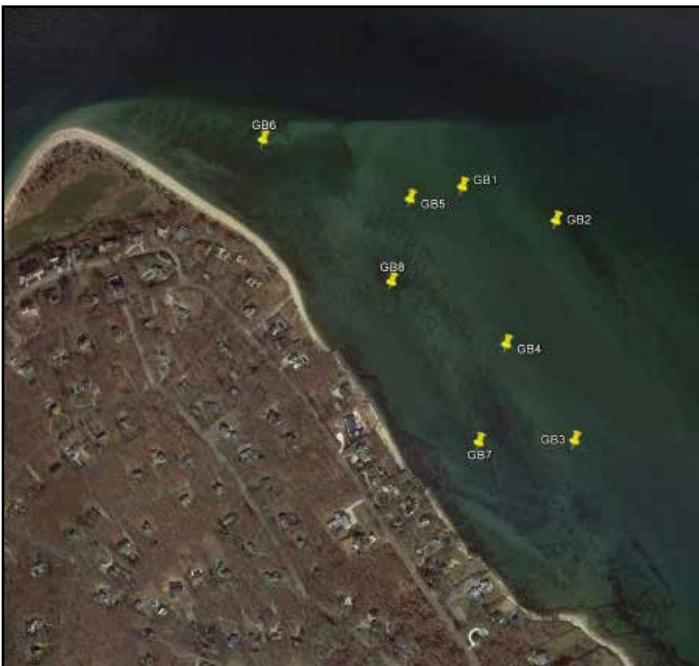
**Figure GB-1.** An aerial view of the Gardiners Bay eelgrass meadow with monitoring stations indicated by the superimposed numbers.

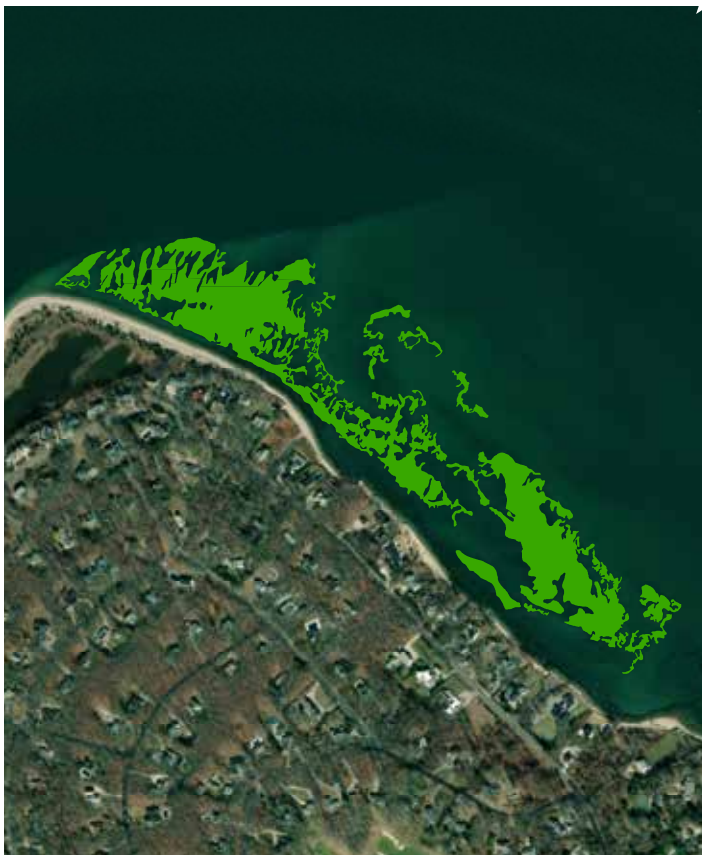
**Figure GB-3.** The 2019 areal delineation of the Gardiners Bay eelgrass meadow on the northeast shore of Shelter Island, NY.

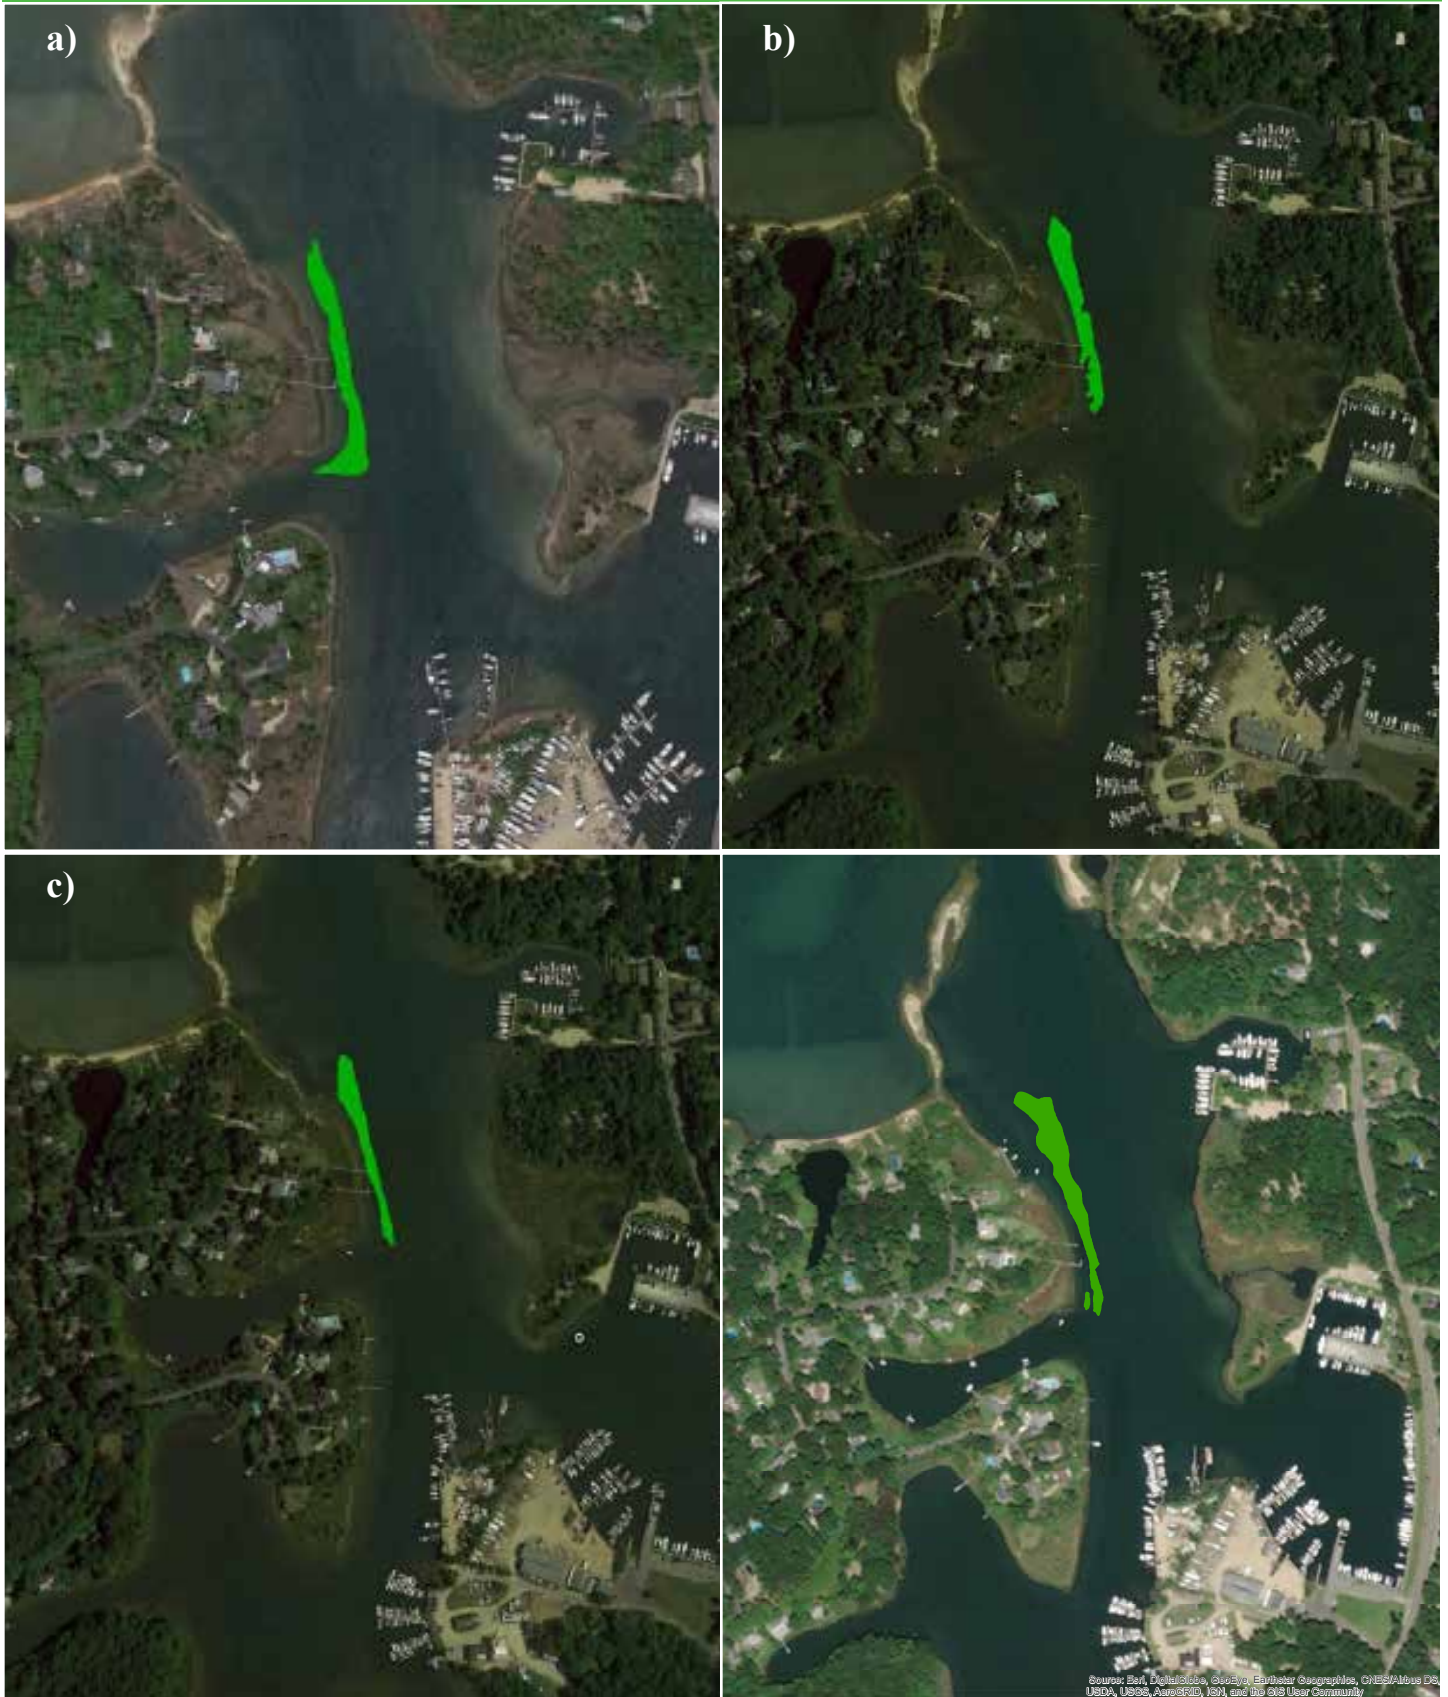
**Figure TMH-3.** Aerial views of the eelgrass meadow (new Three Mile Harbor) at the head of Three Mile Harbor presenting the a) 2014, b) 2017, c) 2018, and d) 2019 meadow delineations.

site was delineated using Google<sup>TM</sup> Earth imagery taken on 19 September, 2019. A progression of aerial delineations of the meadow is presented in Figure TMH-3. The 2019 areal extent of the bed in Three Mile Harbor was found to be 1.4-acres, and increase over previous delineations of the site. Based on the 2019 aerial imagery, the bed appears to be expanding to the north, while pulling away from the shore along its southern end (Figure TMH-3d).

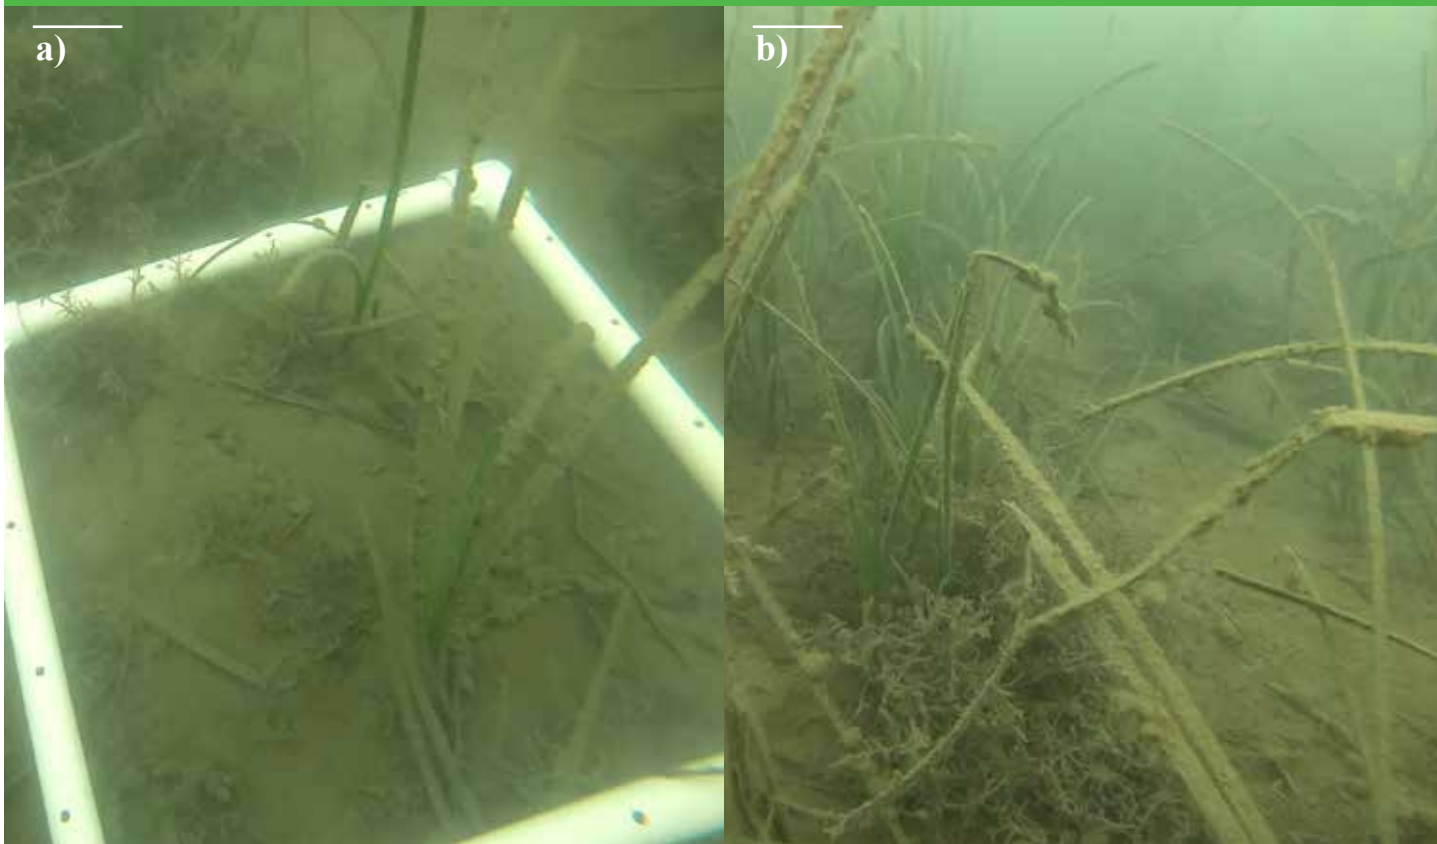
**Figure TMH-4.** Underwater photographs taken by CCE divers during the 2019 monitoring visit to the Three Mile Harbor eelgrass meadow. a) One of the quadrats sampled at Station 1. b) A photograph illustrating the general condition of the meadow at the site.

The Three Mile Harbor eelgrass bed continued to show the decline the was initially reported in 2018 at station 2. During the 2019 monitoring survey, the diver at station 2 could not find eelgrass within the 10-meter radius of the monitoring station. The nearest eelgrass to the site was observed along the slope

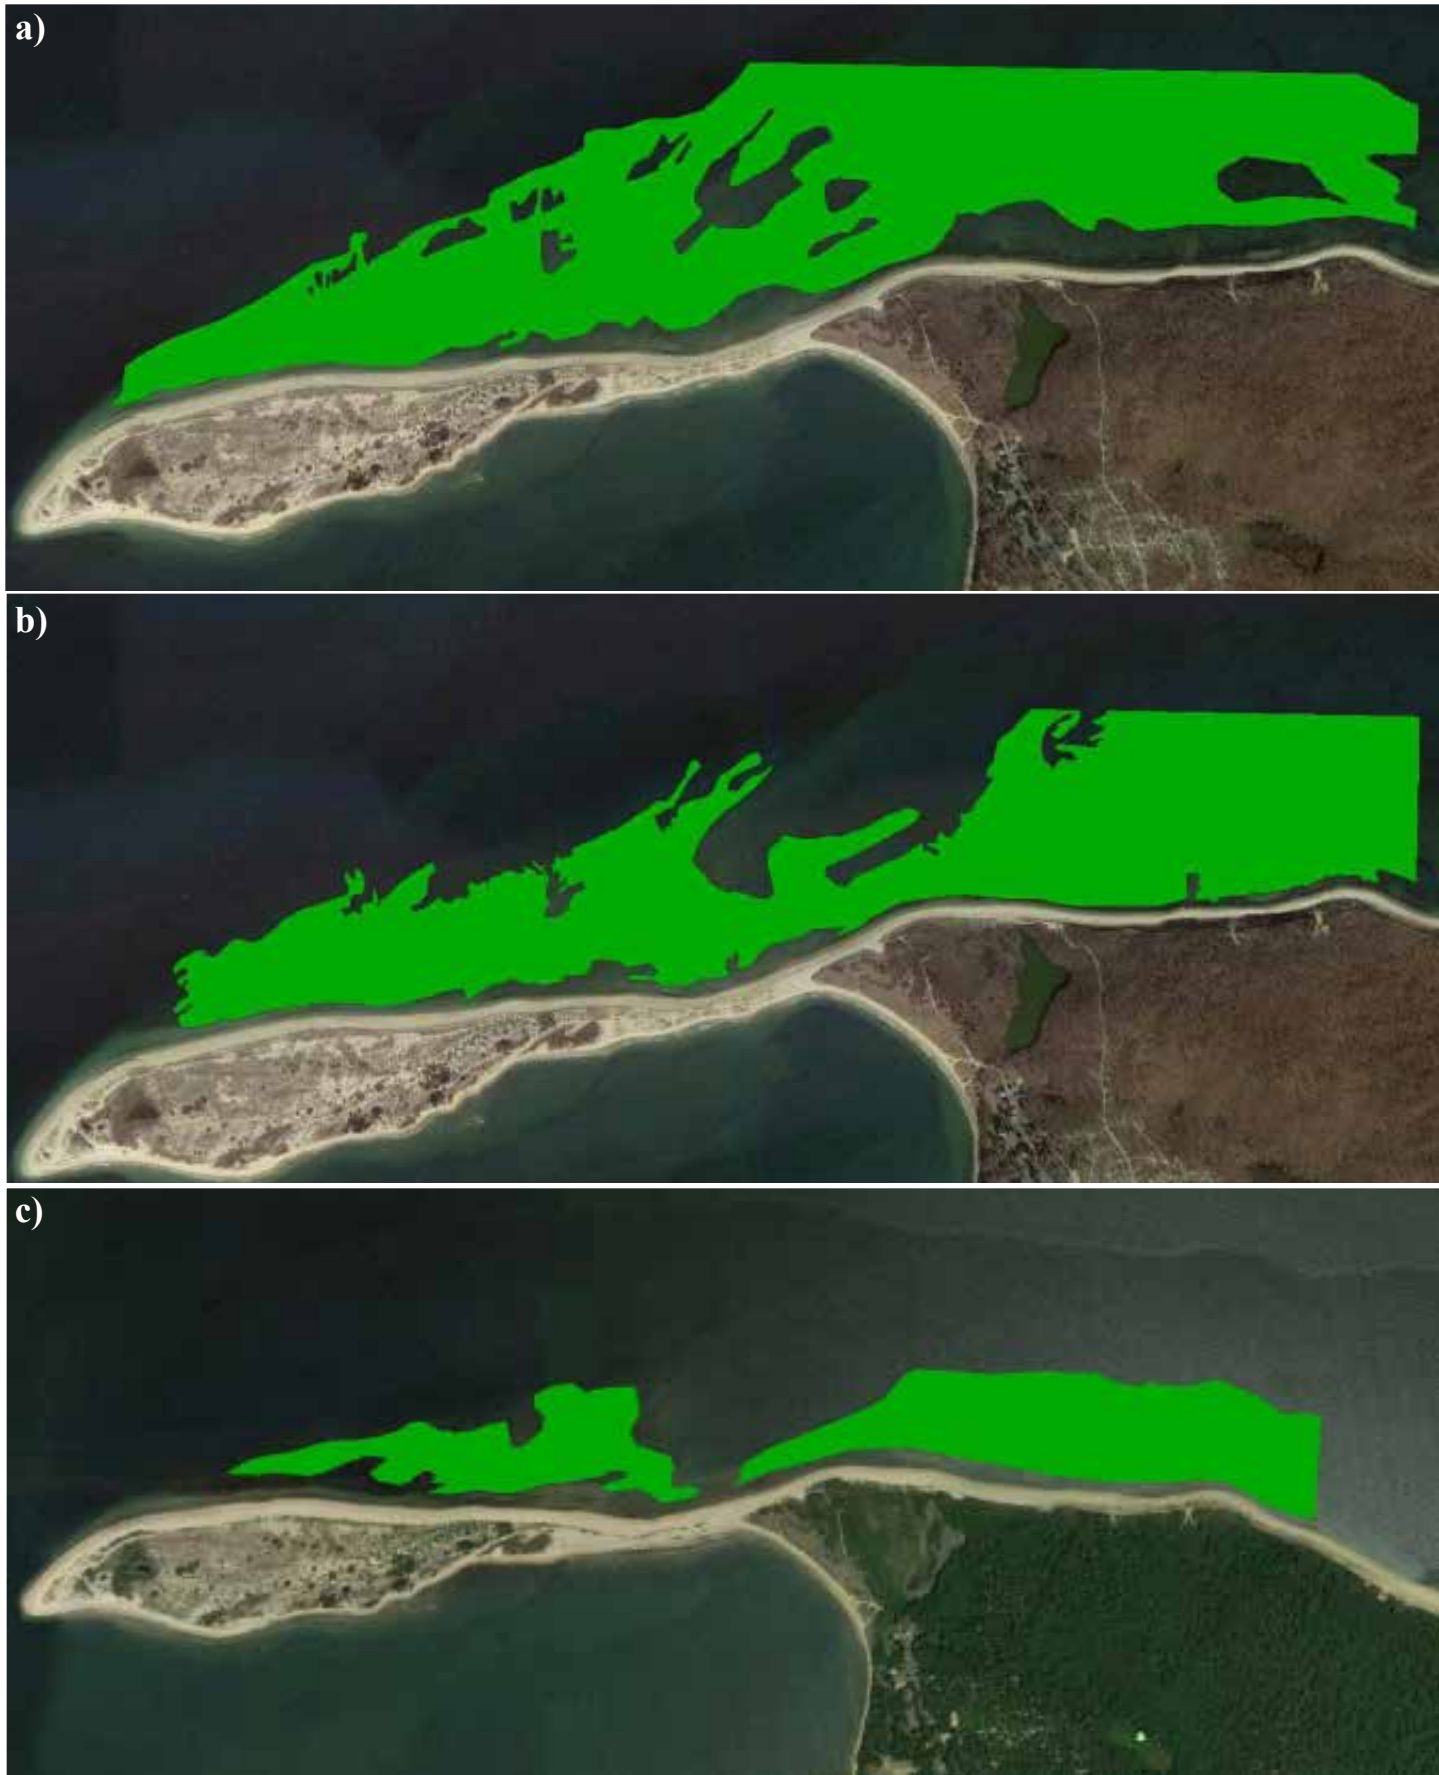
**Figure CP-5.** Delineations of the Cedar Point eelgrass meadow from aerial photographs for a) 2004, b) 2010, c) 2014, d) 2016, e) 2017, and f) 2019 (continued on next page).

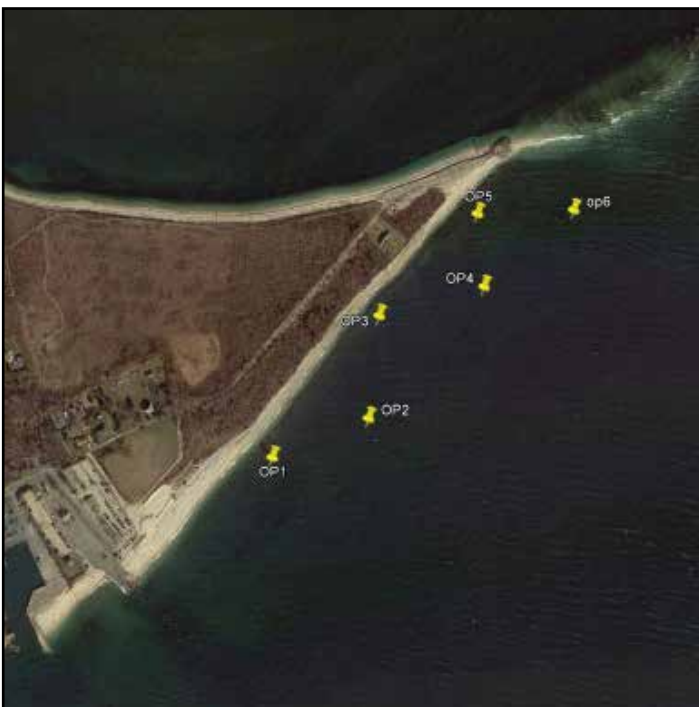
**Figure OP-1.** An aerial view of the Orient Point monitoring site with monitoring stations indicated by the superimposed numbers.

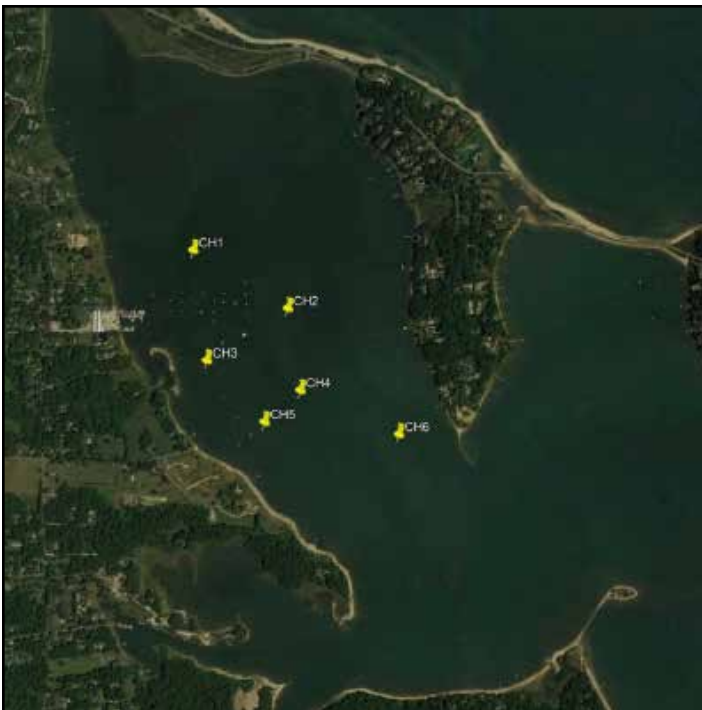
**Figure CH-1.** An aerial view of the Coecles Harbor monitoring site with monitoring stations indicated by the superimposed numbers.

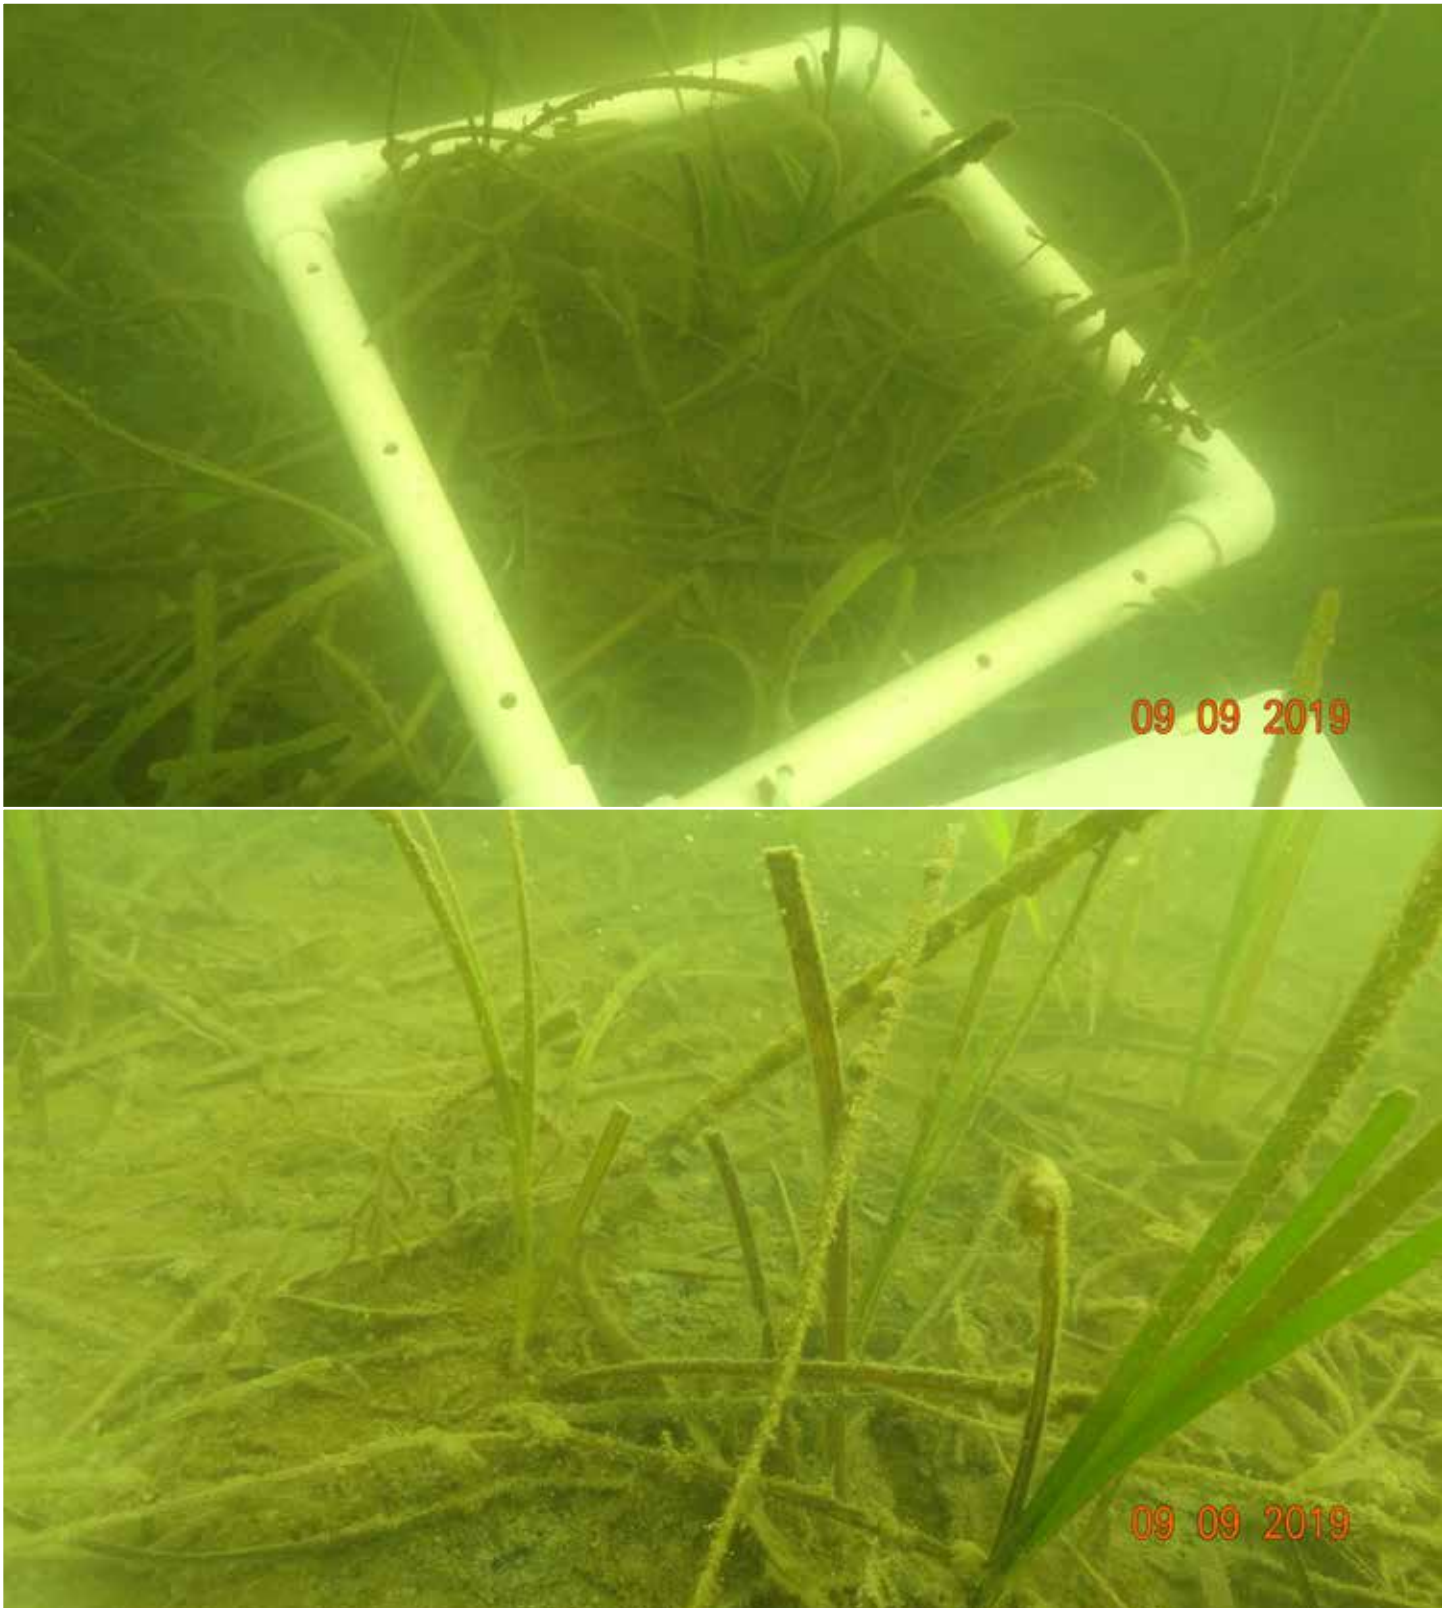
**Figure CH3.** Photographs showing the observed conditions at a) station 2 and b) station 5 during the Coeclis Harbor eelgrass monitoring visit in 2019.

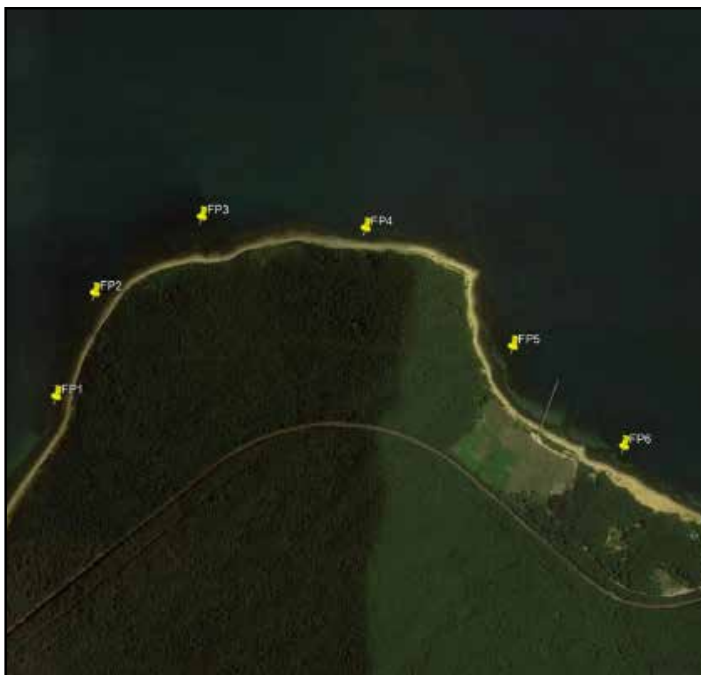
**Figure FP-1.** An aerial view of the Fort Pond Bay monitoring site with monitoring stations indicated by the superimposed numbers.

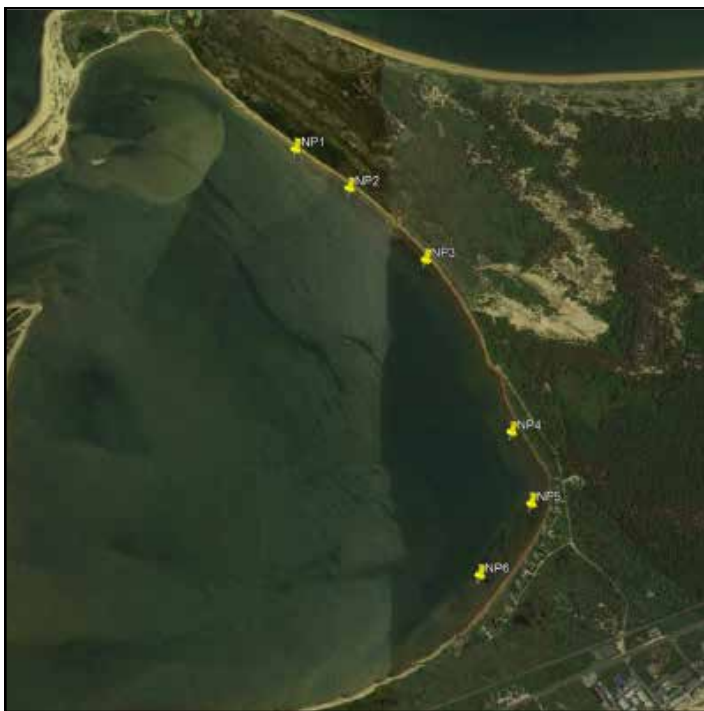
**Figure NAP-1.** An aerial view of the Napeague Harbor monitoring site with monitoring stations indicated by the superimposed numbers.

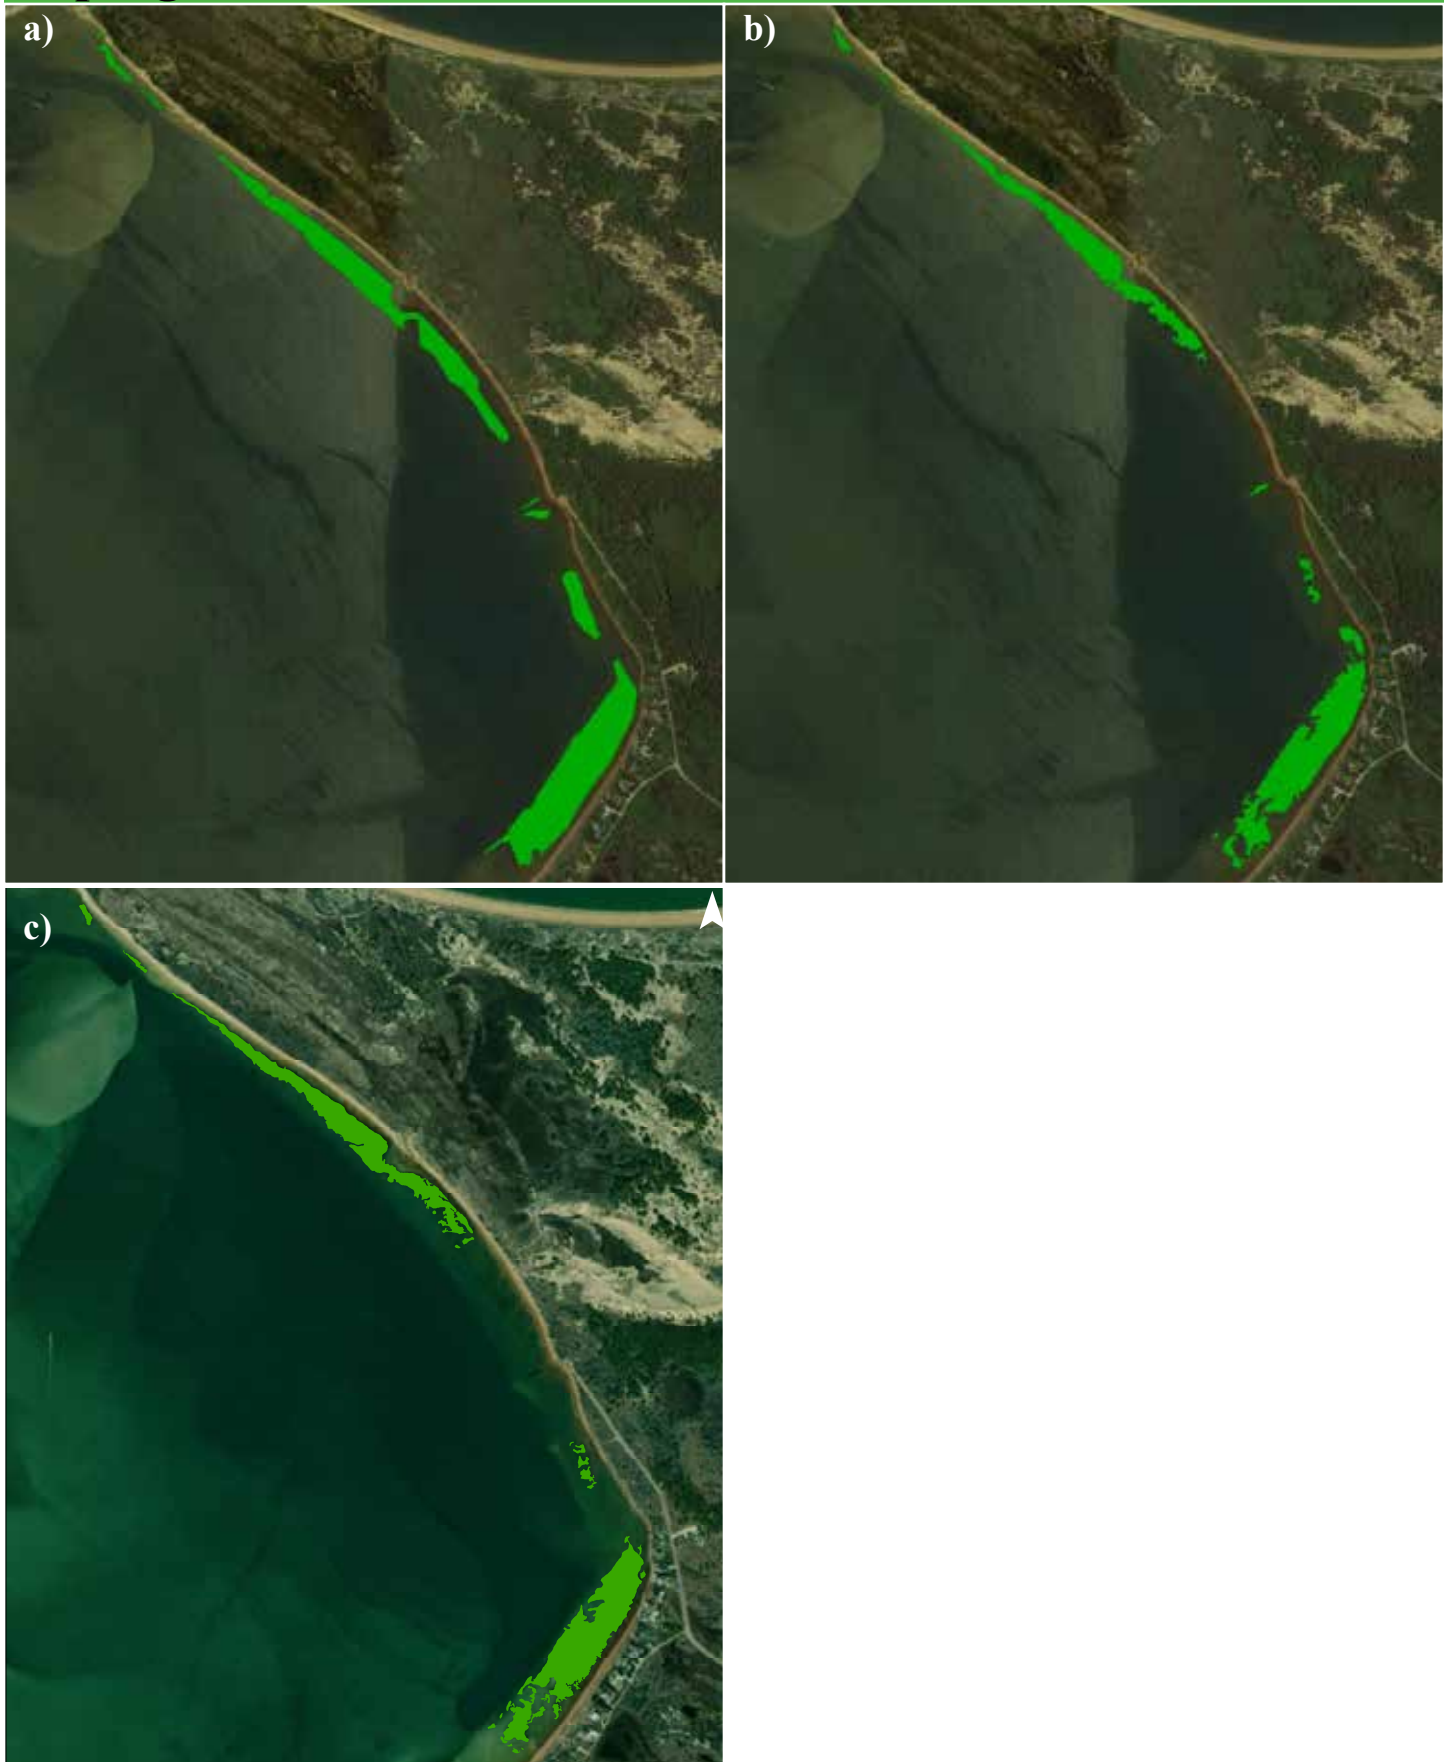
**Figure NAP-2.** A comparison of Napeague Harbor eelgrass meadow delineations completed in a) 2014, b) 2017 and c) 2019.

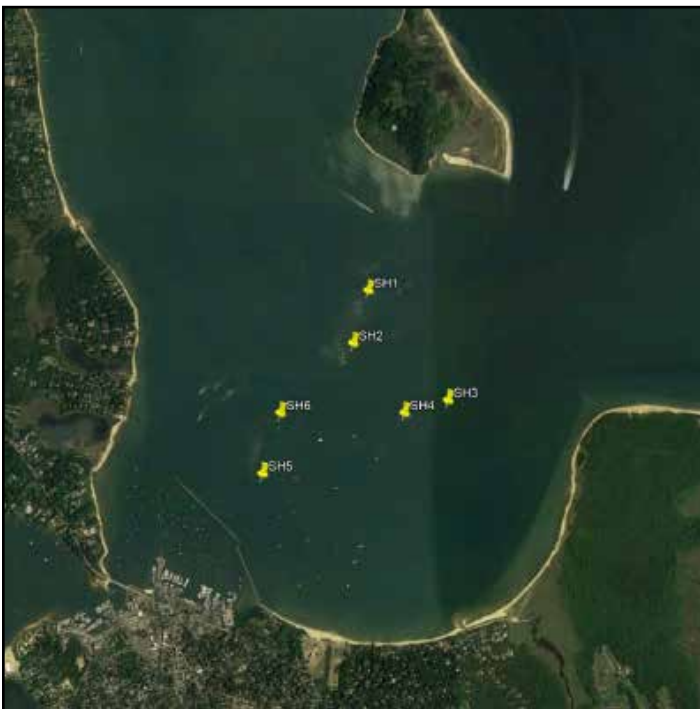
**Figure SH-1.** An aerial view of the Sag Harbor Bay monitoring site with monitoring stations indicated by the superimposed numbers.

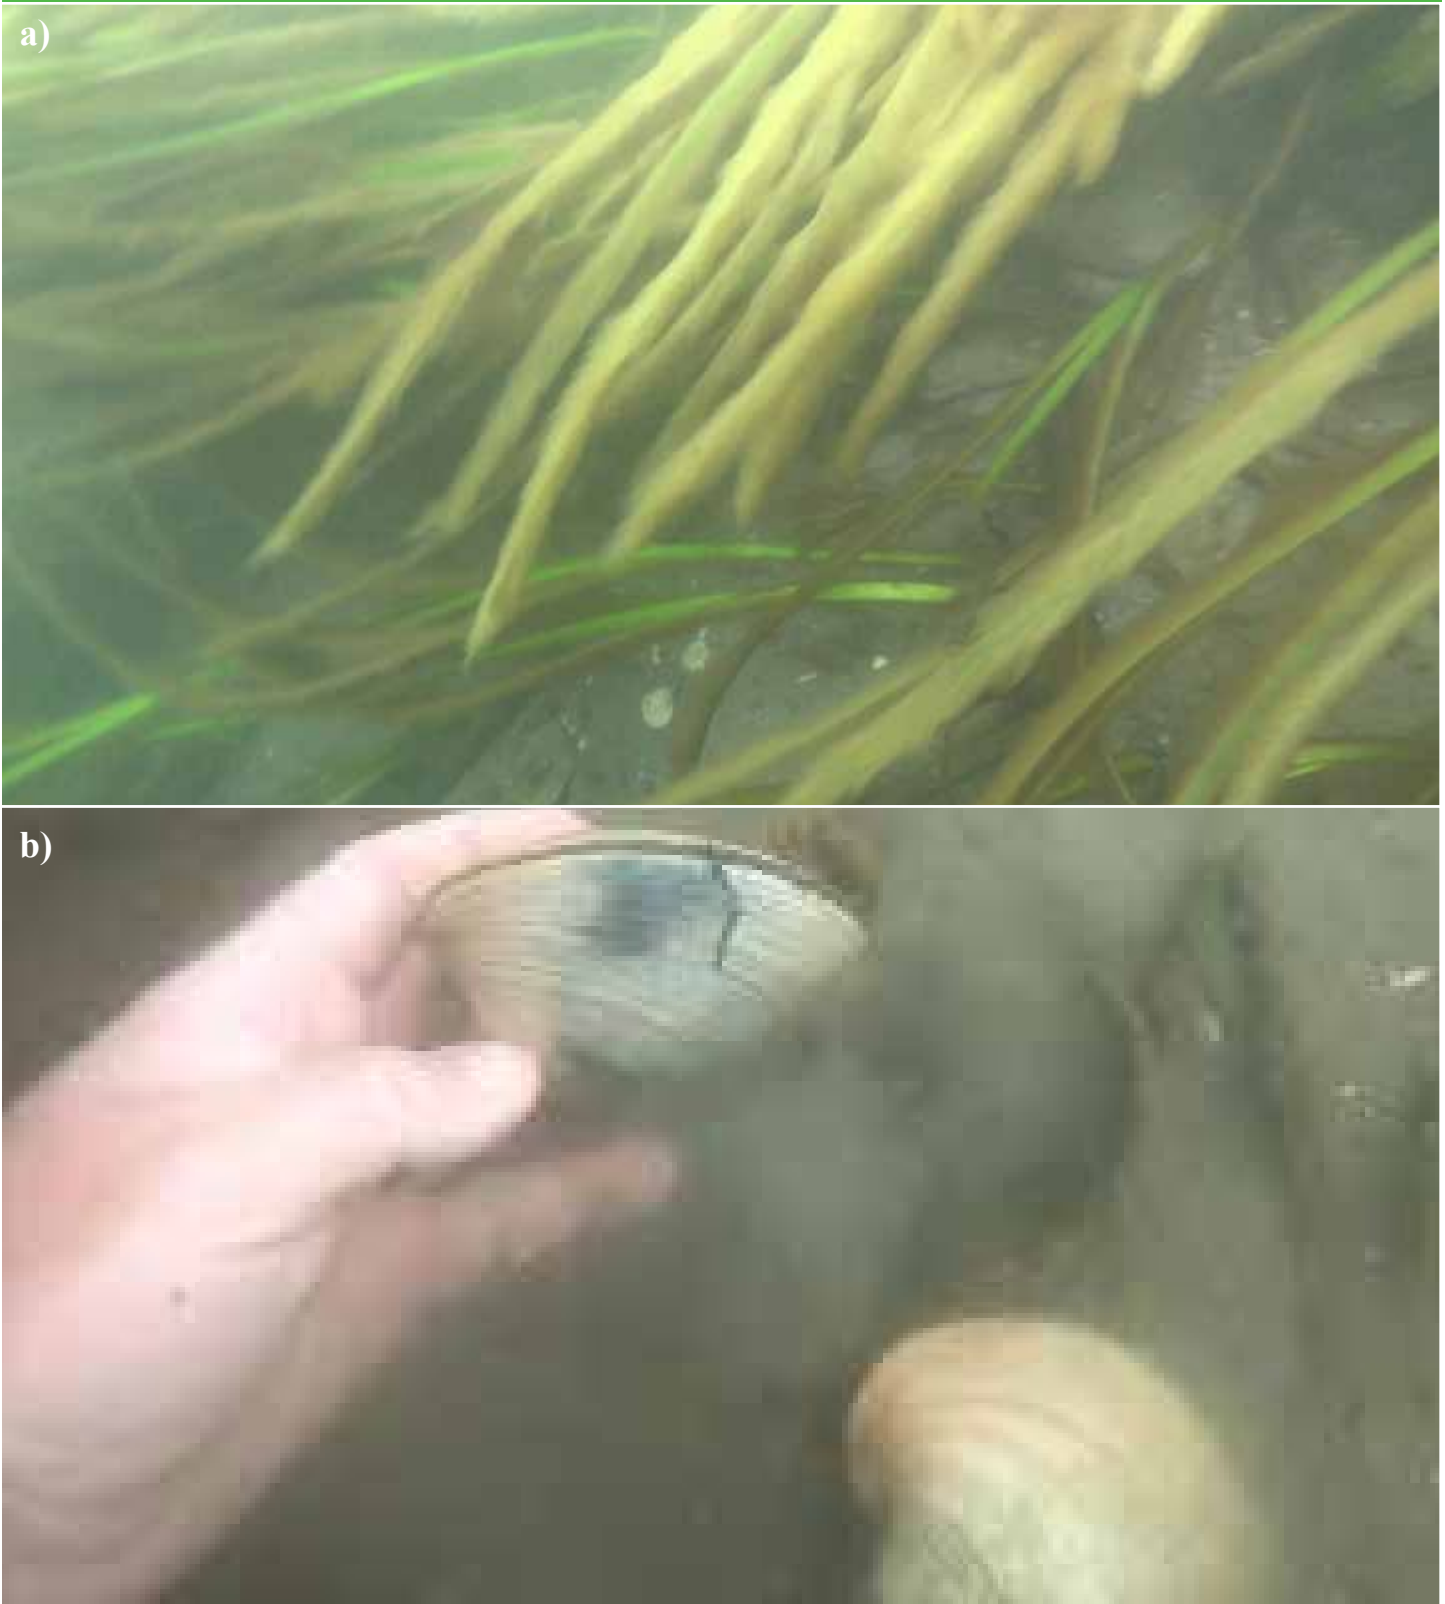
**Figure SH-3.** a). Heavily epiphytized eelgrass blades growing at Station 2. The epiphyte load is high on the older blades, with the younger blades remaining relatively clean. b) Two chowder clams that were washed out of the sediment at Station 5, presumably by wave action as the bottom at the station showed relatively deep sand waves.
