**Peconic Estuary Program 2010 Long-Term Eelgrass  
(*Zostera marina*) Monitoring Program**

***DRAFT* Progress Report 11  
January 2011**

**Submitted By:  
Christopher Pickerell  
and  
Stephen Schott**

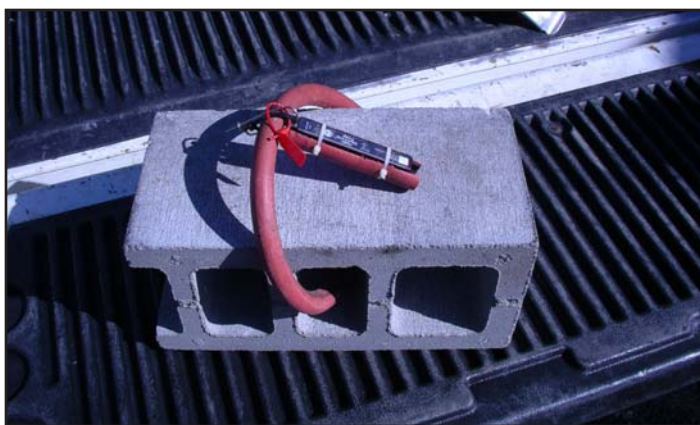
**Figure Intro-1.** A StowAway® temperature logger attached to a cement block, ready for deployment.

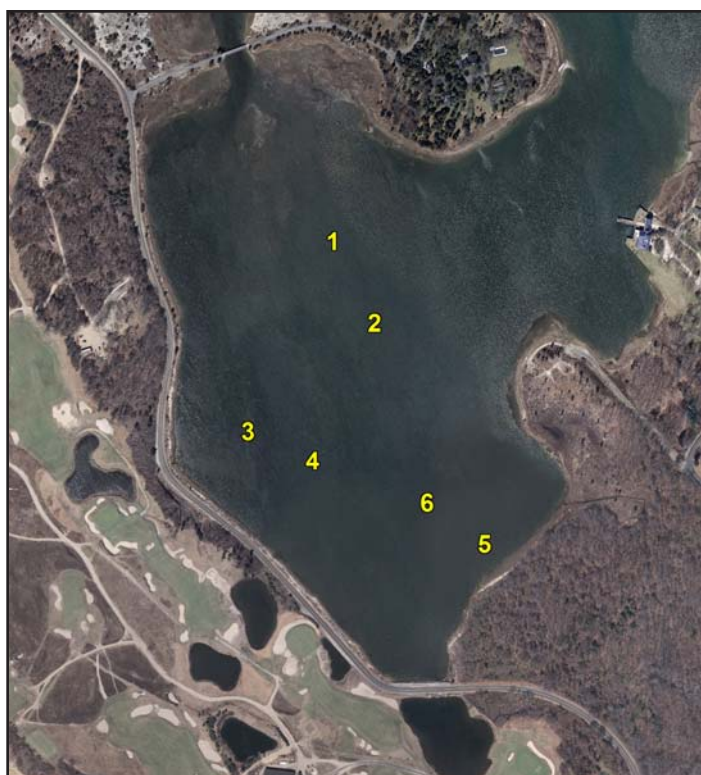
**Figure BB-1.** An aerial view of the Gardiners Bay eelgrass meadow with monitoring stations indicated by the superimposed numbers.

Bullhead Bay is a relatively sheltered embayment; however, winds from the north to northwest do influence the bay (Figure BB-1). The sediments of the bay range from coarse sand to loose muck. The sandy bottoms are found along the eastern and southern

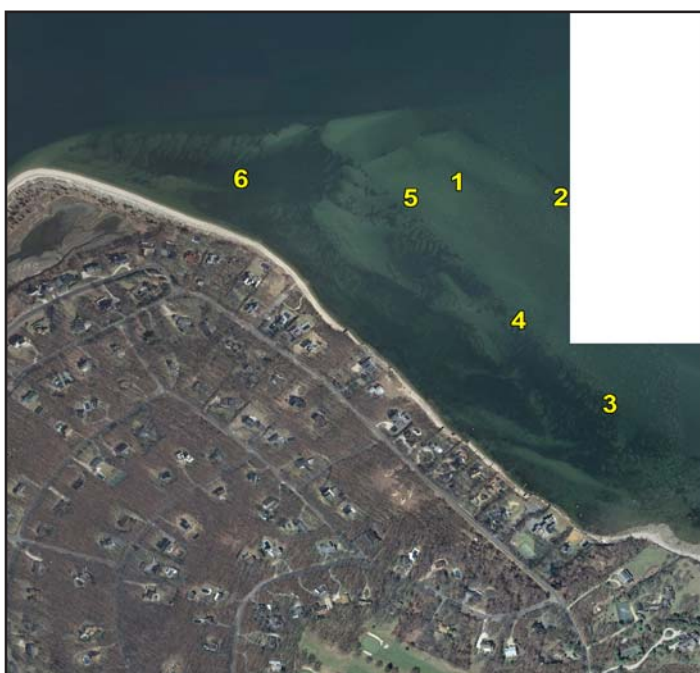
**Figure GB-1.** An aerial view of the Gardiners Bay eelgrass meadow with monitoring stations indicated by the superimposed numbers.

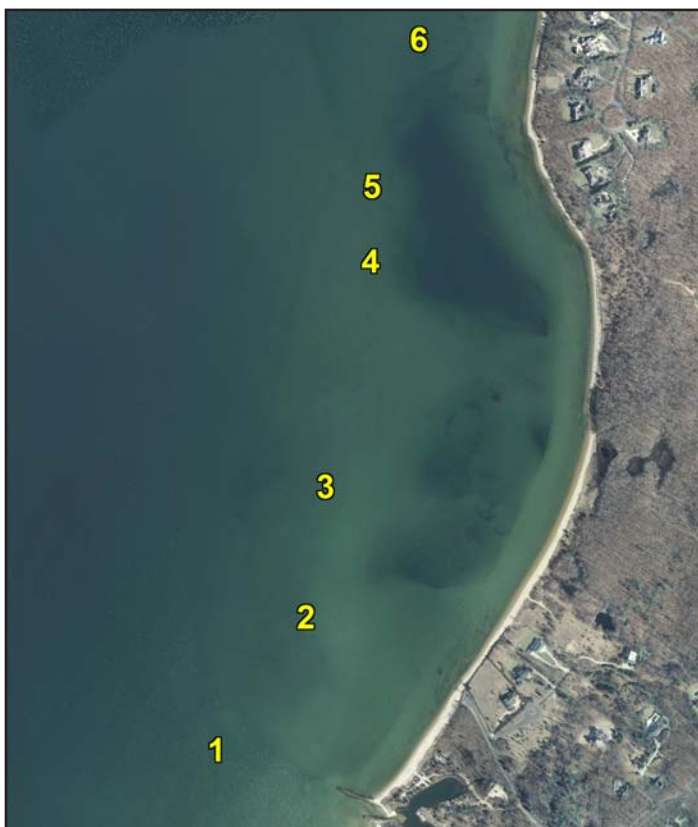
**Figure NWH-1.** An aerial view of the Northwest Harbor eelgrass meadow with monitoring stations indicated by the superimposed numbers.

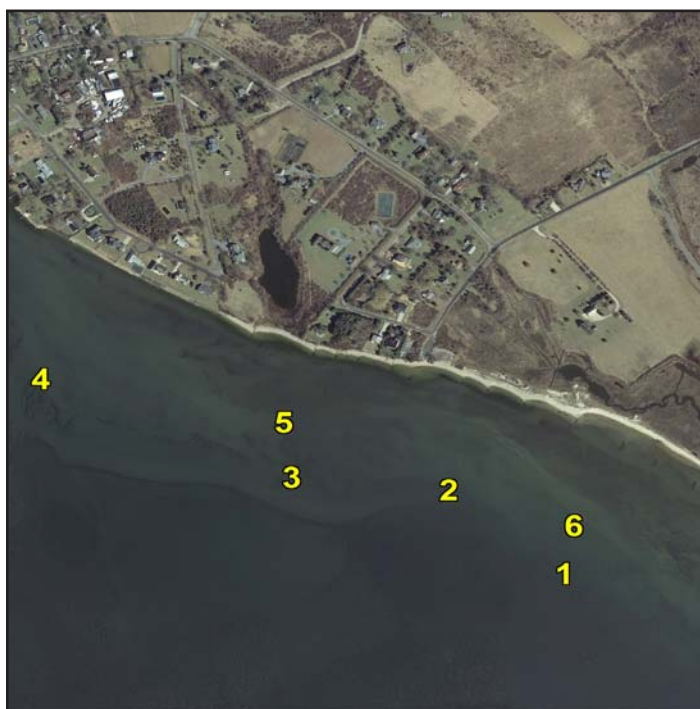
**Figure OH-1.** An aerial view of the Orient Harbor eelgrass meadow with monitoring stations indicated by the superimposed numbers.

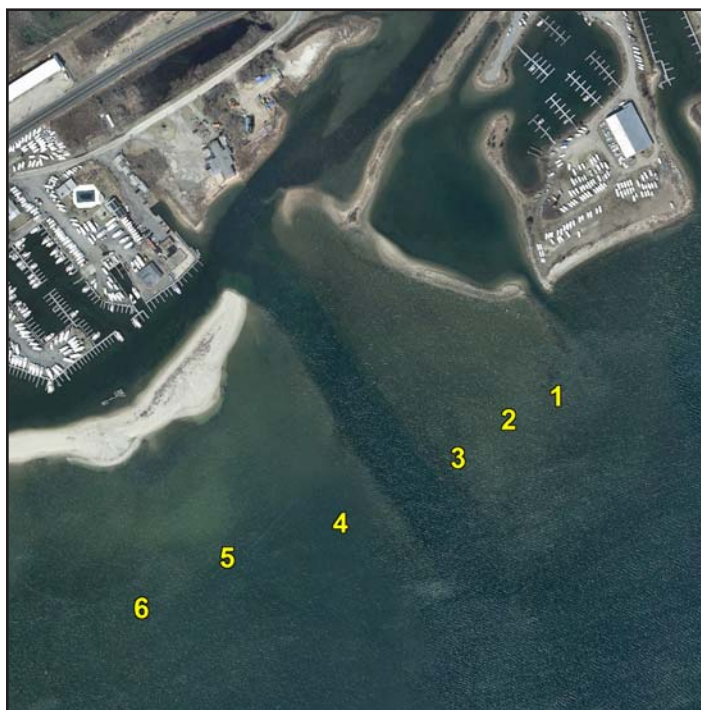
**Figure SB-1.** An aerial view of the Southold Bay monitoring site with monitoring stations indicated by the superimposed numbers.

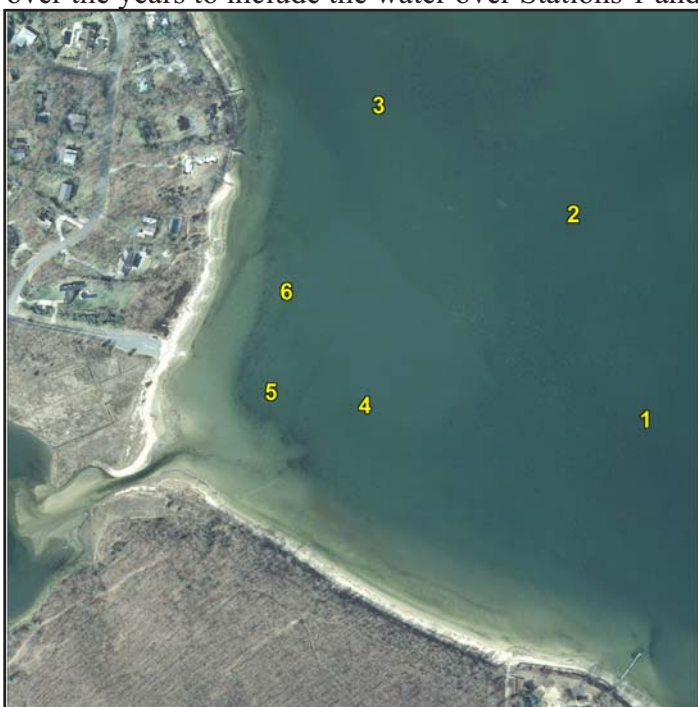
**Figure TMH-1.** An aerial view of the Three Mile Harbor monitoring site with monitoring stations indicated by the superimposed numbers.

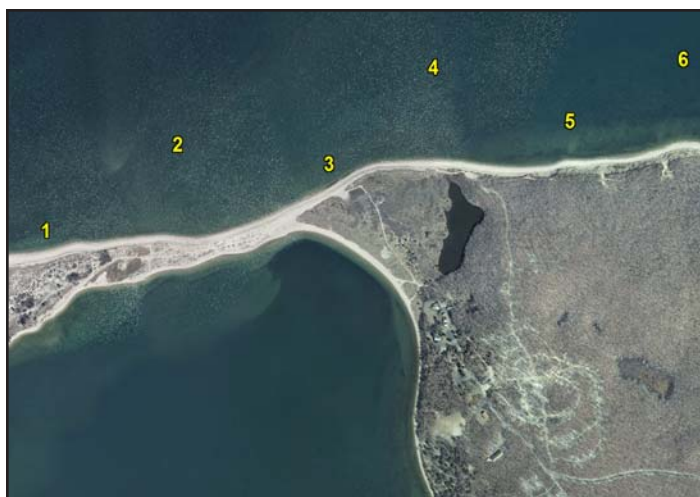
**Figure CP-1.** An aerial view of the Cedar Point monitoring site with monitoring stations indicated by the superimposed numbers.

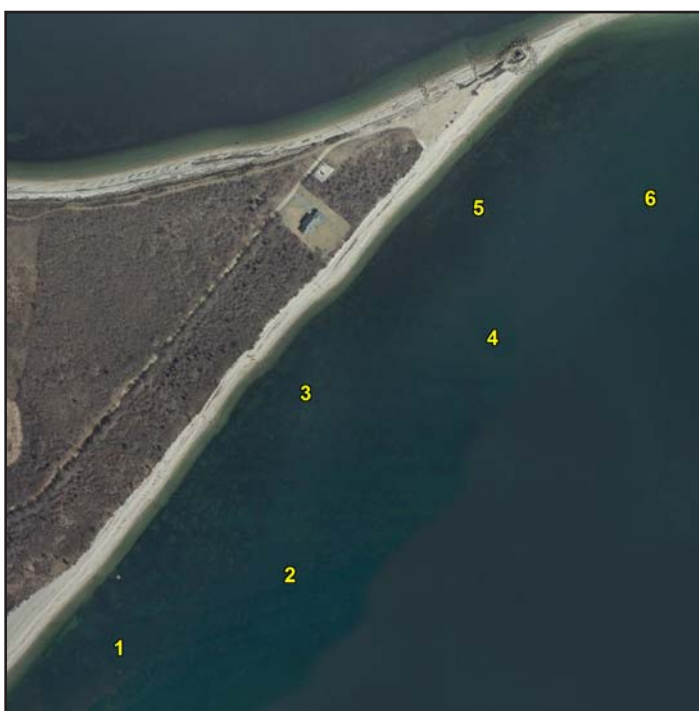
**Figure OP-1.** An aerial view of the Orient Point monitoring site with monitoring stations indicated by the superimposed numbers.

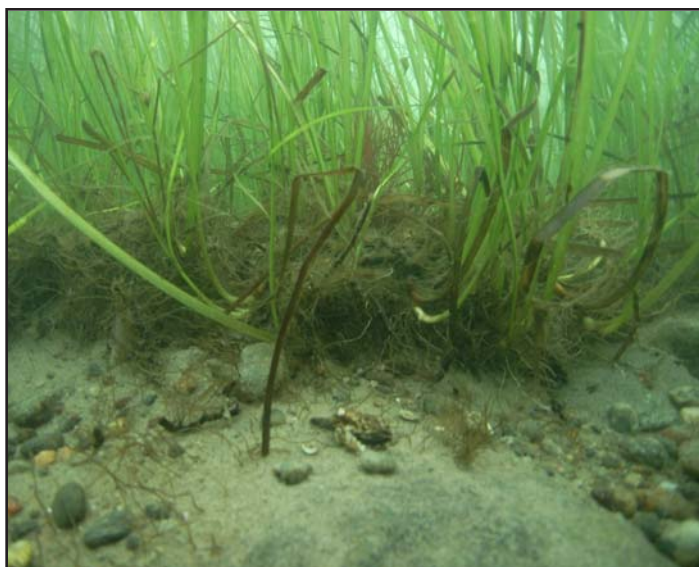
**Figure OP-2.** A side view of a “blowout” where an opening has been eroded in the meadow. The eelgrass is left to grow out over the edge where it is eventually dislodged. Also notice the coarse sediments left behind after the erosion.
