**Peconic Estuary Program 2008 Long-Term Eelgrass  
(*Zostera marina*) Monitoring Program**

***DRAFT* Progress Report 10  
March 23, 2009**

**Cornell University**  
Cooperative Extension  
of Suffolk County  
Marine Program

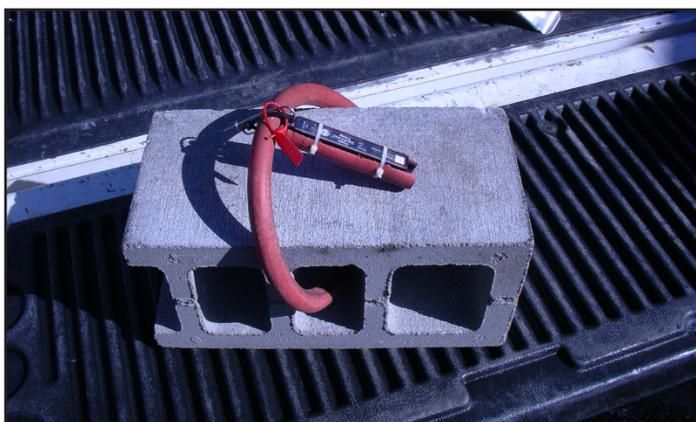
**Figure Intro-1.** A StowAway® temperature logger attached to a cement block, ready for deployment.

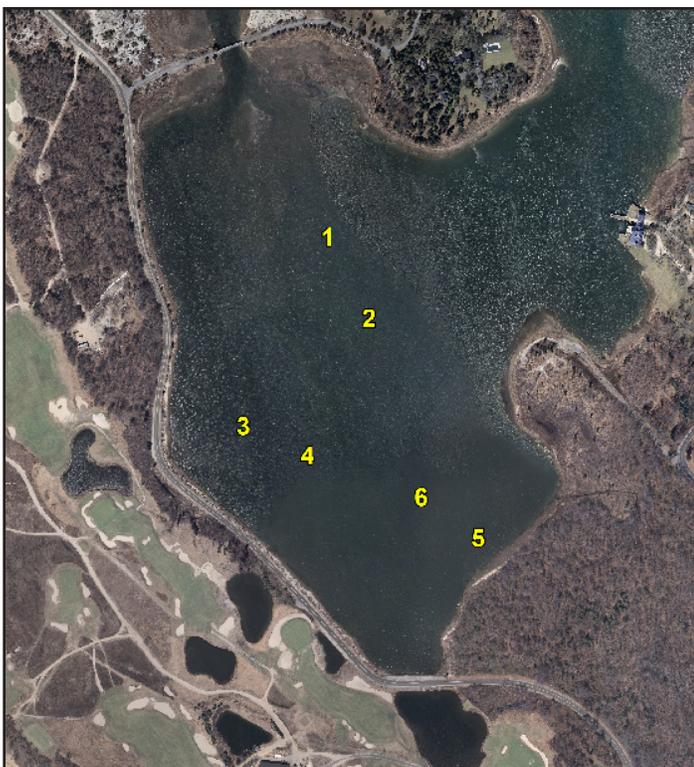
**Figure BB-1.** An aerial view of the Gardiners Bay eelgrass meadow with monitoring stations indicated by the superimposed numbers.

Bullhead Bay is a relatively sheltered embayment; however, winds from the north to northwest do influence the bay (Figure BB-1). The sediments of the bay range from coarse sand to loose muck. The sandy bottoms are found along the eastern and southern

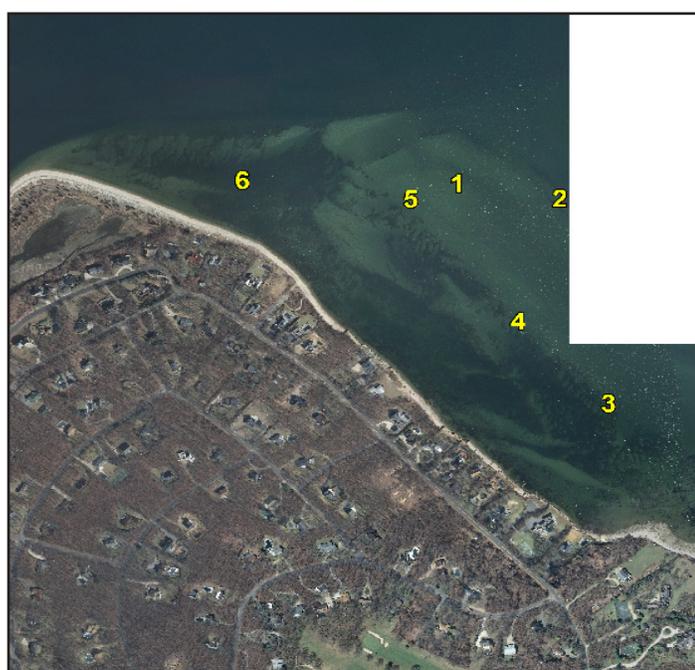
**Figure GB-1.** An aerial view of the Gardiners Bay eelgrass meadow with monitoring stations indicated by the superimposed numbers.

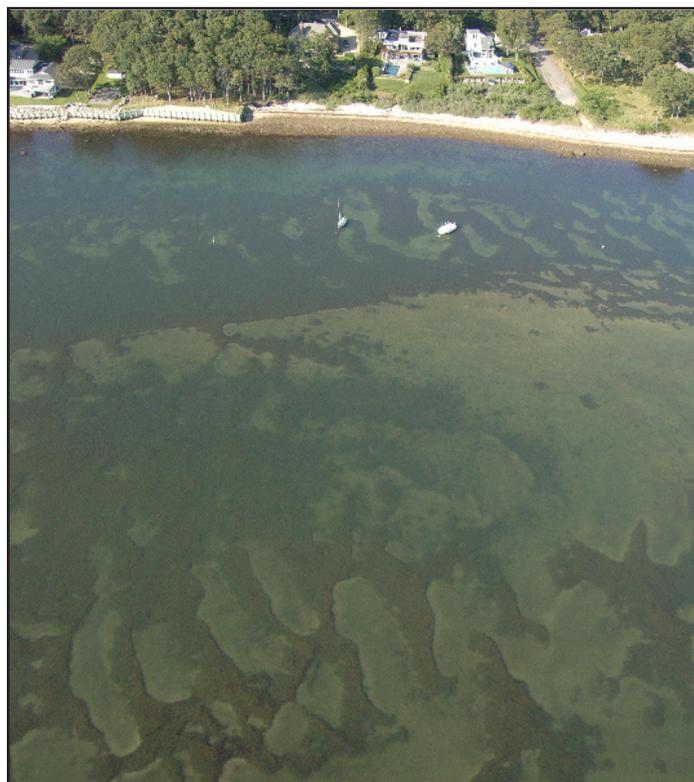
**Figure GB-5.** An aerial photograph (2008) showing the patchiness of one section of the Gardiners Bay eelgrass meadow.

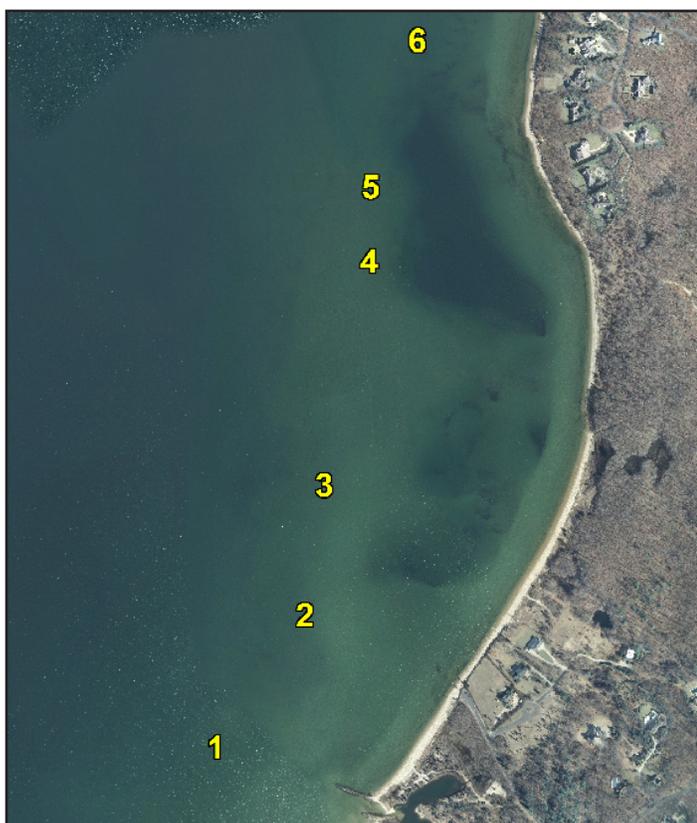
**Figure NWH-1.** An aerial view of the Northwest Harbor eelgrass meadow with monitoring stations indicated by the superimposed numbers.

The water temperature monitoring in Northwest Harbor has always been taken in the southern area of the Harbor near eelgrass monitoring Station 1 (Figure NWH-1). While this station is a considerable

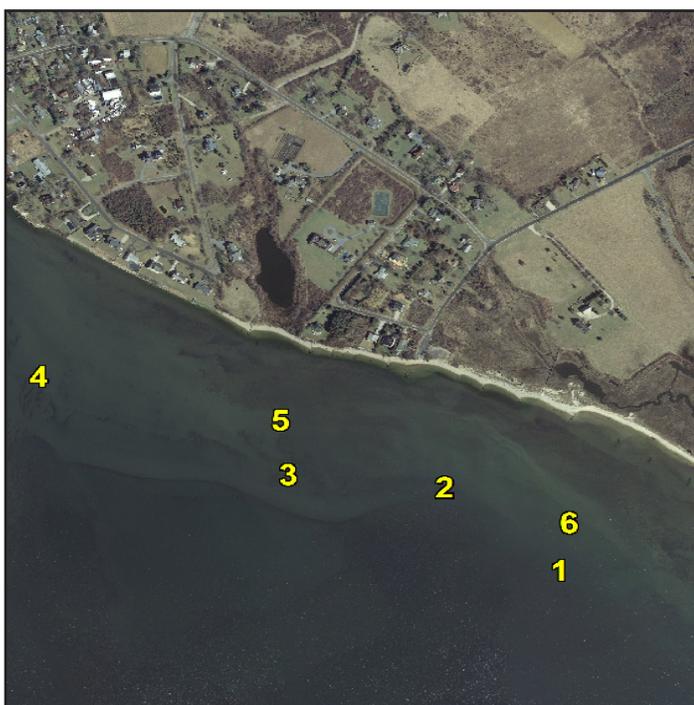
**Figure OH-1.** An aerial view of the Orient Harbor eelgrass meadow with monitoring stations indicated by the superimposed numbers.

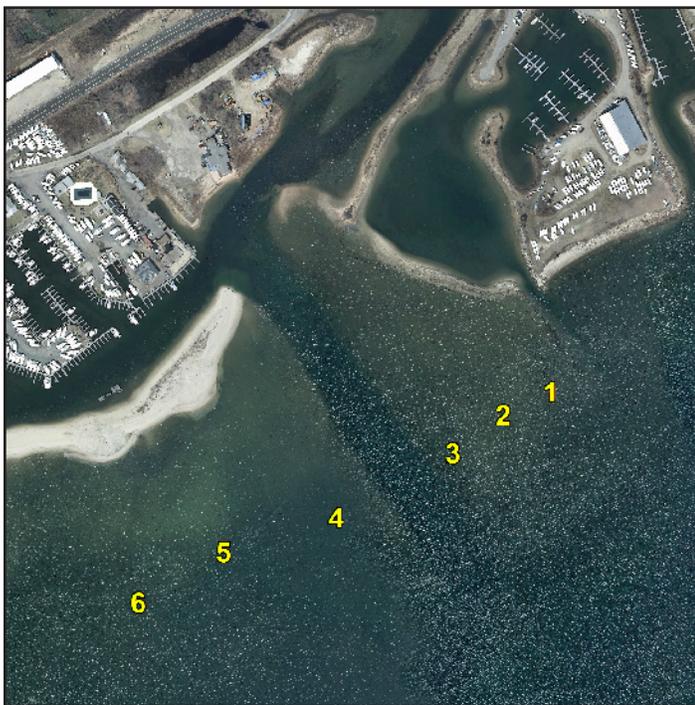
**Figure SB-1.** An aerial view of the Southold Bay monitoring site with monitoring stations indicated by the superimposed numbers.

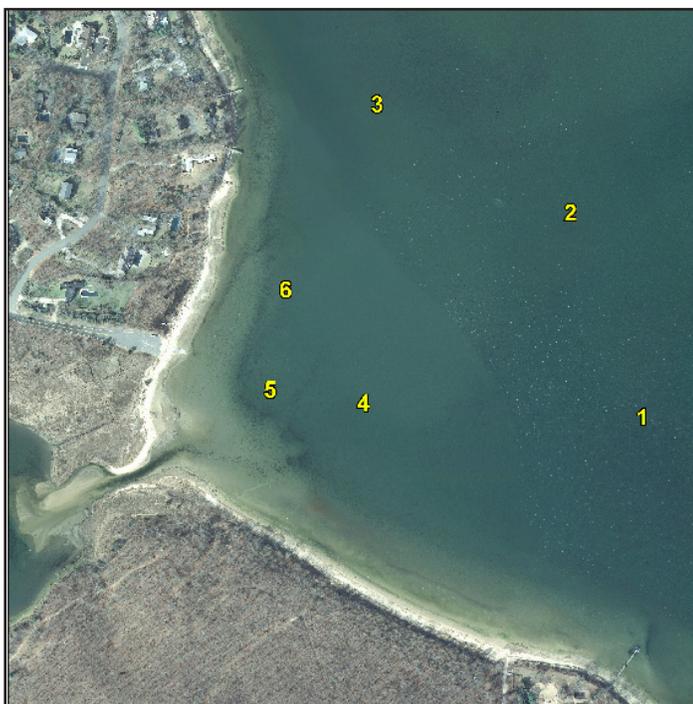
**Figure TMH-1.** An aerial view of the Three Mile Harbor monitoring site with monitoring stations indicated by the superimposed numbers.

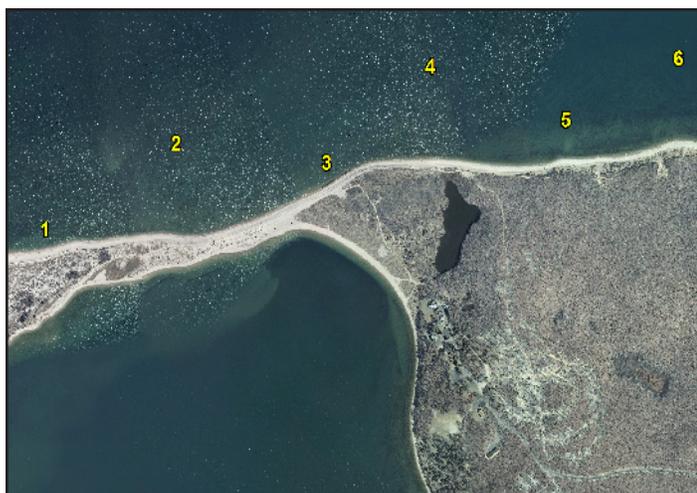
**Figure CP-1.** An aerial view of the Cedar Point monitoring site with monitoring stations indicated by the superimposed numbers.

**Cedar Point** includes a narrow peninsula that separates Gardiners Bay from Northwest Harbor in East Hampton Town. The north shore of Cedar Point (Gardiners Bay side) supports a large, but patchy eelgrass meadow. The site is highly exposed to winds out of the north and there is a moderate current at the site. An overview of the site and the monitoring stations can be found in Figure CP-1, below.

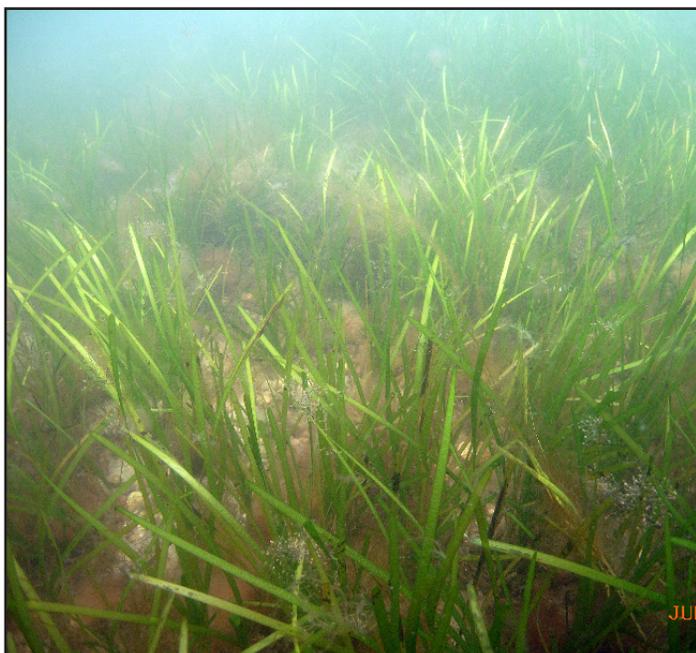
**Figure CP-2.** An underwater view of an eelgrass patch at Cedar Point, East Hampton.

With 2008 being the first year of data collection for this meadow, there is not enough data to determine, or even speculate, trends. Whereas CCE has spent a significant amount of bottom time at the Orient Point meadow and can make some observation regarding the possible directions the eelgrass population may take at that site, the Cedar Point meadow has just become an important meadow in terms of eelgrass restoration as well as for the eelgrass monitoring program. The 2008 monitoring survey found that the average eelgrass shoot density for Cedar Point was 285 shoot per meter<sup>2</sup>. The maximum shoot density counted at the site was 770 shoots per meter<sup>2</sup>. In many ways, the Cedar Point eelgrass meadow resembles the Orient Point meadow, prior to the October 2006 storm that caused large-scale loss. Both sites are patchy with evident blowouts caused by wave action and bioturbation (i.e., crab digging along meadow edges). The two populations show similar range in shoot density and the meadow phenology is similar, with seeds coming to maturity at approximately the same time. Figure CP-2 shows a typical underwater view of an eelgrass patch at Cedar Point.

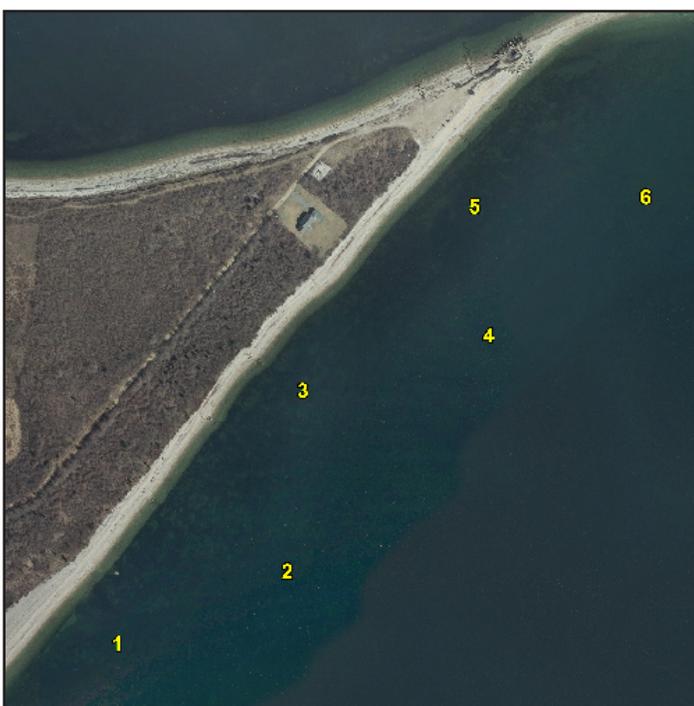
**Figure OP-1.** An aerial view of the Orient Point monitoring site with monitoring stations indicated by the superimposed numbers.

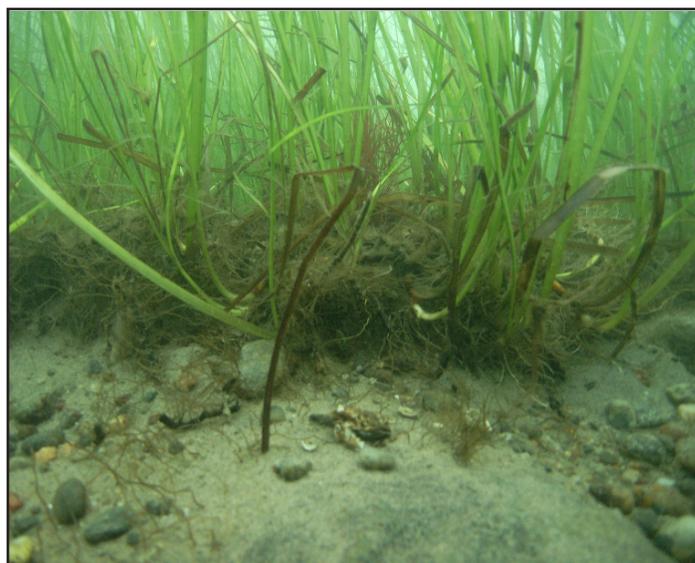
**Figure OP-2.** A side view of a “blowout” where an opening has been eroded in the meadow. The eelgrass is left to grow out over the edge where it is eventually dislodged. Also notice the coarse sediments left behind after the erosion.

are common throughout the shallow portions of the meadow. Where these blowouts occur, the eelgrass meadow abruptly ends at a drop off of several inches to one foot. The edge of the meadow is often left hanging over the edge. Figure OP-2 shows a characteristic blowout found in the Orient Point meadow.

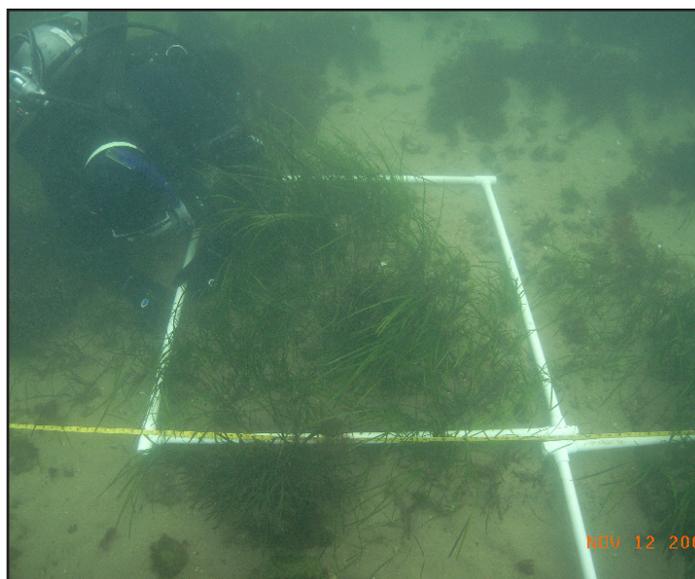
**Figure OP-4.** A CCE diver counts eelgrass shoots in a 1-meter<sup>2</sup> quadrat along one of three permanent transects established in Orient Point to monitor the meadows recovery from a 2006 storm.
