Peconic Estuary Program 2018 Long-Term Eelgrass (*Zostera marina*) Monitoring Program

Progress Report 19

Submitted By:
Christopher Pickerell
and
Stephen Schott

Cornell University
Cooperative Extension
of Suffolk County

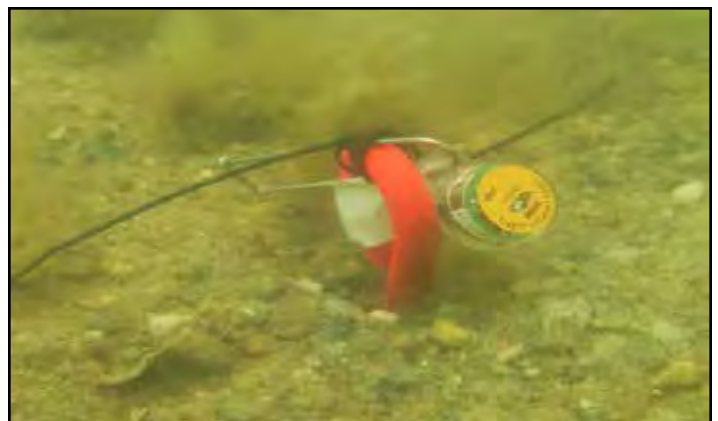
Figure Intro-2. A TidBit v2™ temperature logger attached to a screw anchor, deployed on-site.

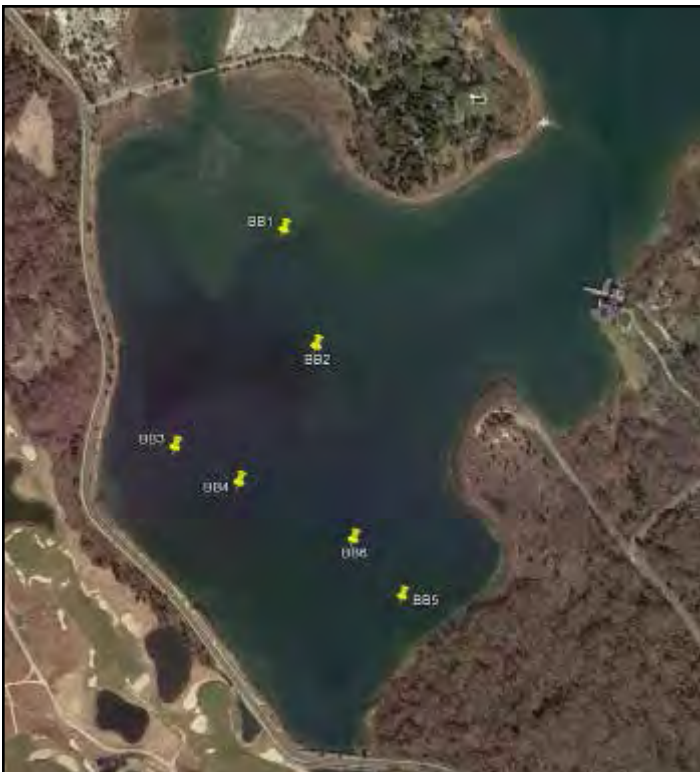
Bullhead Bay is a relatively sheltered embayment; however, winds from the north to northwest do influence the bay (Figure BB-1). The sediments of the bay range from coarse sand to loose muck. The sandy bottoms are found along the eastern and southern shore (likely influenced by the winter winds out of the north and northwest) as well as the northern areas of the bay where water is funneled under a bridge. The remaining bay bottom is loose mud of various depths. The mud areas have a relatively high organic content, especially for sediments supporting an eelgrass population. Sediment analysis conducted in 1997 at this site found organic content in some areas exceeded 8%. The follow-up sediment analysis conducted in 2017 found similar results, with an average organic content of 7.2%. Locally, sediment organics exceeded 12% in the 2017 analysis. It seems that this eelgrass population can tolerate these high levels of organics in the sediment. Water quality at the site has always been in question. There is a major golf course (Shinnecock Hills) along the entire west side of Bullhead Bay (separated by a road but with culverts running underneath the road). It is unknown what levels of nutrient/chemical loading may be sourced to the golf course, but it could be significant. Aside from the golf course, the residential housing along Sebonac Creek could also be a source of nutrient loading for the bay.

Figure BB-1. An aerial view of the Gardiners Bay eelgrass meadow with monitoring stations indicated by the superimposed numbers.

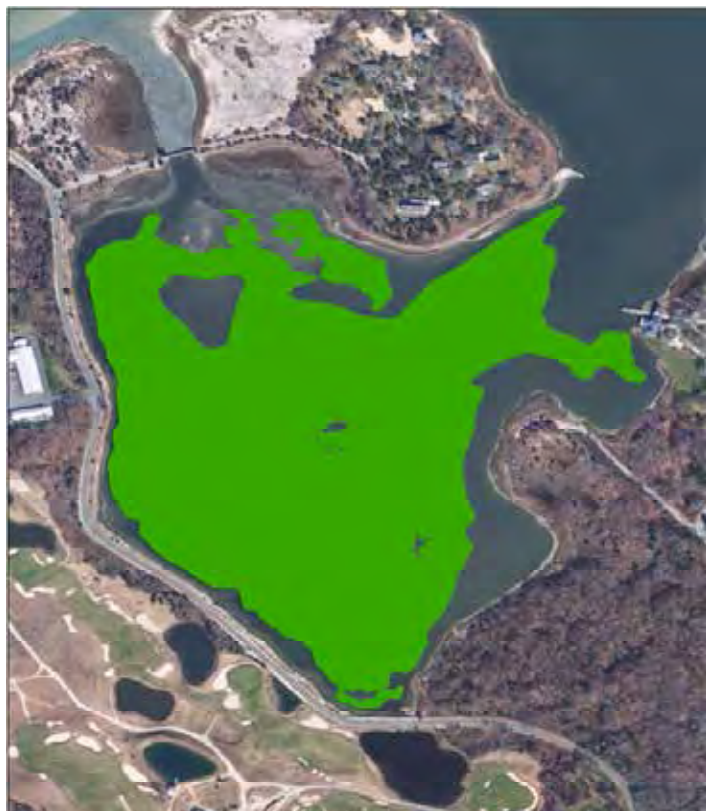
Figure BB-3. The 2018 delineation of the Bullhead Bay eelgrass meadow.

Delineation of the Bullhead Bay eelgrass meadow was completed using aerial imagery from Google Earth™ taken on 29 June, 2018. The expansion of the Bullhead Bay eelgrass meadow in 2018 was noted on the first visit by CCE in May 2018 to set up the light and temperature monitoring station. While the 2017 extent of the meadow had expanded toward Sebonac Creek to the east, the edge of the meadow had moved even closer to Sebonac Creek and the Southampton Town mooring field bordering Bullhead Bay in 2018 (Figures BB-3 and BB-4f). Based on the delineations from

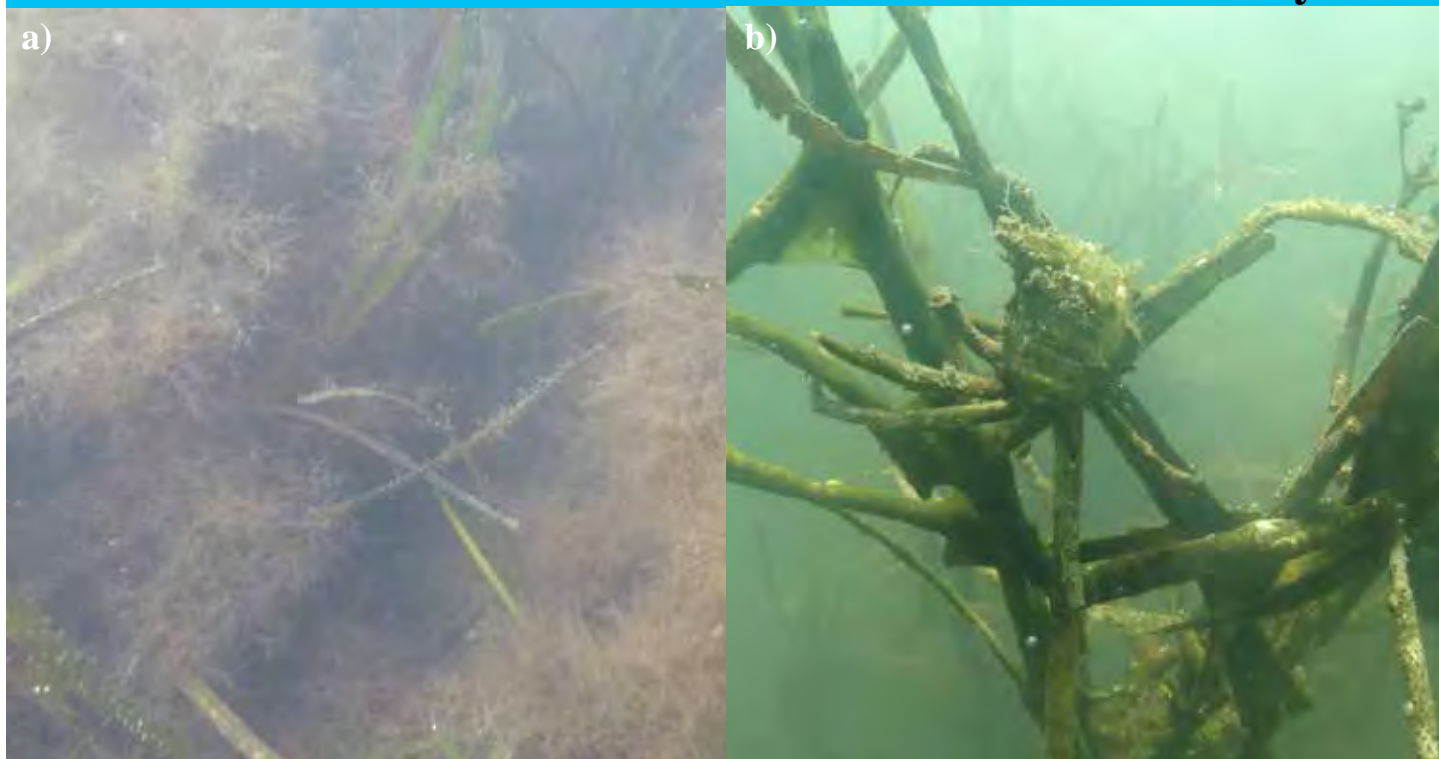
Figure BB-5. Underwater photographs taken during the 2018 monitoring survey in Bullhead Bay showing a) station 2 with high percent cover of *Spyridia filamentosa* growing within the eelgrass and b) the cyanobacterial mat that was observed growing around station 4 and covering the eelgrass. The cyanobacterial mat connected eelgrass shoots, providing enough structural support for this spider crab to climb into the eelgrass canopy.

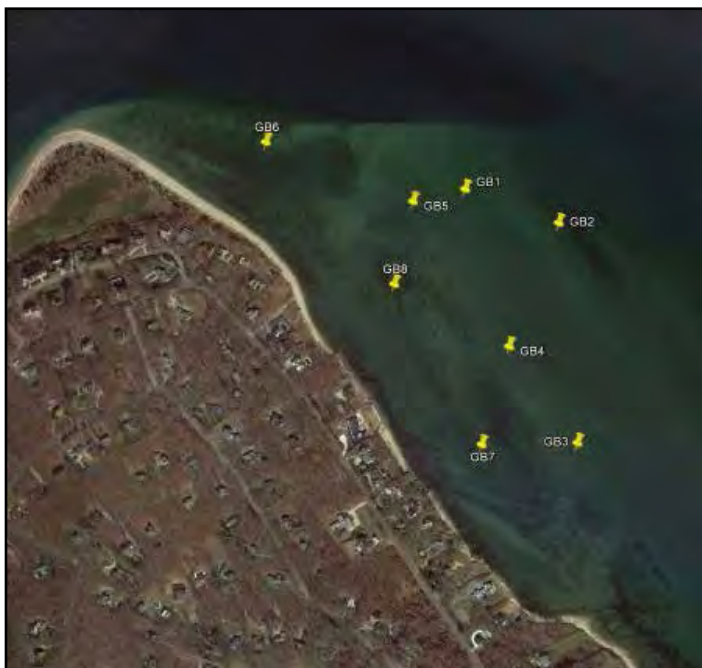
Figure GB-1. An aerial view of the Gardiners Bay eelgrass meadow with monitoring stations indicated by the superimposed numbers.

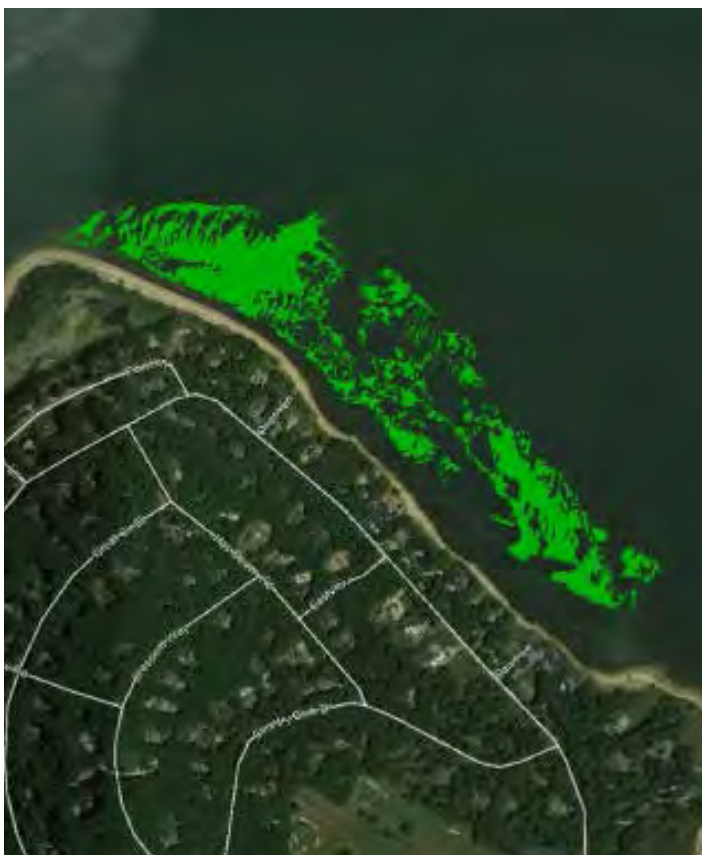
Figure GB-3. The 2017 areal delineation of the Gardiners Bay eelgrass meadow on the northeast shore of Shelter Island, NY.

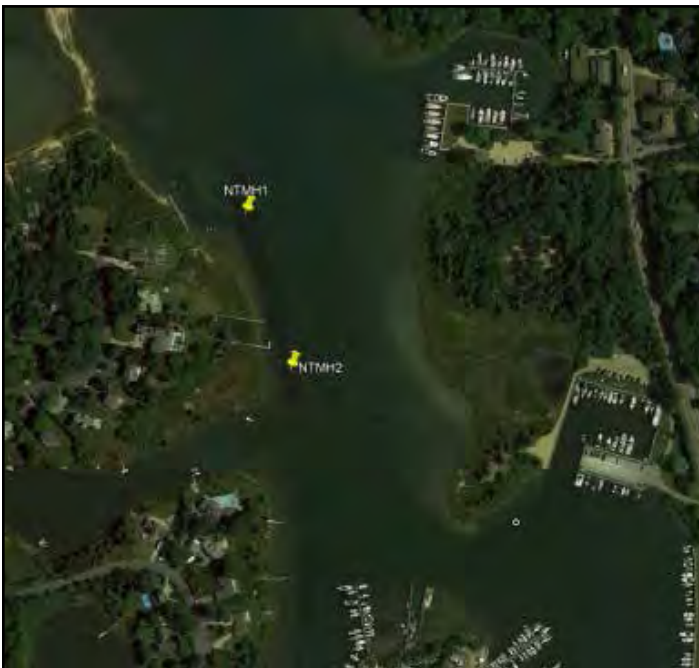
Figure TMH-1. An aerial photograph showing the location of the new Three Mile Harbor eelgrass meadow and its two monitoring stations.

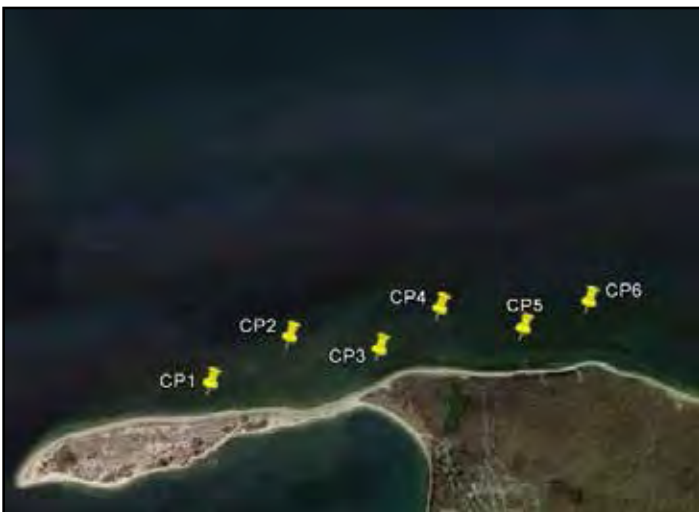
Figure CP-1. An aerial view of the Cedar Point monitoring site with monitoring stations indicated by the superimposed numbers.

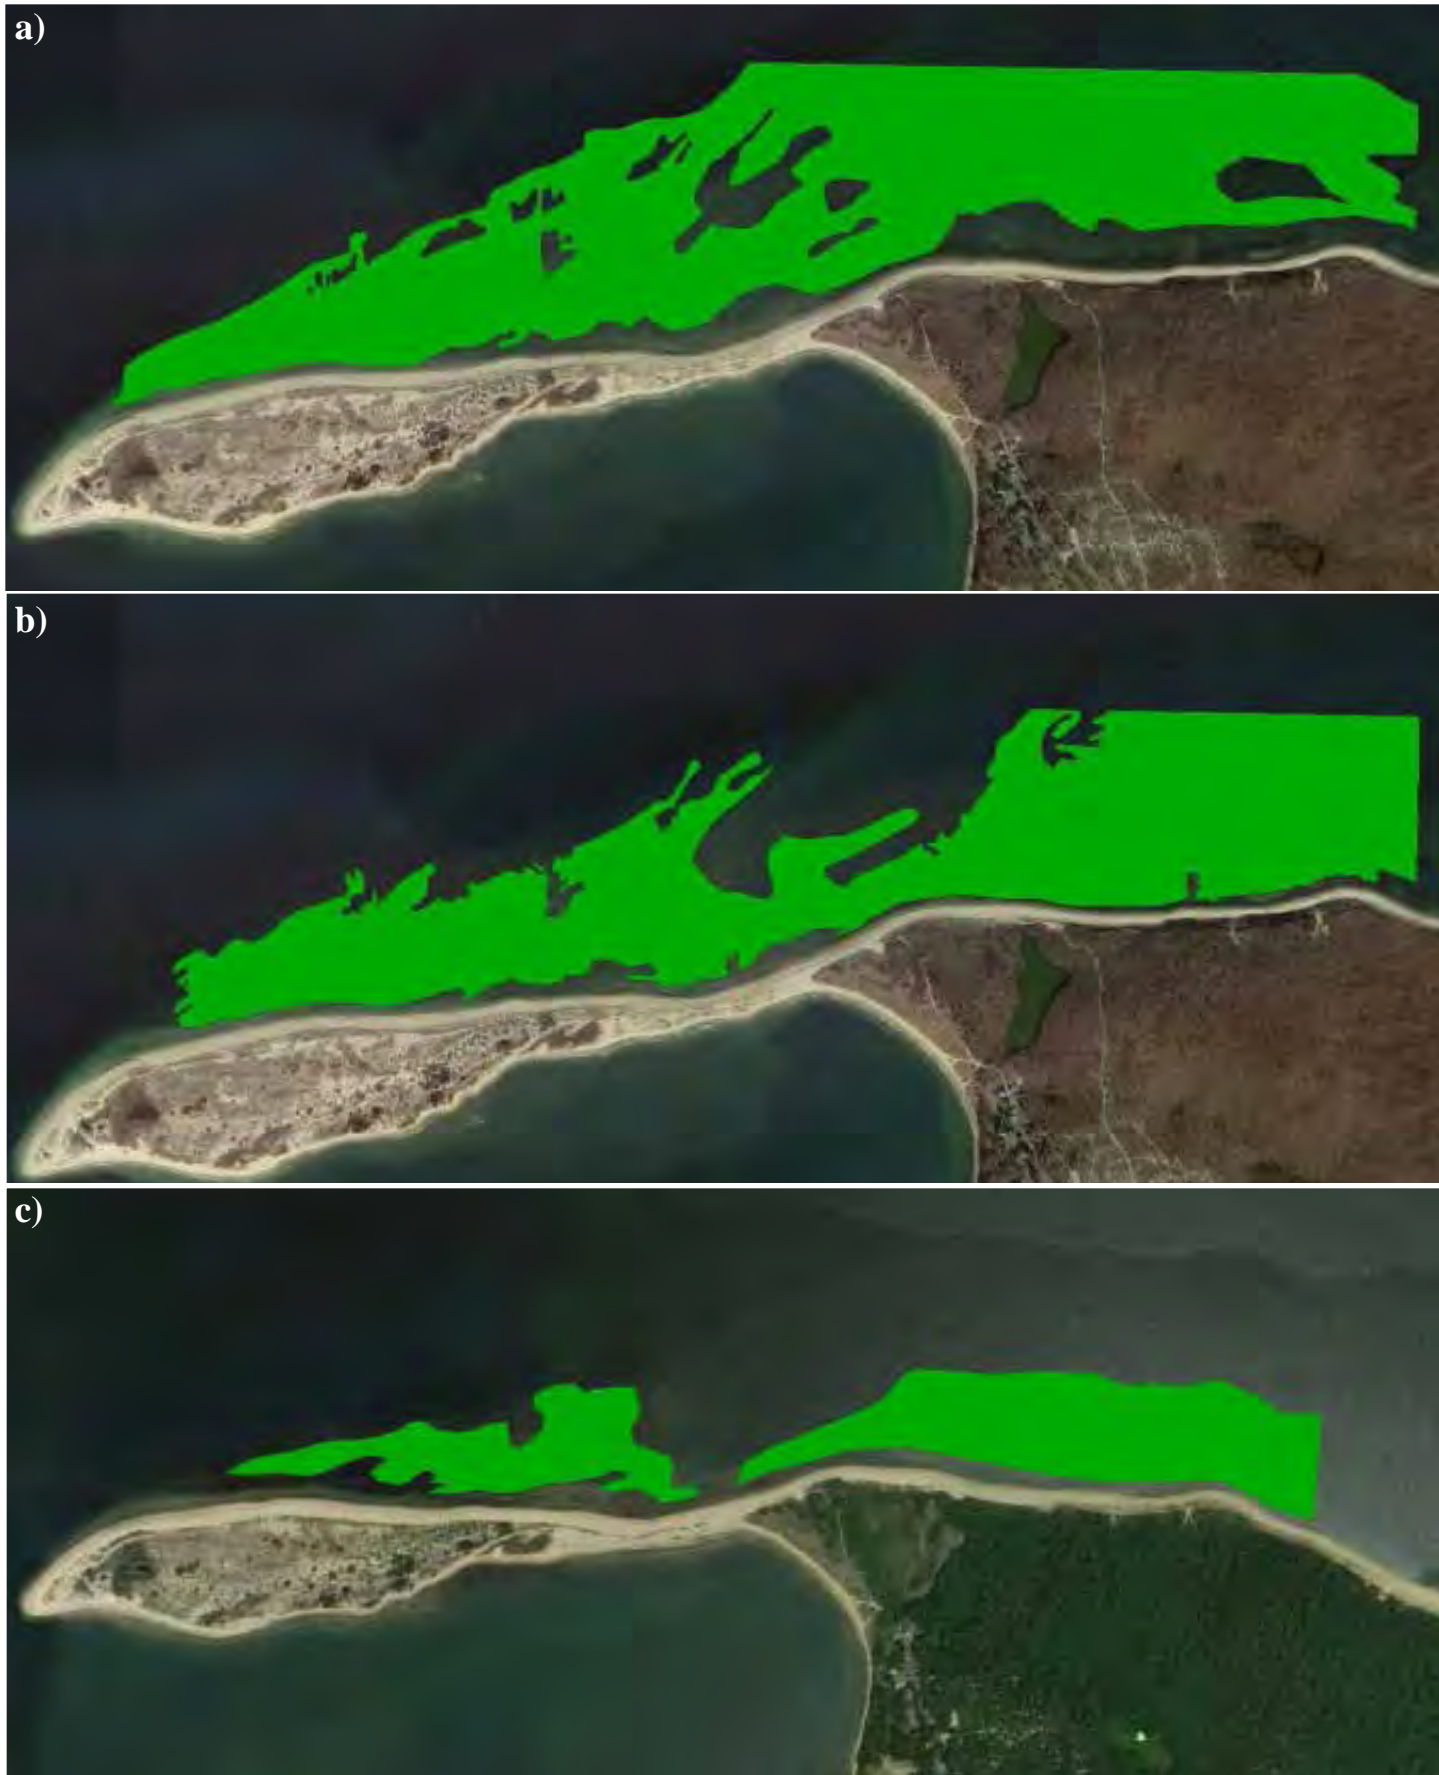
Figure CP-5. Delineations of the Cedar Point eelgrass meadow from aerial photographs for a) 2004, b) 2010, c) 2014, d) 2016, e) 2017, and f) 2018 (continued on next page).

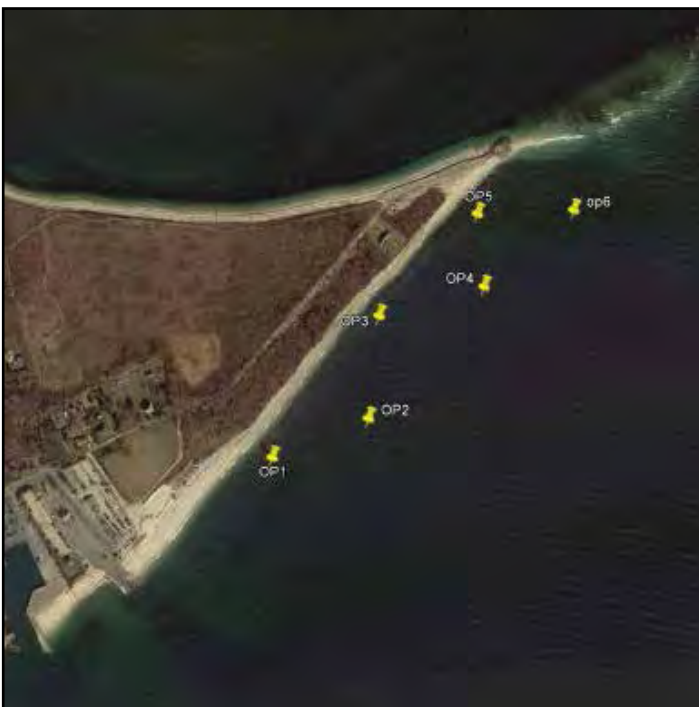
Figure OP-1. An aerial view of the Orient Point monitoring site with monitoring stations indicated by the superimposed numbers.

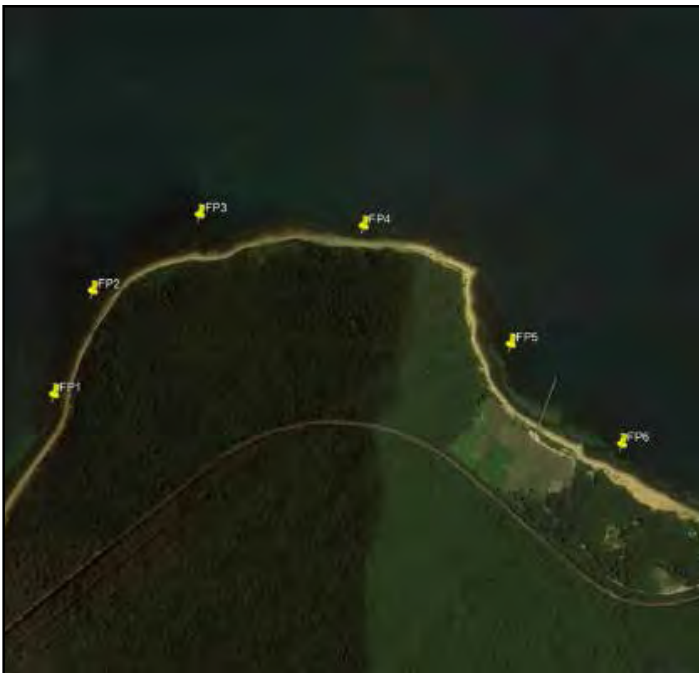
Fort Pond Bay is the easternmost eelgrass meadow in the LTEMP. The meadow starts in Fort Pond Bay near the pier at the Edward Vincent Ecker, Sr. County Park, extends north, then west toward Hither Hills State Park (Figure FP-1).

Figure FP-1. An aerial view of the Fort Pond Bay monitoring site with monitoring stations indicated by the superimposed numbers.

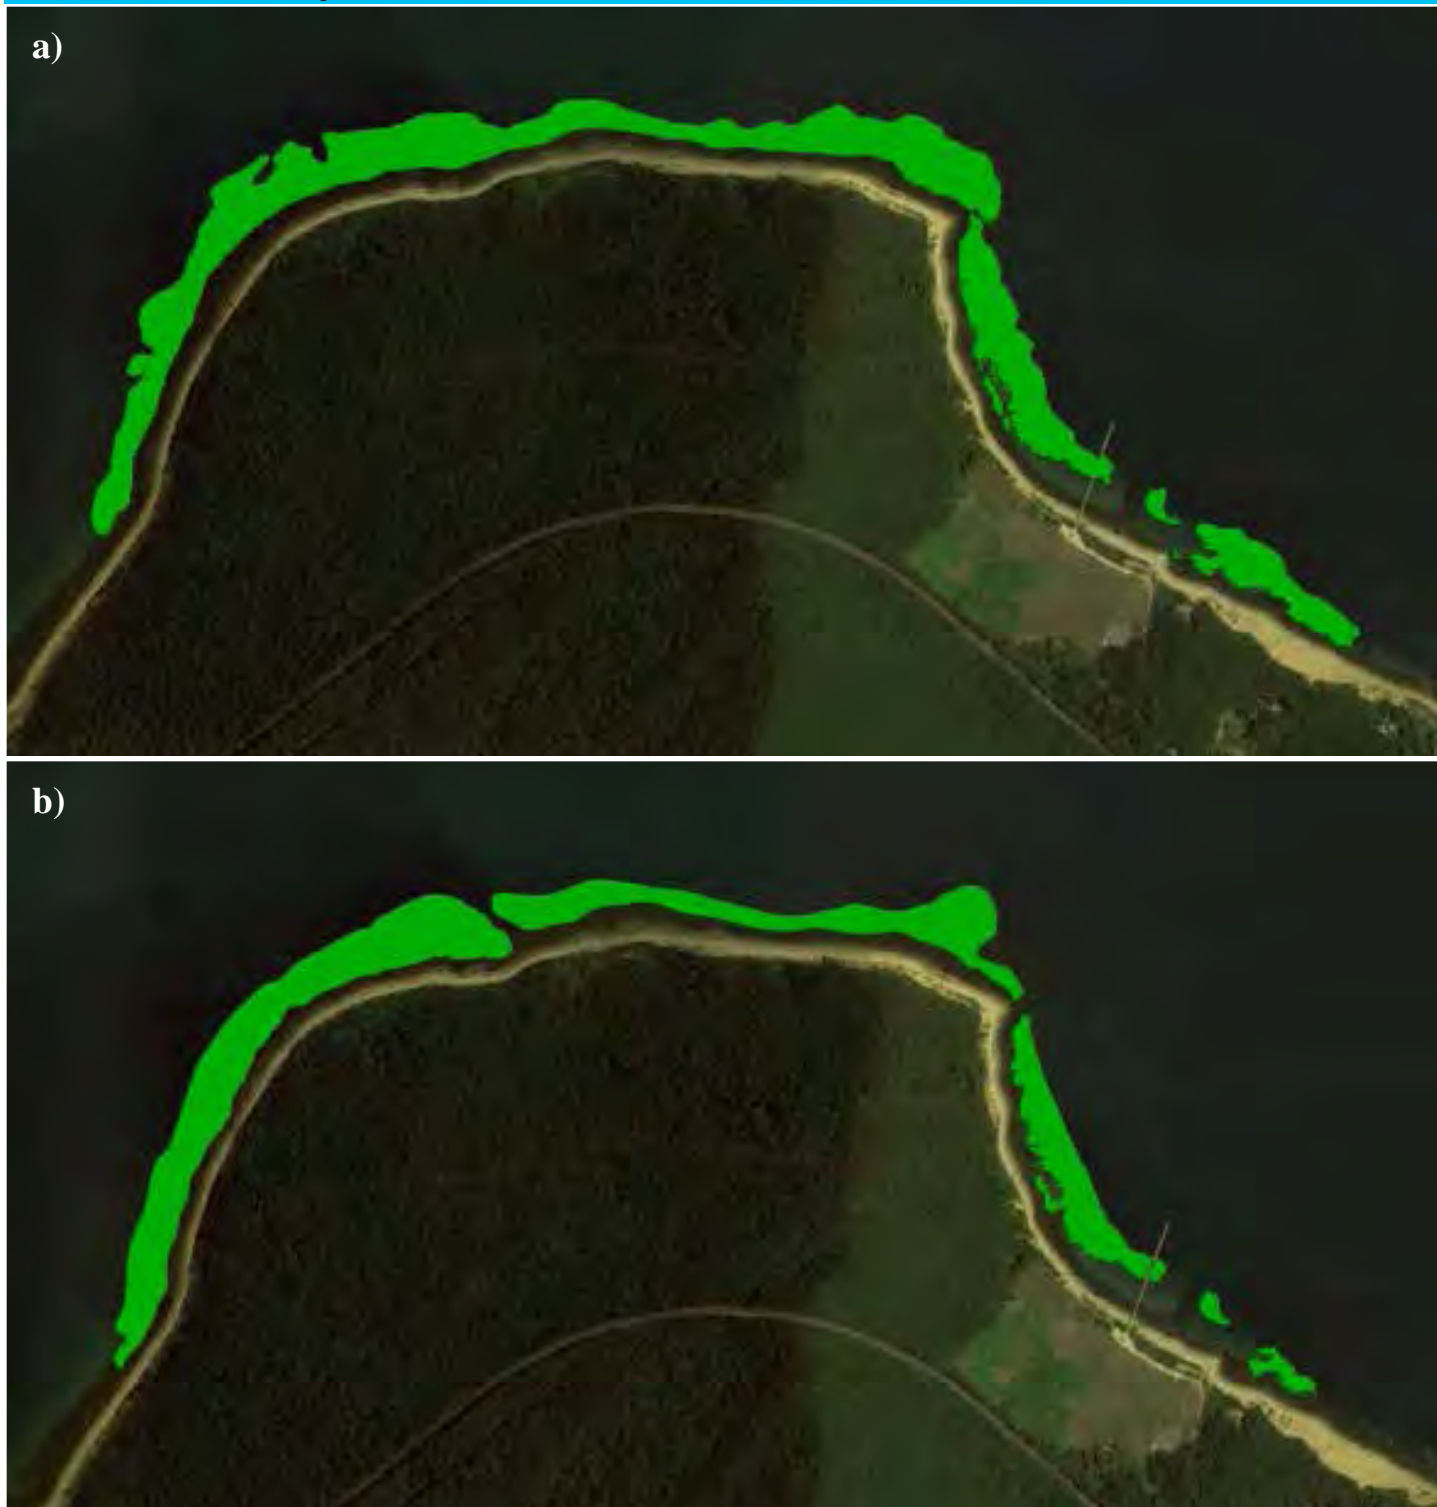
Figure FP-2. A comparison of Fort Pond Bay eelgrass meadow delineations completed in a) 2017 and b) 2018.

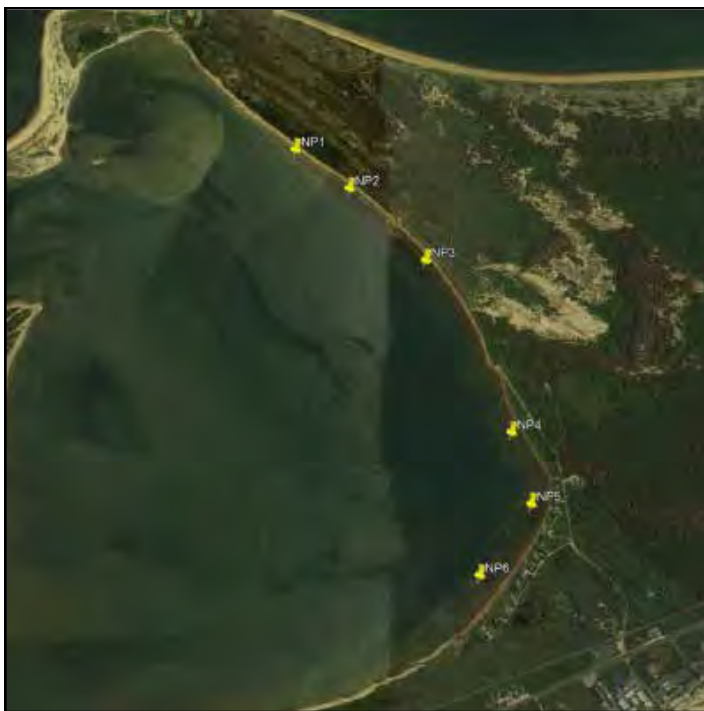
Napeague Harbor is an enclosed embayment located in East Hampton and opens into Napeague Bay. The eelgrass meadow is situated in a shallow band along the east side of the harbor (Figure NAP-1).

Figure NAP-1. An aerial view of the Napeague Harbor monitoring site with monitoring stations indicated by the superimposed numbers.

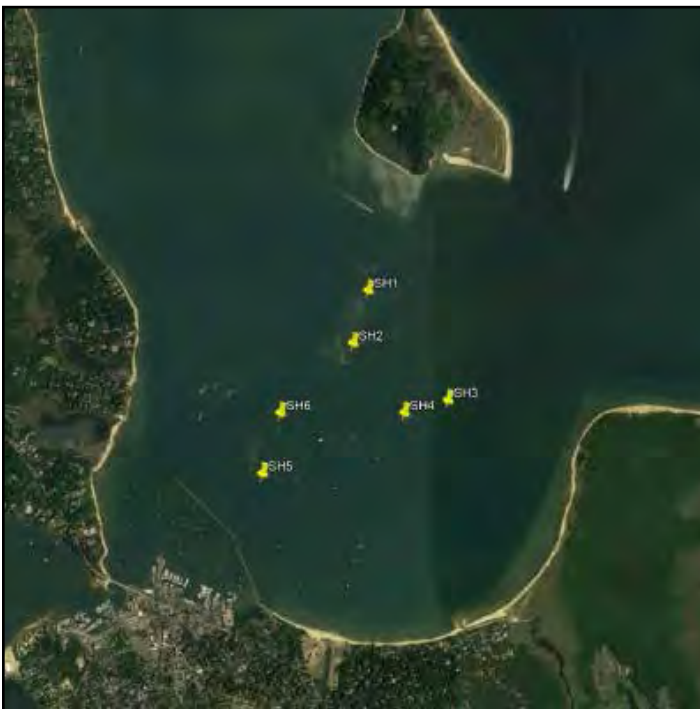
Sag Harbor Bay is an open bay surrounded by North Haven (Southampton Town) to the west, Mashamock (Shelter Island) to the north and Barcelona Point (East Hampton) to the east. The eelgrass meadow monitored at this site is actually a group of distinct eelgrass beds within the bay. The LTEMP monitors three of these beds with 6 monitoring stations divided among the beds (Figure SH-1).

Figure SH-1. An aerial view of the Sag Harbor Bay monitoring site with monitoring stations indicated by the superimposed numbers.
