# Paul Stoutenburgh Preserve Restoration Studies Stakeholder Update

May 26, 2023

# Project Progress Summary

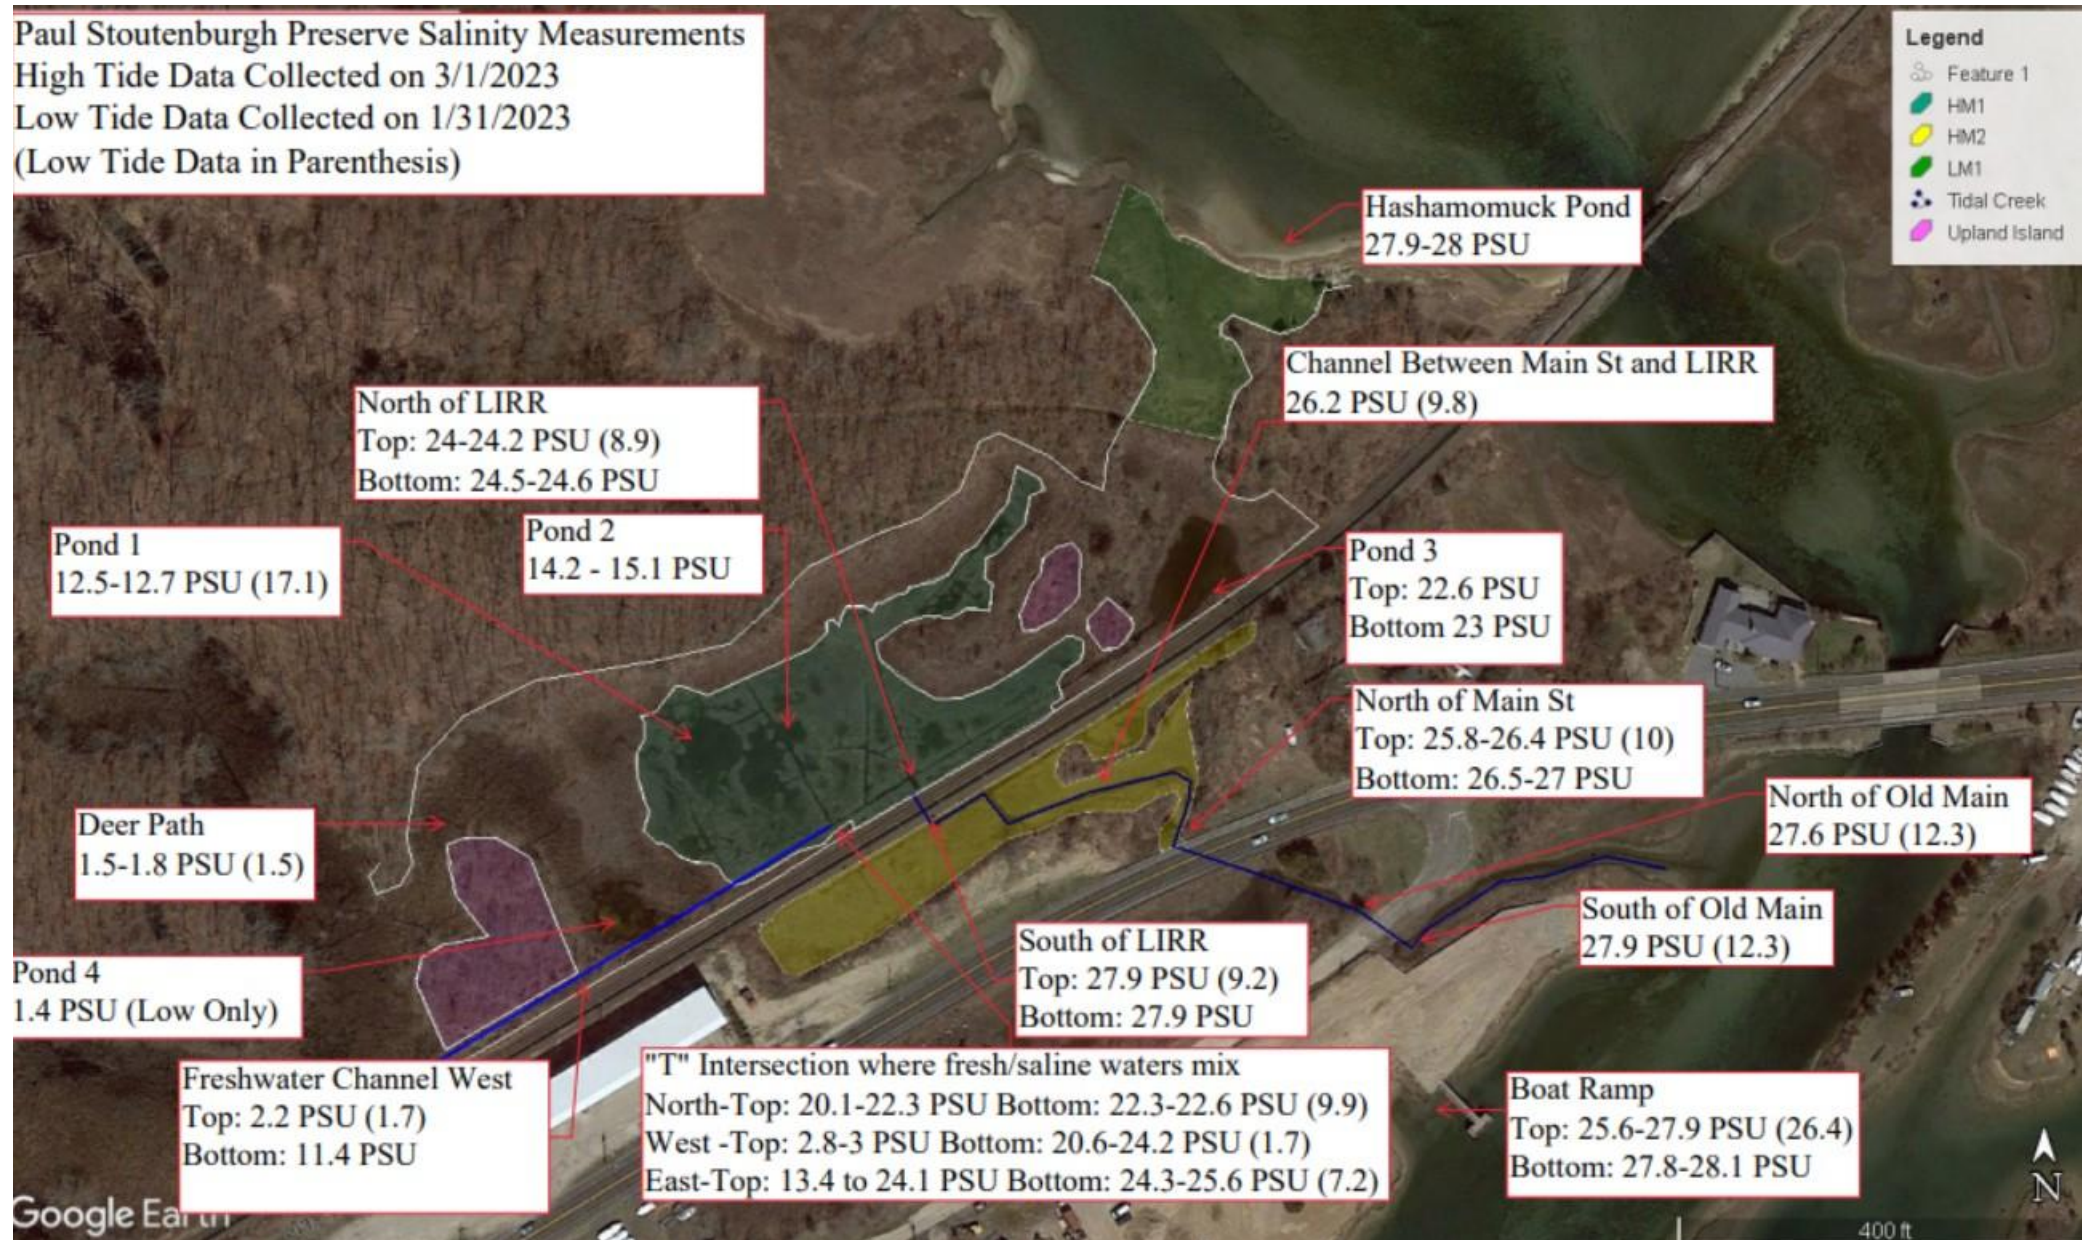
Paul Stoutenburgh Preserve Salinity Measurements  
High Tide Data Collected on 3/1/2023  
Low Tide Data Collected on 1/31/2023  
(Low Tide Data in Parenthesis)
